**RE: Cull Drain Truss Bridge (000310) on Old Lakeshore Road**

On September 24, 2013 BMROSS reviewed the Cull Drain Bridge for the purpose of providing repair options for the structure. By way of this letter-report, we wish to make our observations, and recommendations, provide a work plan, and a budget. A site location map is provided in Appendix 'A'.

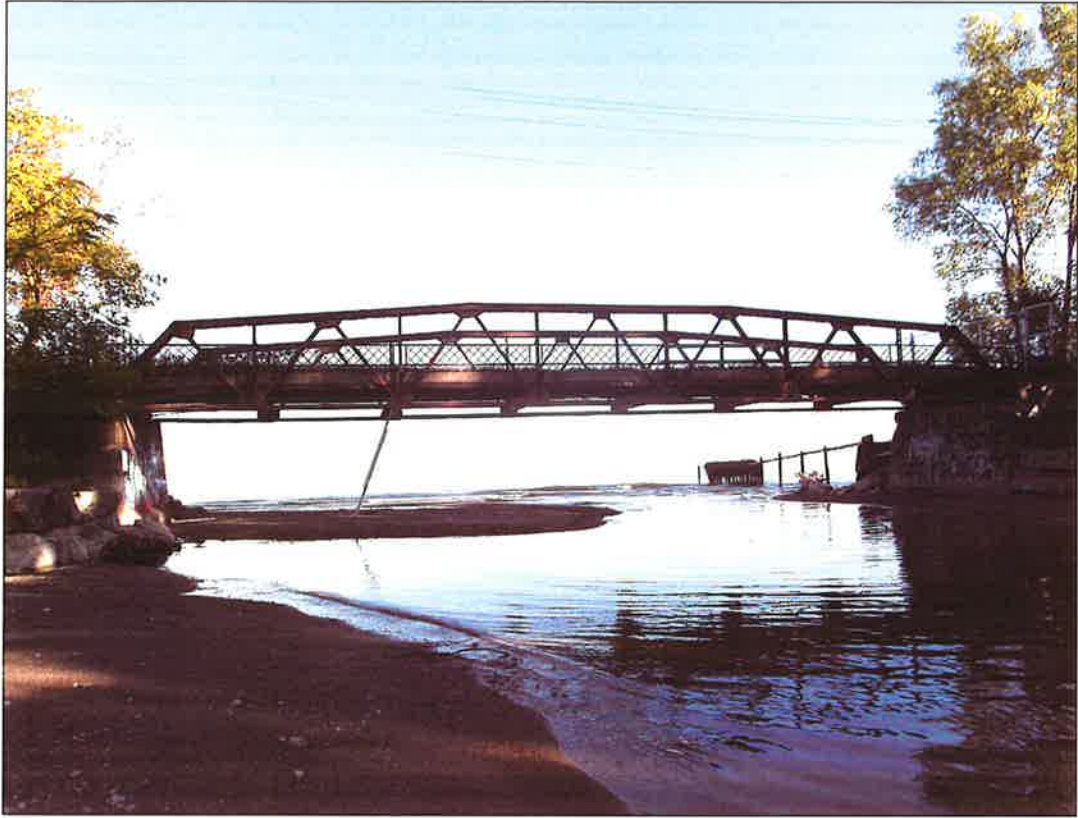
**South Elevation**

The bridge is a riveted steel half-through truss with a clear span of 28.7 m and a bearing span of 30.5 m +/- . The truss is supported by back-battered mass concrete abutments. Site photographs are provided in Appendix 'B'.

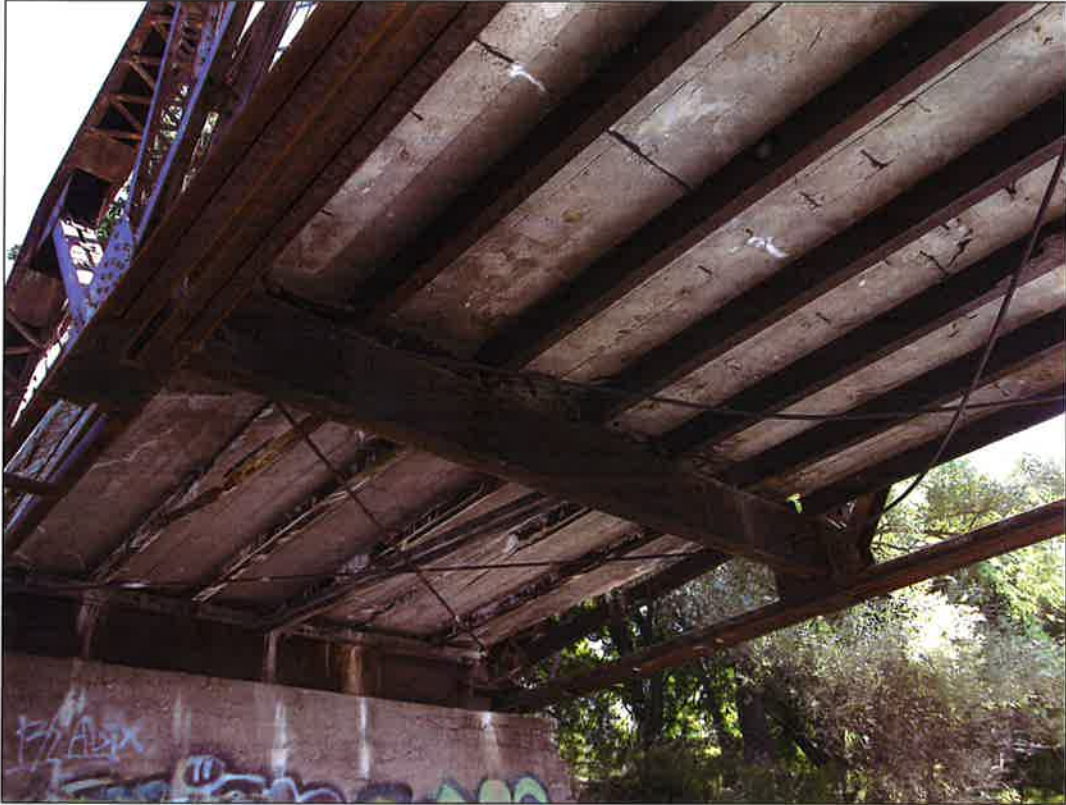
The concrete deck is estimated to be 160 mm to 170 mm thick with an outside to outside width of 5.0 m. The deck is in poor condition and has failed at the most easterly bay of the structure due to a lack of support from the disintegrated deck stringers below. The bottom mat of reinforcing steel is exposed at many locations due to a lack of concrete cover under the steel. The top of the deck is hidden below asphalt and gravel with an average estimated thickness of 100 mm and could not be observed.

**Deck Failure – East Bay**

REPLACE CONCRETE DECK AND CURBS

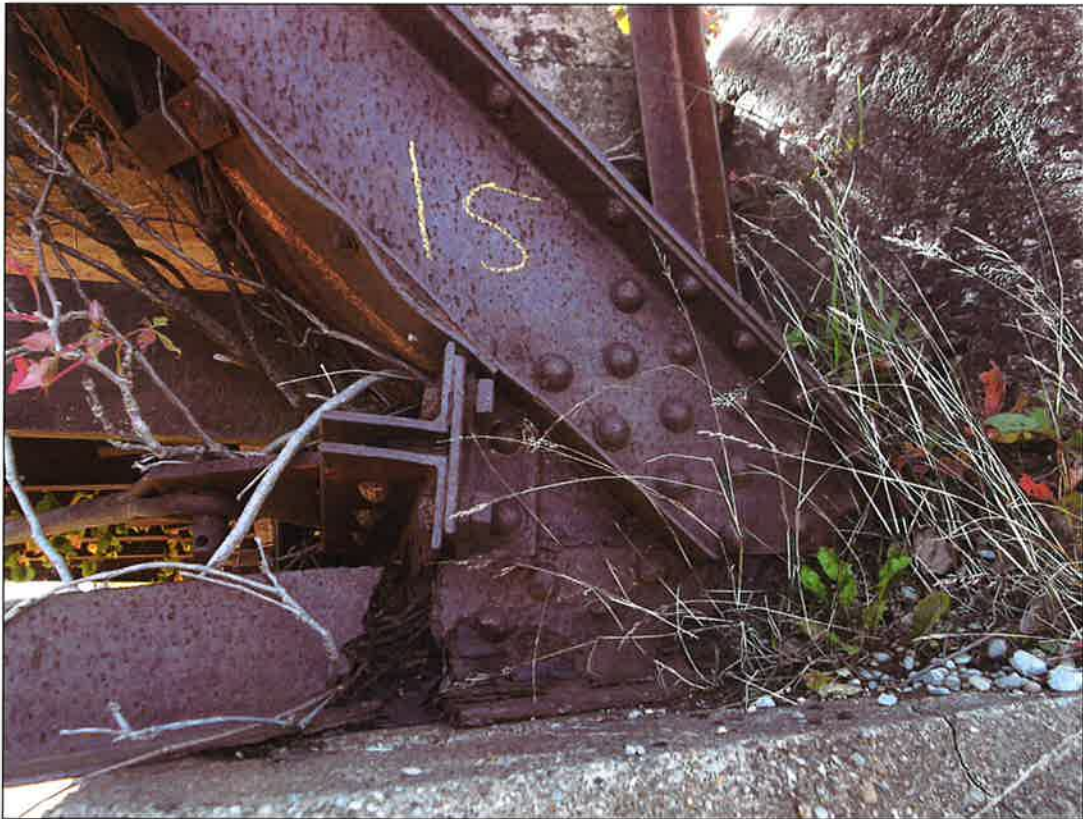
The top chord consists of 2 – C-channels back to back connected to a top plate with rivets. The C-channel components appear to be predominately in fair condition. However, pack rust is forming between the C-channels and the top plate which could cause the connecting rivets to fail in tension in the 5 to 10 year period. The C-channels are in poor condition at the locations of the bearing seats.

The bottom chord consists of 2 angle irons back to back in the outside bays and 4 angle irons back to back in the interior bays. The angle irons are completely disconnected from the truss at all 4 bearing locations. Also the bottom leg of the bottom chords are perforated at a number of locations along the length of the truss at various gusset locations.

The two abutments appear to be mass concrete. The lower 0.6 m of the west abutment and the outside edges of both abutments are delaminated. Some narrow cracks can be observed on the west abutment at the bearing seat locations. Delaminations, cracks and spalling can be observed at the bearing seats of the east abutment. The remainder of the abutments sounded to be in fair condition when struck with a hammer.

**Bearing Seat at Northwest Corner of Bridge**

REPLACE BEARINGS, REINFORCE  
TOP CHORD AT BEARING SEAT

PATCH REPAIR EDGES, BOTTOM, AND  
BEARING SEATS OF WEST ABUTMENT

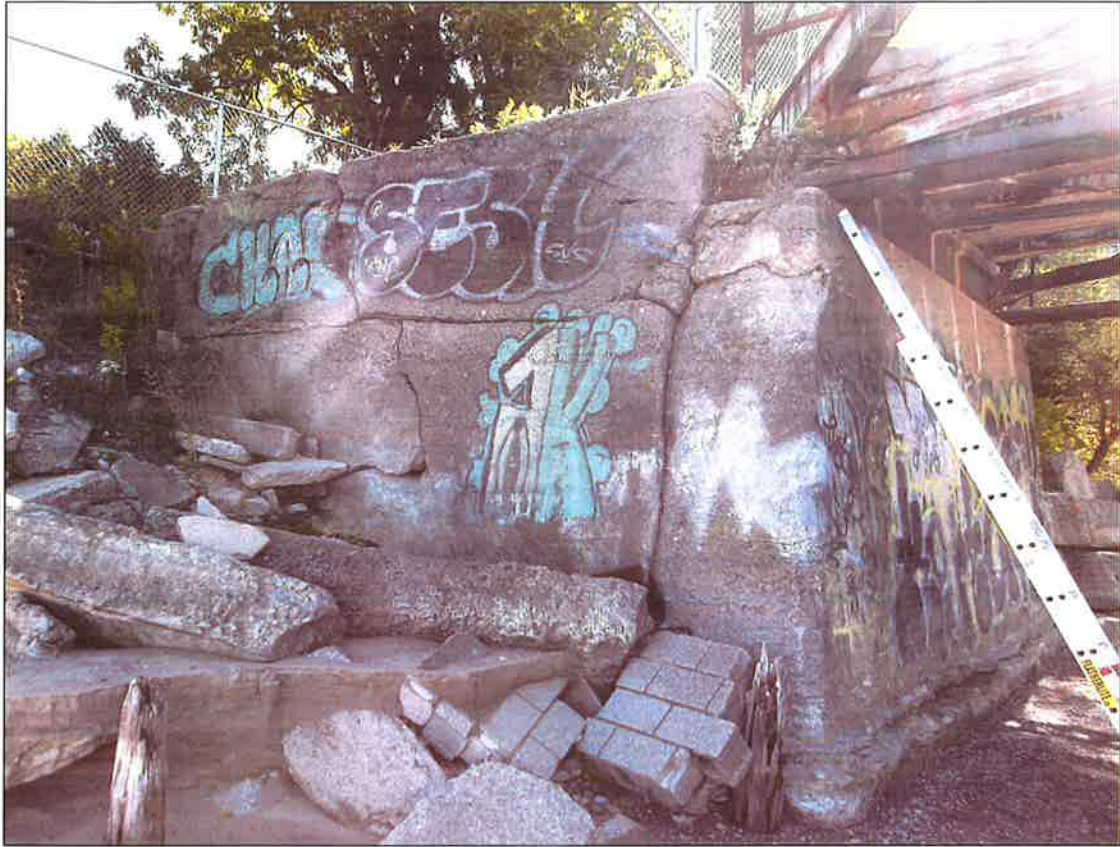
The northeast wingwall is cracked across its full width in a number of locations and has failed. The northwest wingwall is cracked and delaminated. Mass concrete blocks are used as front fill at both of the wingwalls on the north side of the structure.

**Northeast Wingwall**

REPLACE NORTHEAST  
WINGWALL WITH NEW  
GABION BASKETS
