## SHOREPLAN

November 30, 2017

### RE: 834 Lakeshore Road, Sarnia, Ontario Shoreline Hazards Assessment Our File 17-2577

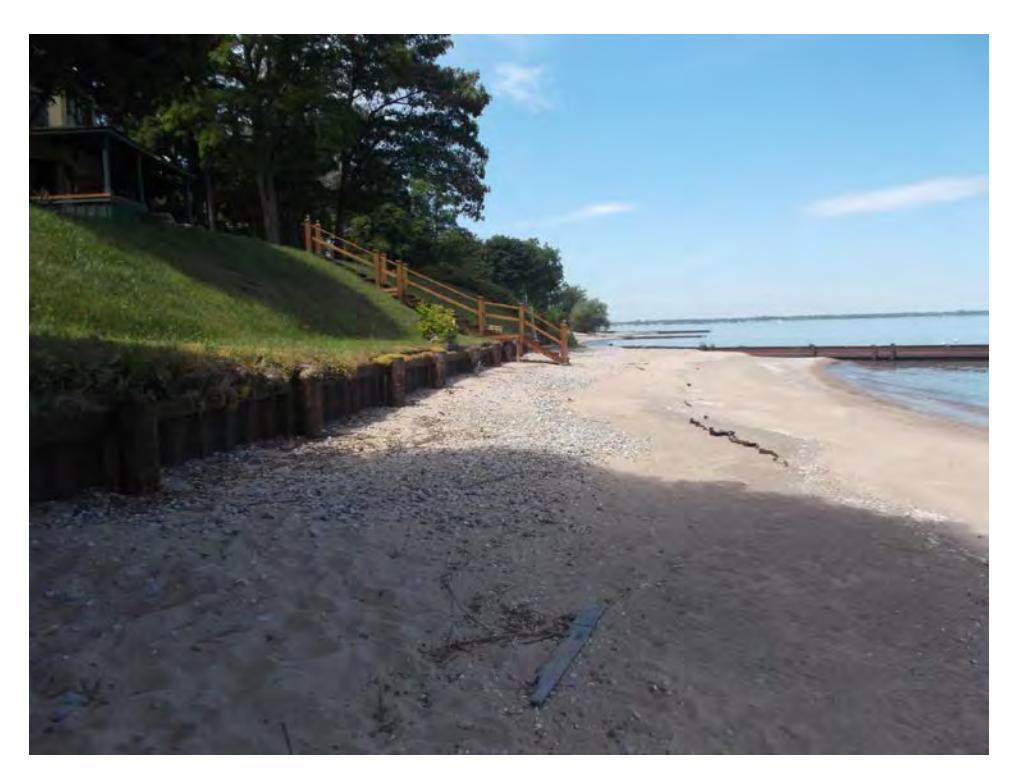
The property is fronted by a sand beach (Photo 1). The beach slope above the waterline is in the order of 14h:1v. The back of the beach is delineated by a steel sheet pile (SSP) wall. The top of the wall is approximately 178.3 m GSC. The sand beach material extends from approximately 0.5 to 0.8 m below the top of the wall to almost to the top of the wall (Photos 1and 2).

Photo 1: 834 Lakeshore Rd Sarnia as seen from the east

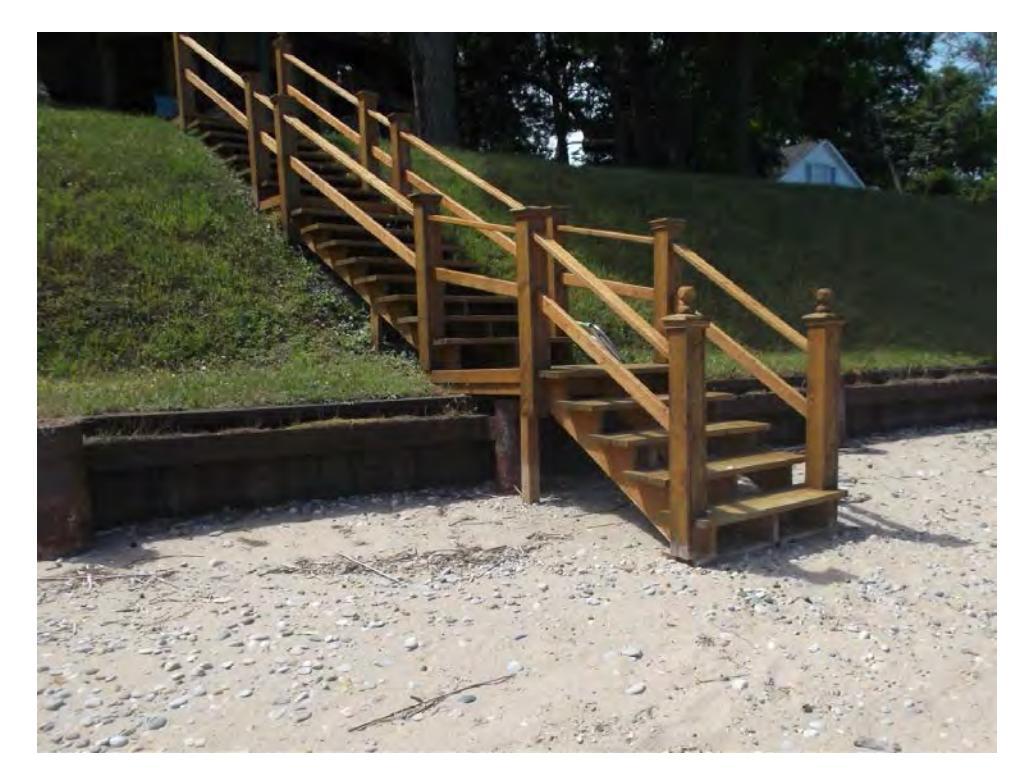
We understand, based on your conversations with the original contractor, Shoreline Maintenance And Construction Limited, that the original wall was constructed prior to 1990 and the pipe support piles were installed in about 1990. The SSP piles are 3.6 m to 4.2 m long and pipe piles fronting the SSP are approximately 6 meters long. The wall is vertical and no sign of excessive corrosion or pitting on the wall was seen.

The backshore is near flat behind the SSP wall for zero to two meters and then slopes up for approximately four to six metres. The average height of the slope is in the order of 3.5 m with average slope approximately 1.5h:1v or marginally steeper. The slope and flat area at the back of the SSP wall are vegetated. No signs of instability or surface erosion were observed (Photos 2 and 3).

Photo 2: SSP wall and slope at back of the beach

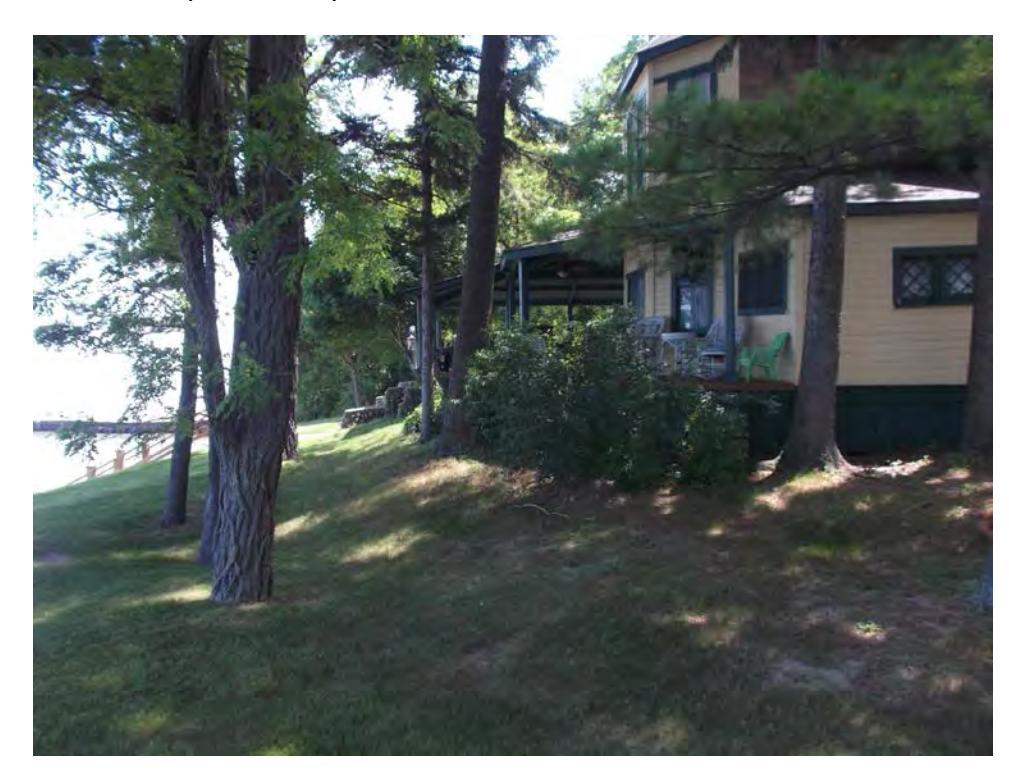
Photo 3: Top of the slope above the beach

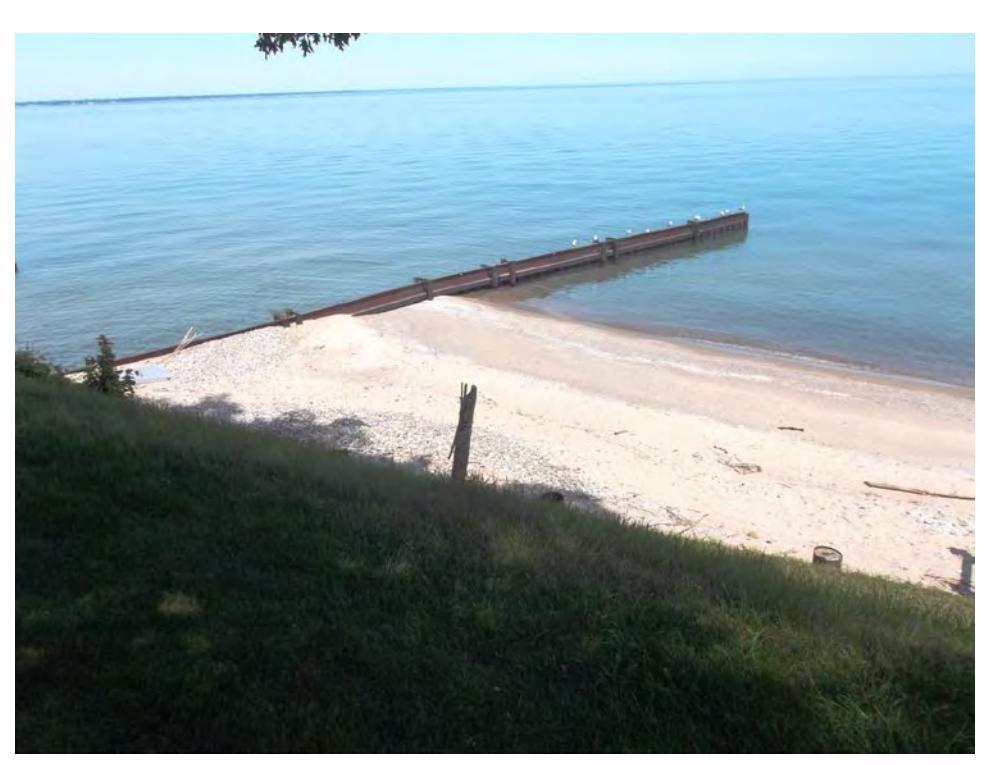
A steel sheet pile groyne approximately 30 meters long extends out near the west limit of the site (see Photo 4) and is responsible for retaining the sand beach in front of this property. The groyne curves slightly to the east as it extends out into the water. The details of the groyne construction or the date of construction are not known. The groyne appears to function well and no significant damage to the structure was noted. This groyne is a part of a groyne system that exists along this part of Lake Huron shoreline (see Photo 5).

Photo 4: Steel sheet pile groyne to west of subject property

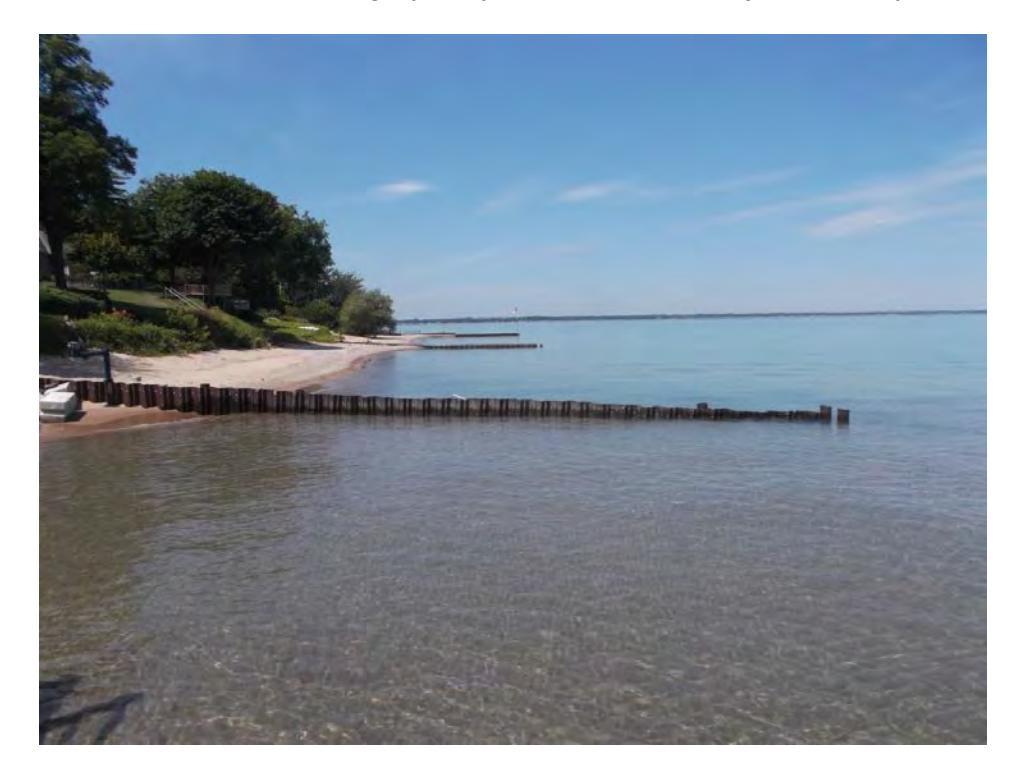
Photo 5: Steel sheet pile groyne system to west of subject property

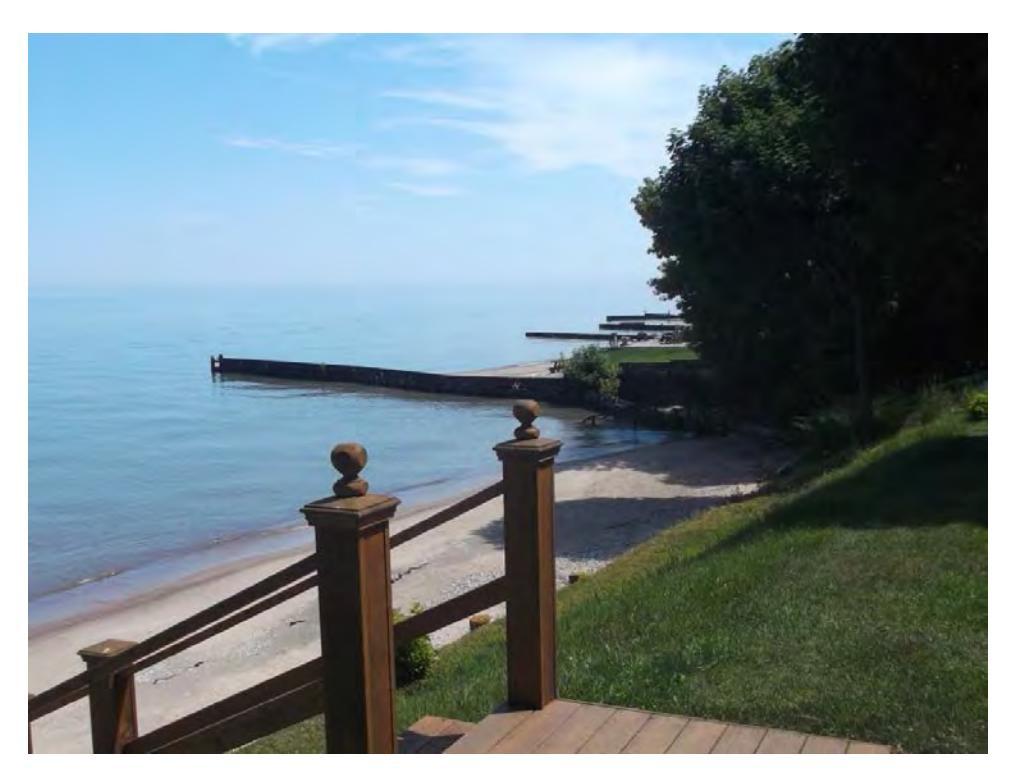
The shoreline to the east of 834 Lakeshore Road consists of a similar sand beach backed by wall structures at the back of the beach. A groyne, approximately fifty metres long extends out at the east side of the adjacent property (see Photo 6).

Photo 6: Steel sheet pile groyne to east of subject property

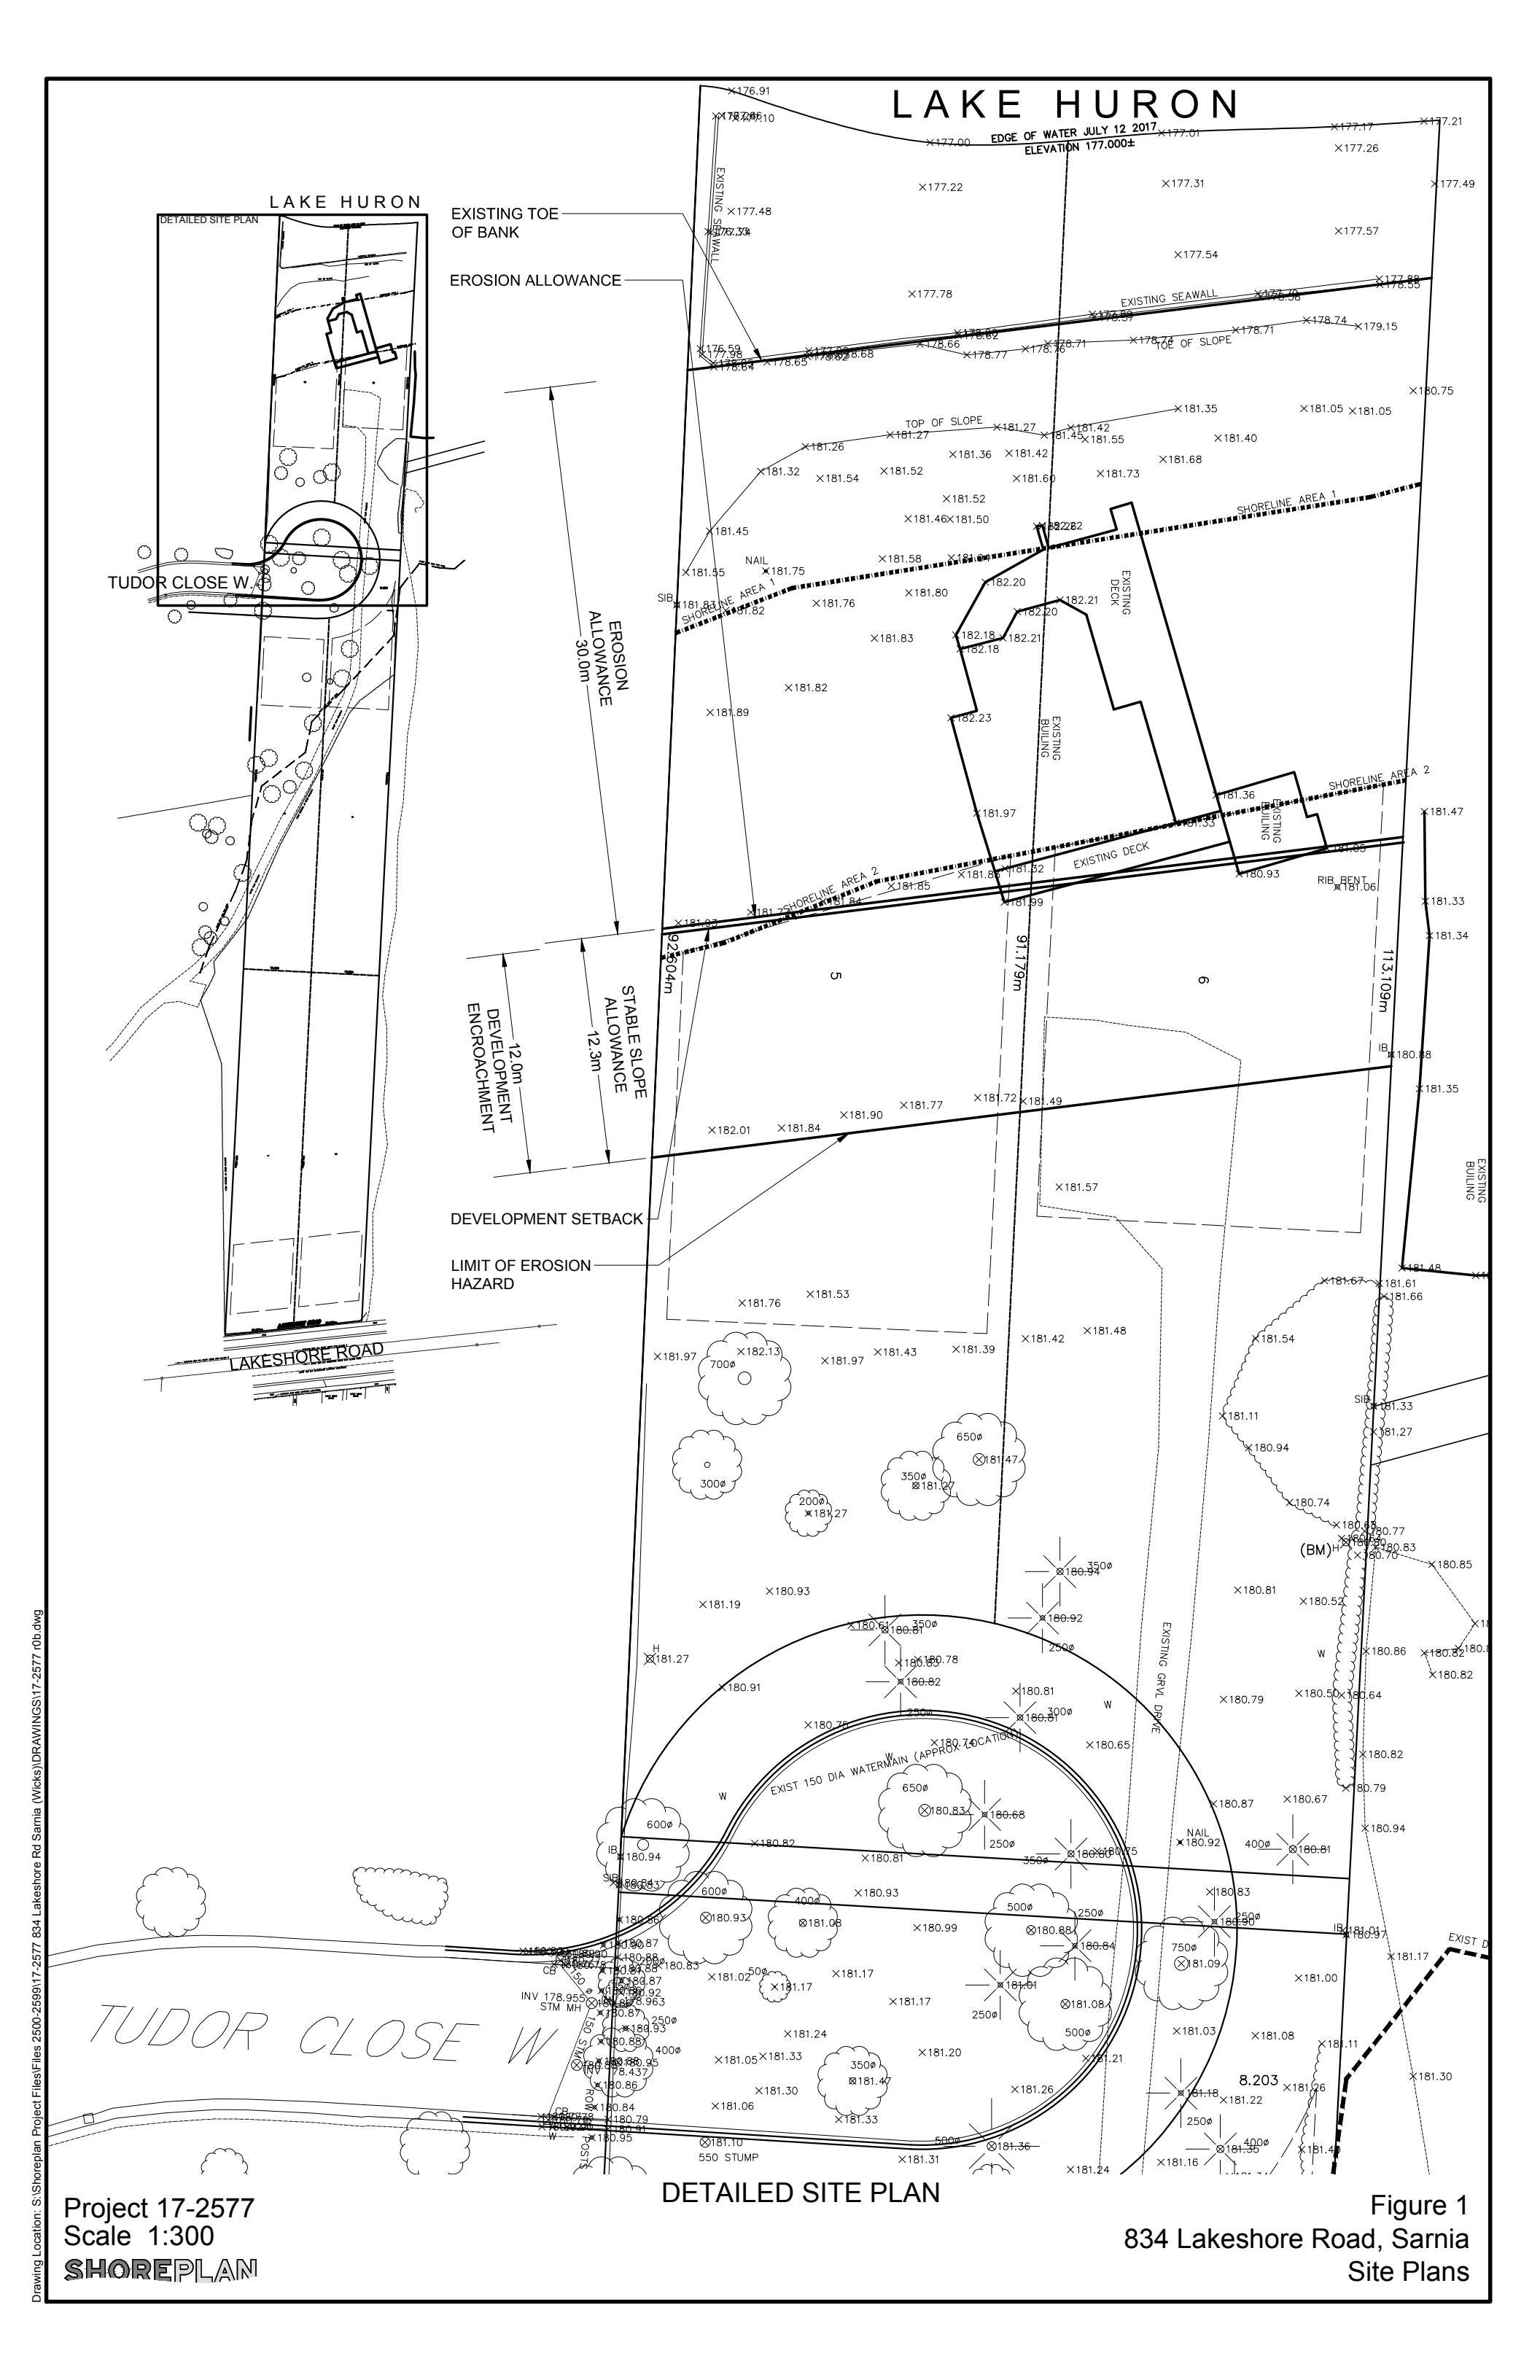
The erosion hazard is the sum of the erosion allowance and the stable slope allowance and is 42.3 m (30.0 m + 12.3 m). The erosion allowance is applied from the toe of the slope at the steel sheet pile wall and is shown on Figure 1.

The maintenance access should be a minimum of 5 metres wide from the municipal roadway to and along the shoreline. Based on a 40 year structure life, development can encroach 12.0 m (0.3 m/year x 40 years) into the erosion hazard. The position of the development setback is shown on the site plan on Figure 1. The development setback is in line with existing development along the shoreline.
