THE CORPORATION OF THE CITY OF SARNIA
People Serving People

ENGINEERING DEPARTMENT

OPEN SESSION REPORT

SUBJECT: 2018 Donohue Bridge Project Update

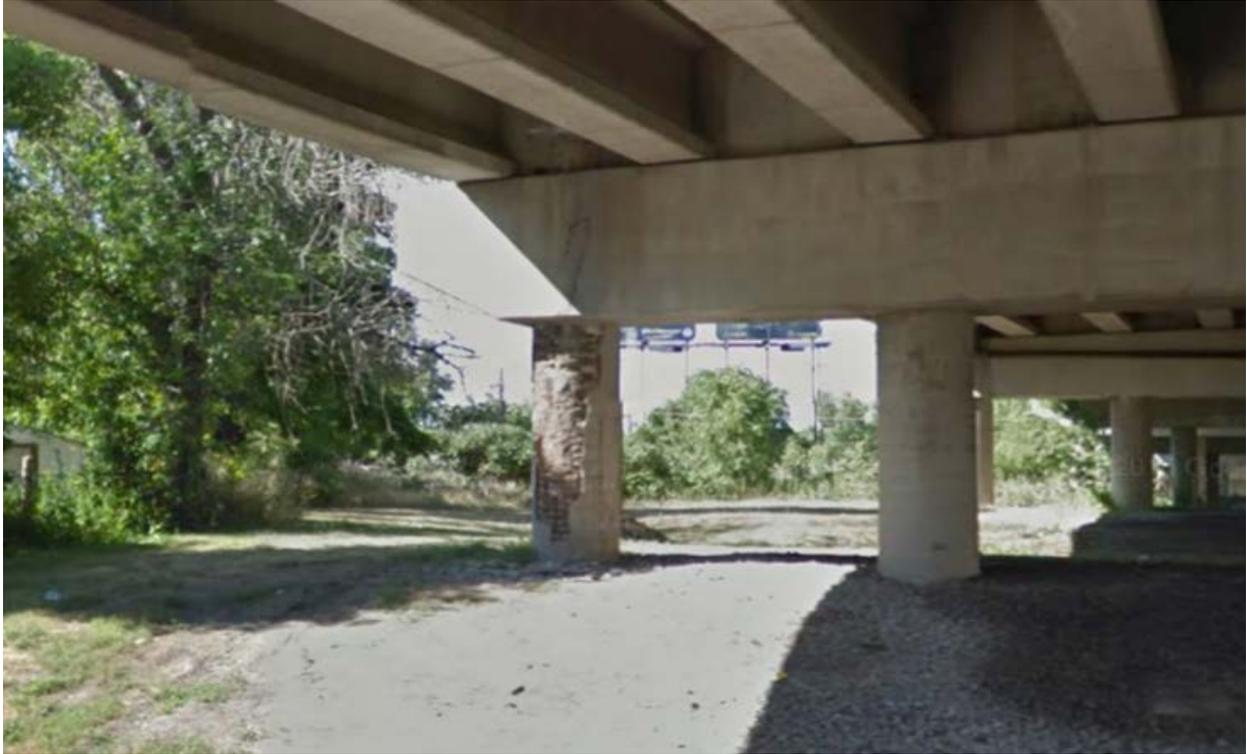
Above: Column in need of repair. Deteriorated concrete cover and corroded reinforcing is visible in 2012.

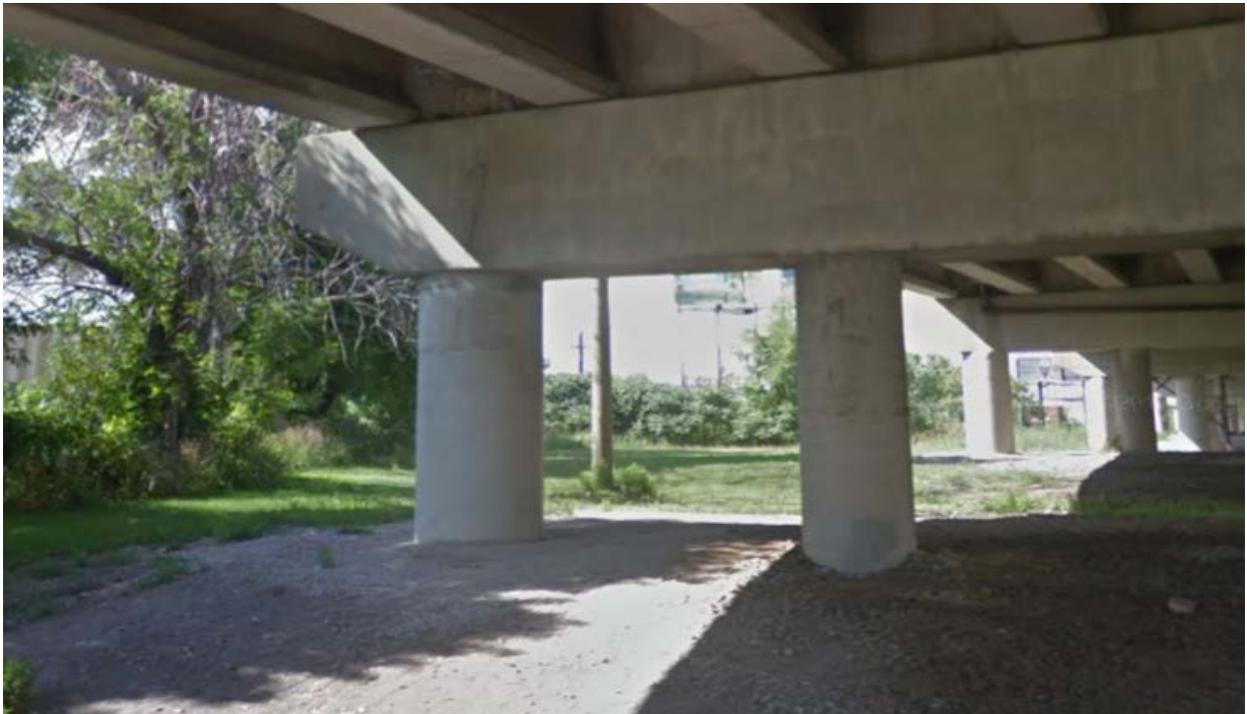
Above: Typical Column Repair completed in 2013.

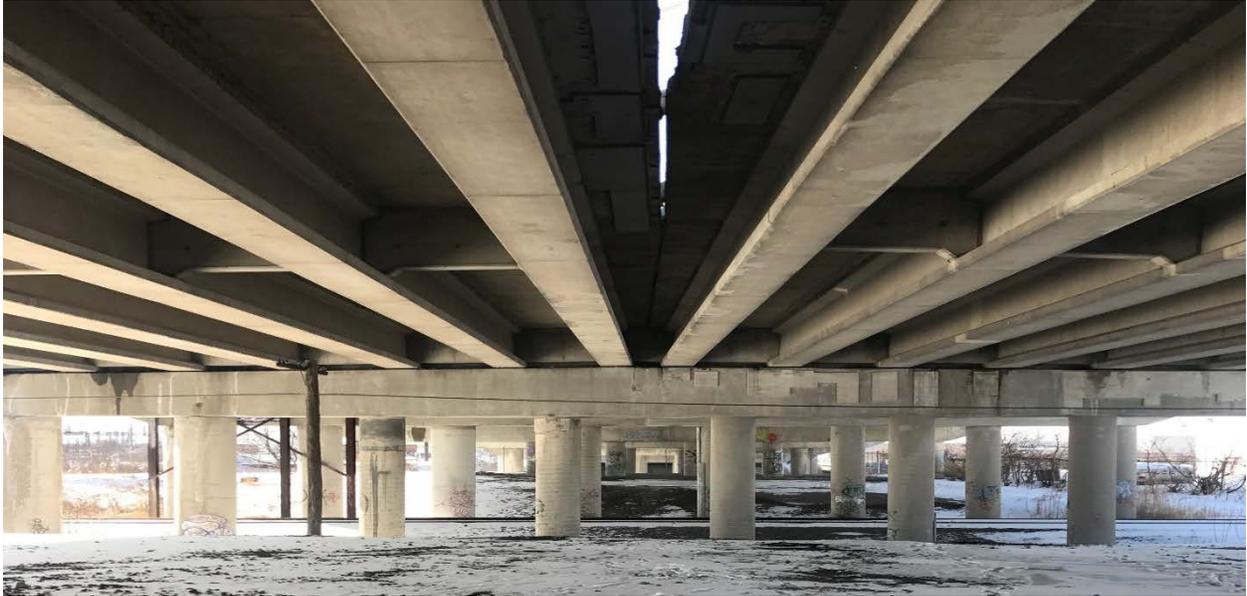
Magnitude of size of Structure

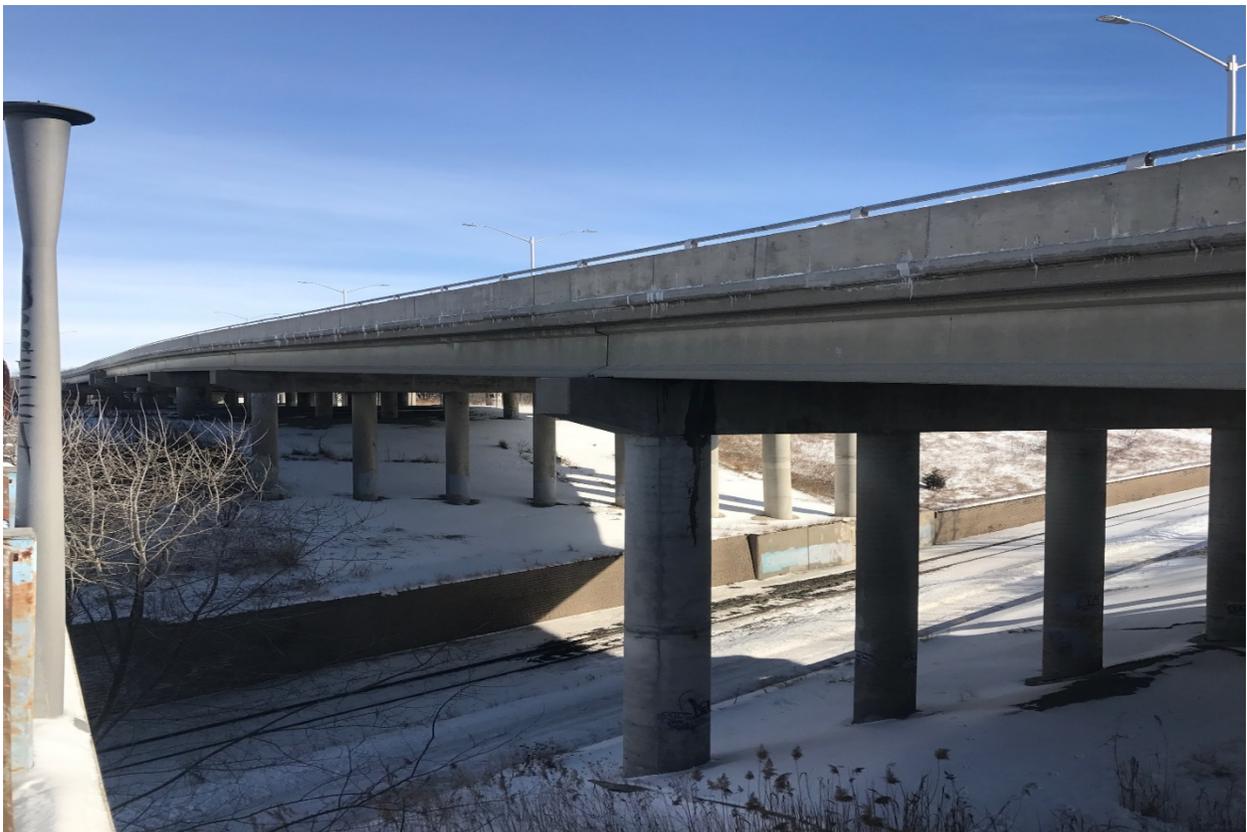
Columns repairs extremely close to CN Tracks which requires delays in work for passing trains

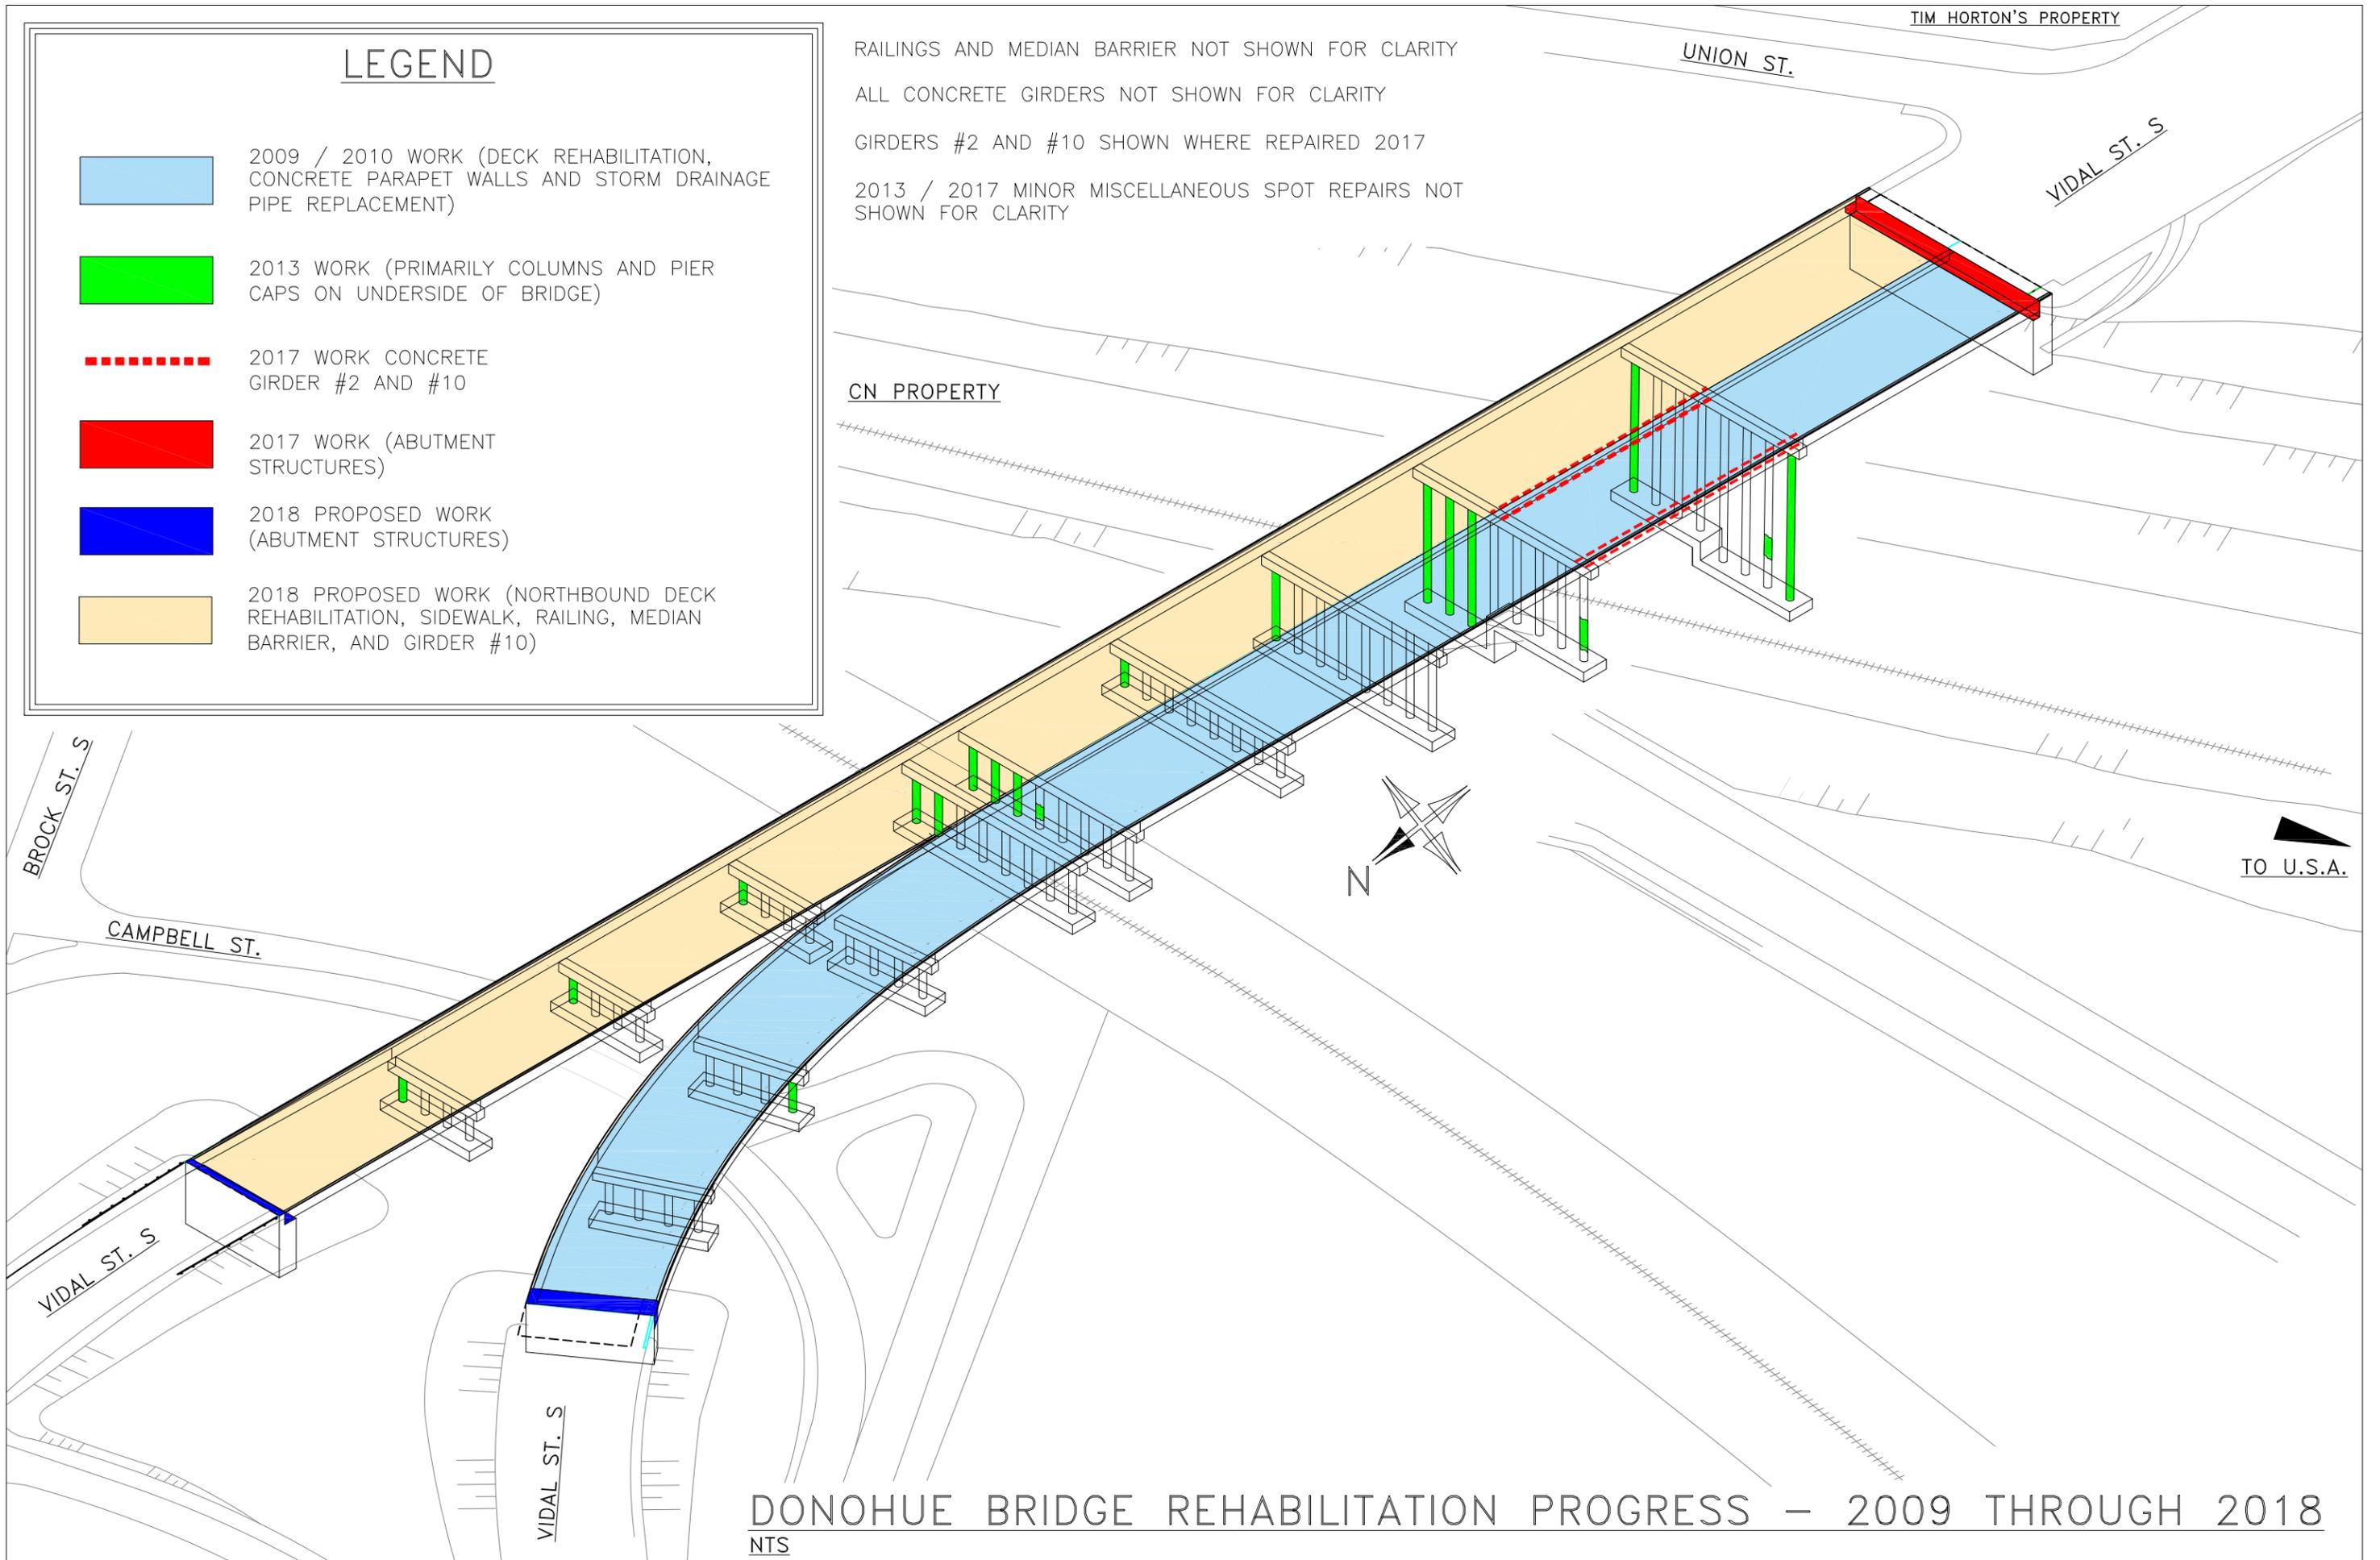
DONOHUE BRIDGE REHABILITATION PROGRESS – 2009 THROUGH 2018
 NTS

RAILINGS AND MEDIAN BARRIER NOT SHOWN FOR CLARITY
 ALL CONCRETE GIRDERS NOT SHOWN FOR CLARITY
 GIRDERS #2 AND #10 SHOWN WHERE REPAIRED 2017
 2013 / 2017 MINOR MISCELLANEOUS SPOT REPAIRS NOT SHOWN FOR CLARITY

This report is being provided to Sarnia City Council to accompany the attached drawing prepared by City staff. The drawing titled, Donohue Bridge Rehabilitation Progress – 2009 through 2018, was prepared to offer a visual understanding of the various bridge components that have received rehabilitation in past projects. It is also very helpful in understanding how significantly large a structure the Donohue Bridge is. The drawing is an isometric view looking down from the northwest above the bridge.

The various project years and components have been referenced by different colours. This is helpful in understanding how much of the bridge has been rehabilitated and even more helpful in understanding how much of the

bridge is original. For clarity, the girders and diaphragms were not shown on the drawing. Individual repairs to some substructure components were also not shown as they were too numerous and random to accurately portray.
