JR Capital Holdings Inc.

Phase Two Environmental Site Assessment
1873 London Line, City of Sarnia

GMBP File: 219125

July 2019

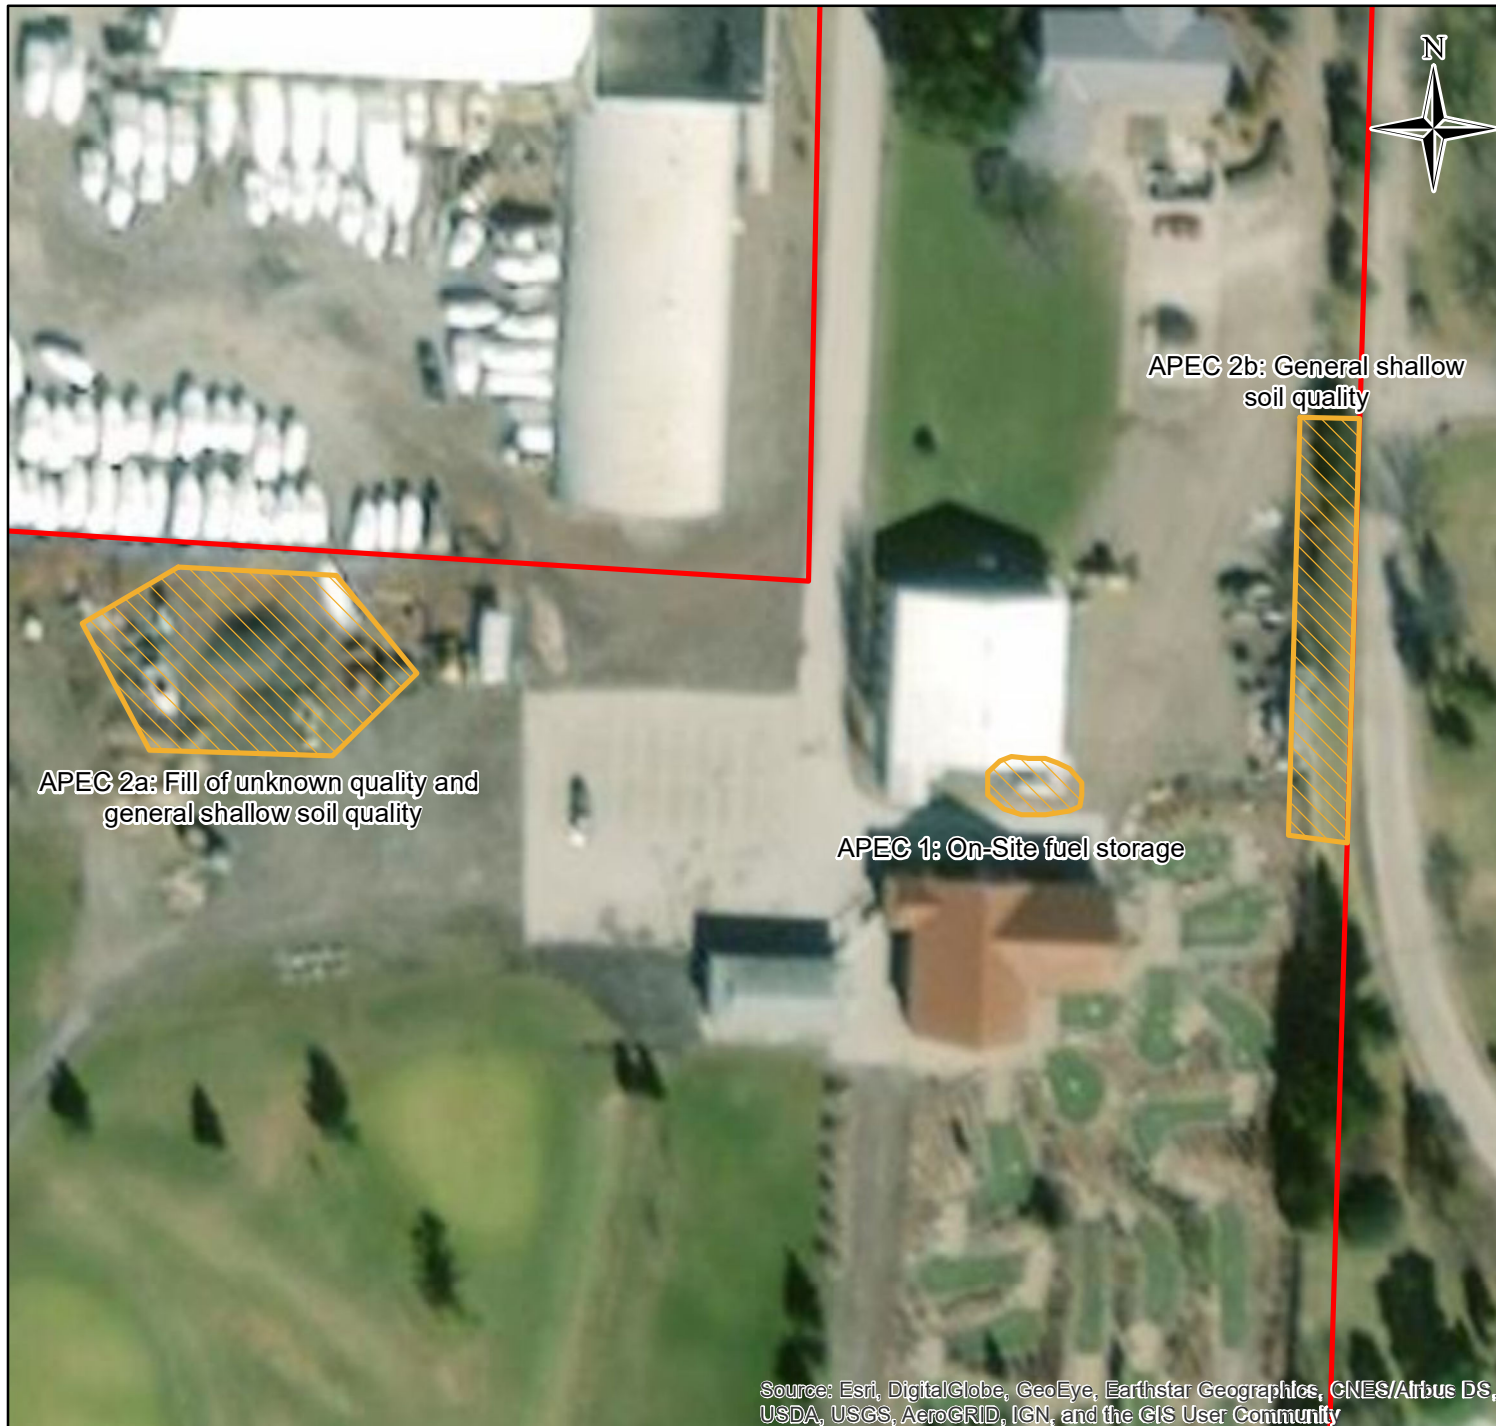
Figure 2: Site Layout
and APECs

The Site is approximately 9.2 hectares (47.6 acres) in size and is located in the east part of the City of Sarnia, south of London Line, east of Blackwell Side Road as presented on Figures 1 and 2. The Site is currently owned by JR Capital Holdings Inc., who operate a golf course on the Site. The Site has been historically under agricultural and landscaping/garden centre (nursery) use.

The results of the Phase One ESA indicated the following Areas of Potential Environmental Concern (APECs) regarding the property:

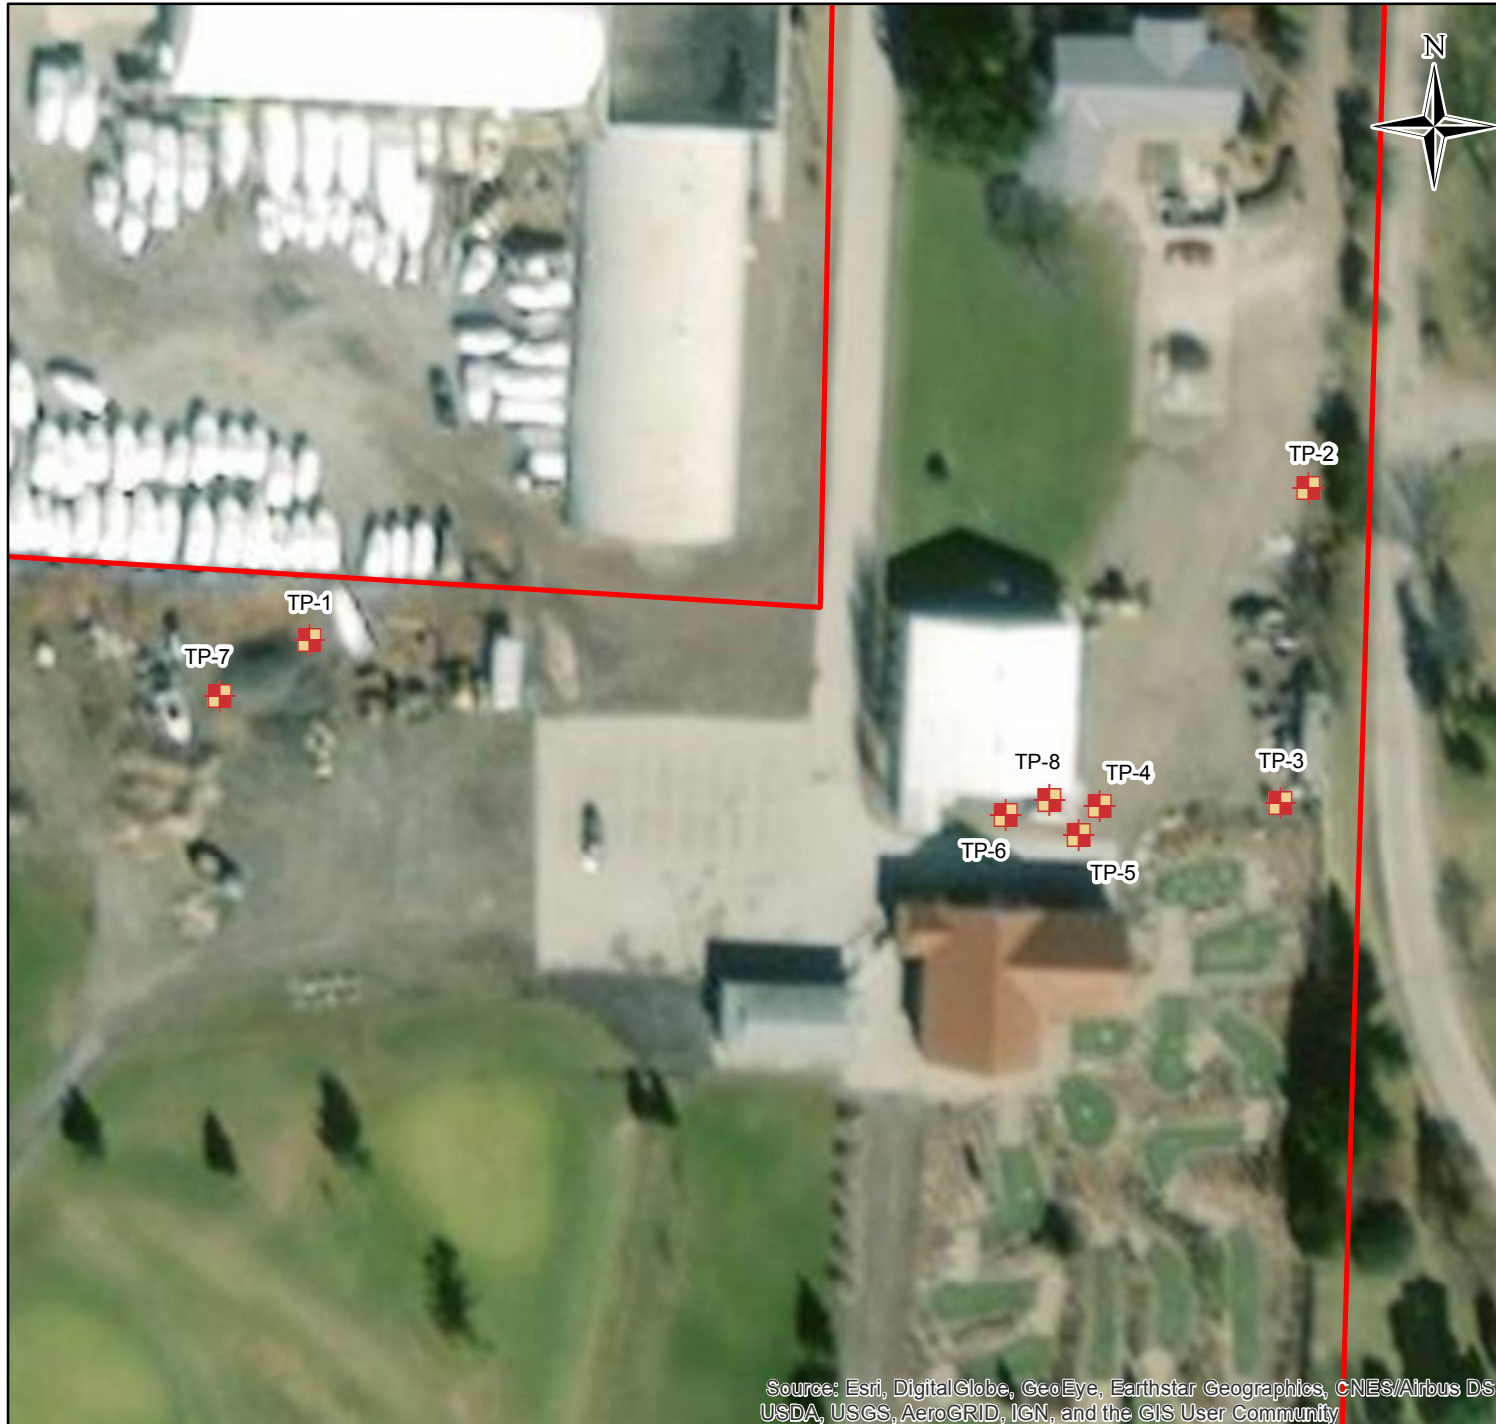
The subsurface investigation involved the excavation of eight (8) test pits/testholes (i.e. TP1 through TP8) at the locations shown on Figure 3 to depths from 0.5 to 1.7 mbgs. The test pits were located in areas that were accessible and reported as clear of utilities, in order to obtain information on the general soil quality and subsurface conditions throughout the property. Groundwater was encountered in TP1 and TP7 at the northwest portion of the property, and in TP4 east of the above ground storage tanks. Stratigraphic logs describing the soil conditions encountered during the investigation are provided in Appendix A. Select photographs of the test pits are provided in Appendix B.

Nine (9) soil samples, were submitted to the laboratory for one (1) or more of the following analyses: metals, PAHs, and PHCs. The samples were collected from depths ranging from 0 to 1.0 mbgs (from the overlying fill material) down to 1.5 mbgs, from the native clays at the investigated locations at the Site. The laboratory results are summarized in Table 2 (PHCs), Table 3 (PAHs) and Table 4 (metals), and the laboratory Certificate of Analysis is enclosed in Appendix C. The approximate locations of the investigative test pits are presented on Figure 3.

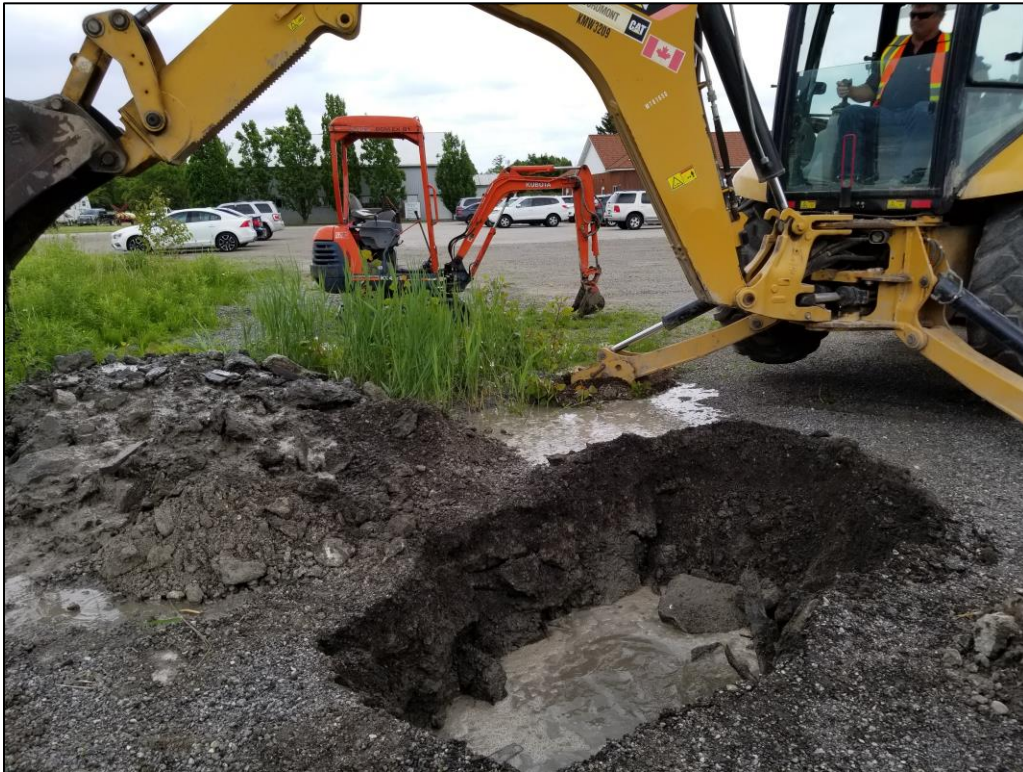
In the northwest portion of the Site (APEC 2a), granular fill material encountered from the ground surface to a depth of approximately 1.5 mbgs at the location of TP1 and TP7, was dark grey and wet, and contained miscellaneous construction debris. During the investigation, no field evidence of PHCs or apparent PHC odours were detected at these locations (PID readings of 0 ppm), therefore PHC analysis was not requested on the sample from this location. Based on presence of fill, samples of this fill material were analyzed for PAHs

Photograph 1: Test pit TP1, located in the northwest portion of the property.

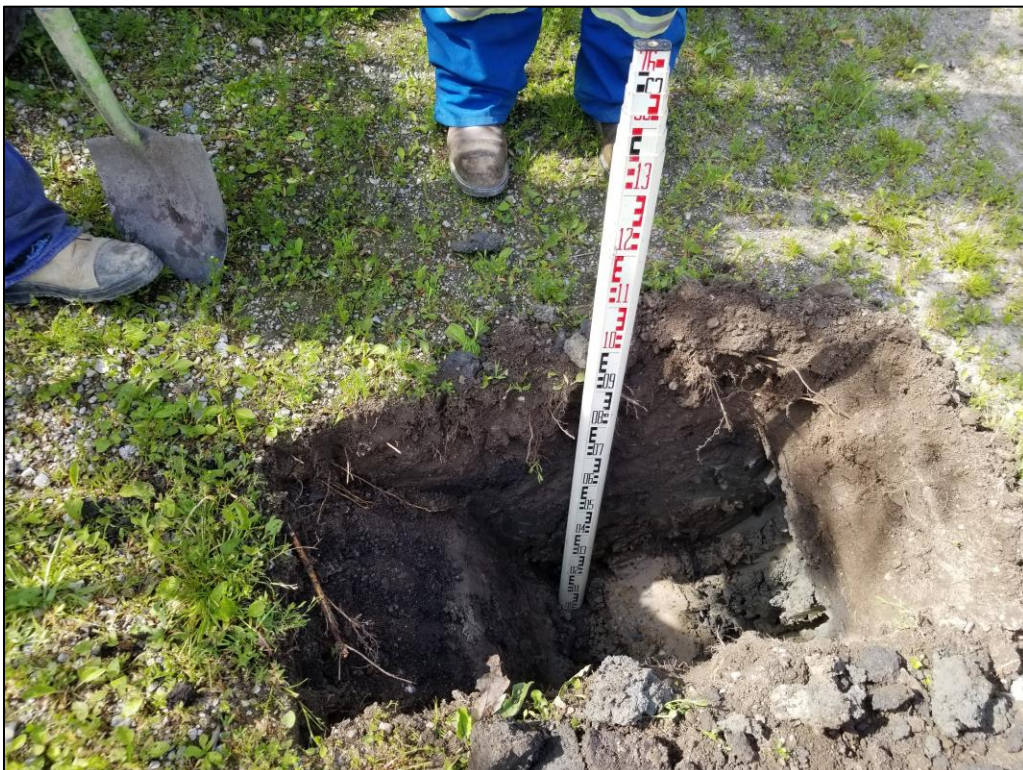
The silty sand to sandy fill encountered at approximately 0.2 m to 1.0 m at the location of TP2 and TP3 at the easterly portion of Site, was brown to dark brown in appearance and contained occasional brick fragment (at TP2). To confirm shallow soil quality, samples of fill collected from 0.0 to 1.0 mbgs were analyzed for metals (both test pits) and PAHs (TP3). During the investigation, no apparent PHC odours were observed at this location (PID readings of 0 ppm), therefore PHC analysis was not requested at these locations.

Photograph 2: Test pit TP2, located in the northeast portion of property.

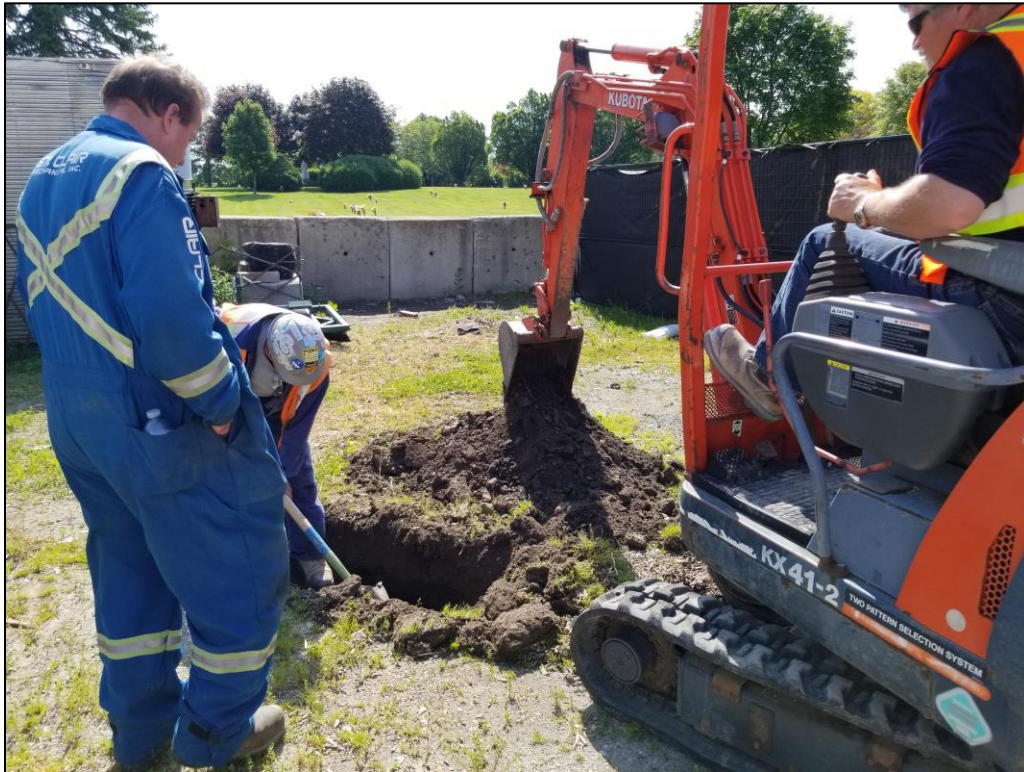
Photograph 3: Test pit, TP3, located in the northeast portion of property.

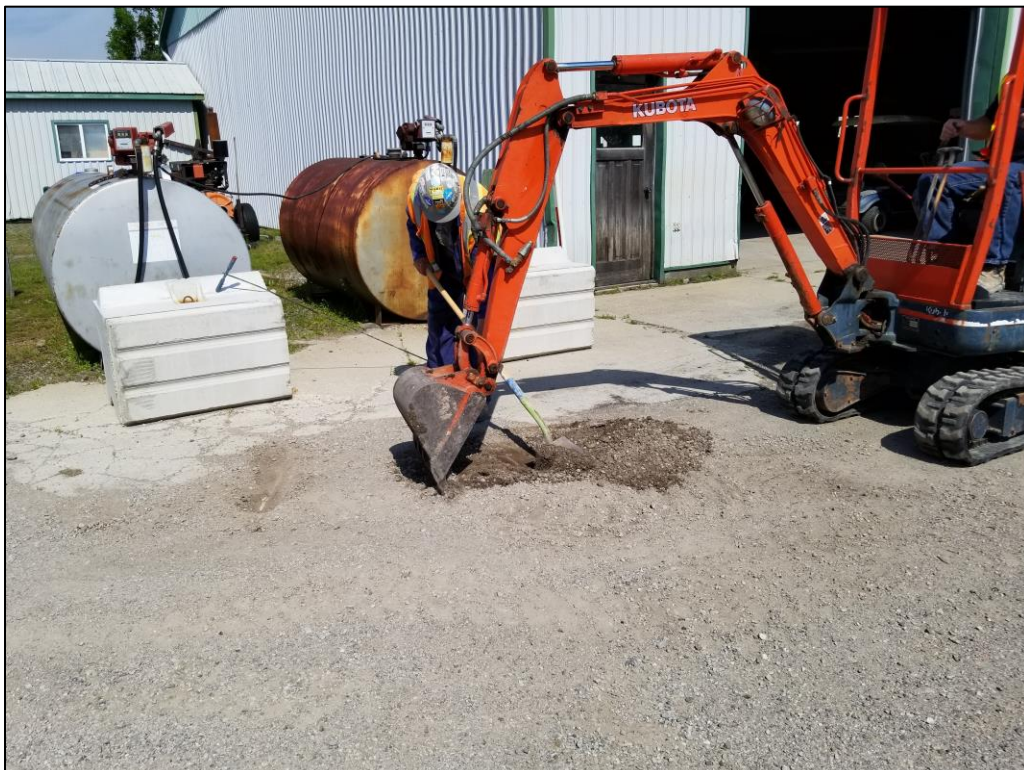
In the vicinity of the ASTs, at the locations of TP4, TP5, TP6, and TP8, the silty sand/sand with cobbles and clay loam/clay inclusions fill, encountered beneath the granular surface cover material at approximately 0.2 m to 1.0 m, was light to dark brown in appearance. During the investigation, slight evidence of PHC odours was encountered in samples from location of TP5 and TP8, up to 1.0 mbgs, with PID field-screening readings of up to 7.7 ppm. Samples of this shallow fill material, retrieved from test pits TP5 (south of the ASTs) and TP8 (between the ASTs), where elevated PID readings were encountered at 6.0 and 7.7 ppm, respectively, were analyzed for PHCs (sample IDs: TP5 0-1.0M and TP8 0-0.6M). A sample from the native clay from location of TP5 (TP5 1-1.5M) was also collected to assess this location for vertical extent of potential impacts at this location. At the location of TP4 and TP6, as well as in the sample from TP5 at depth (1-1.5 mbgs), no field evidence or PID readings indicative of PHC impacts was observed.

Photograph 4: Test pit TP4, located to the east of the above ground storage tanks.

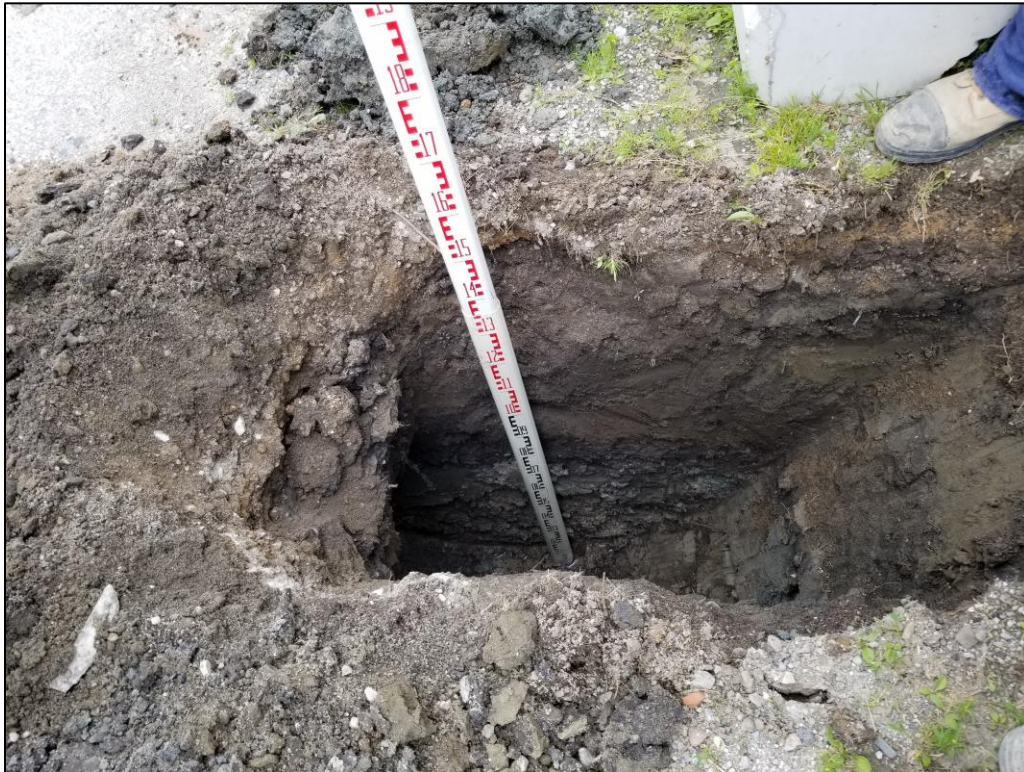
Photograph 5: Test pit TP5, located south of the above ground storage tanks.

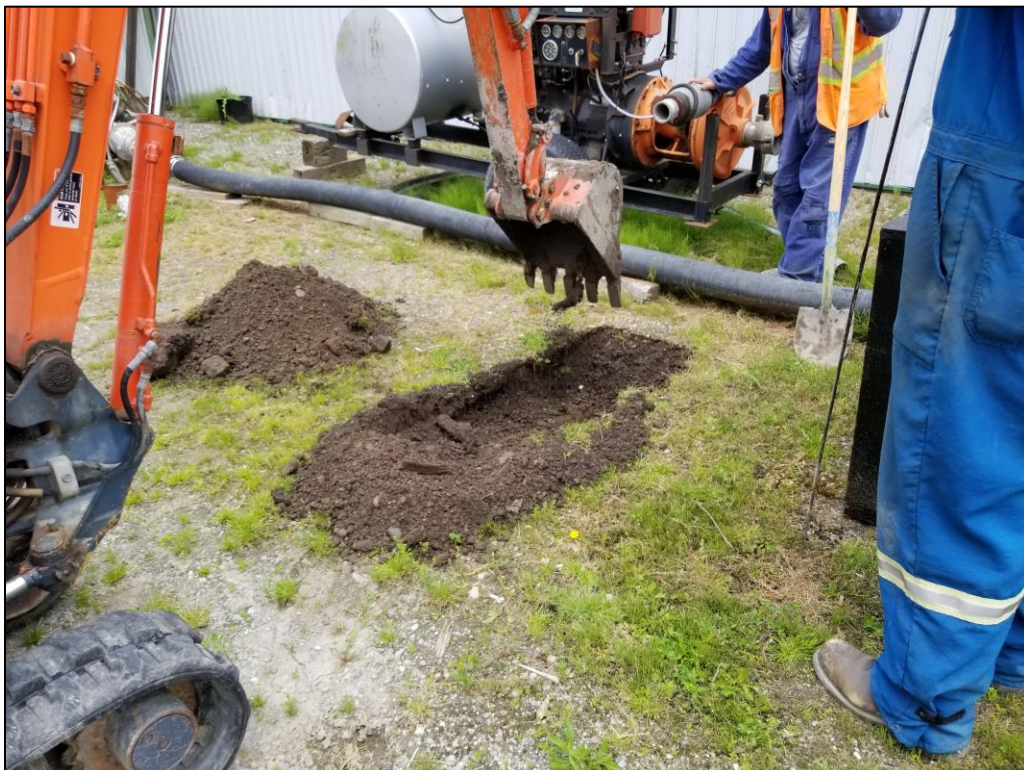
Based on presence of fill material at this location, the sample from location of TP6 (TP6 0-0.5M) collected from the silty sand fill was also analyzed for PAHs and metals, to confirm fill material quality in the vicinity. The reported analytical results of the soil sample from this location indicated non-detectable concentrations of PAHs and trace presence of a few metals, at concentrations below the applicable Table 3 criteria of the Standard for each of the analyzed parameters.

Photograph 6: Test pit TP6, located west of the above ground fuel storage tanks.

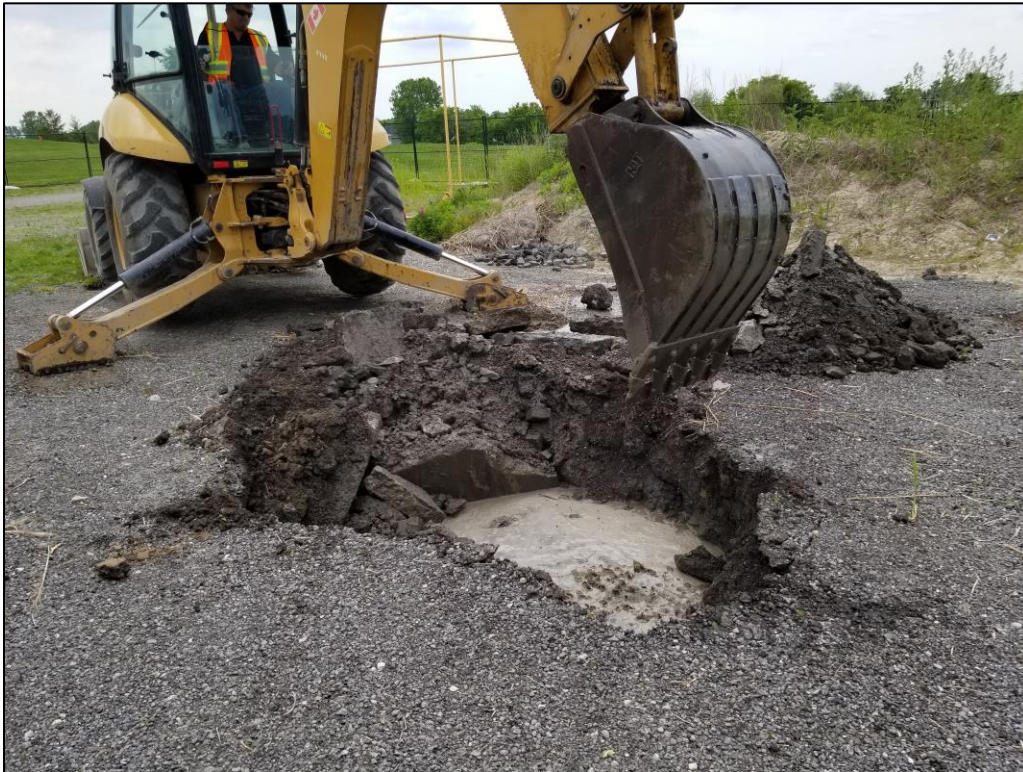
Photograph 7: Test pit TP7, located in the northwest portion of the property.

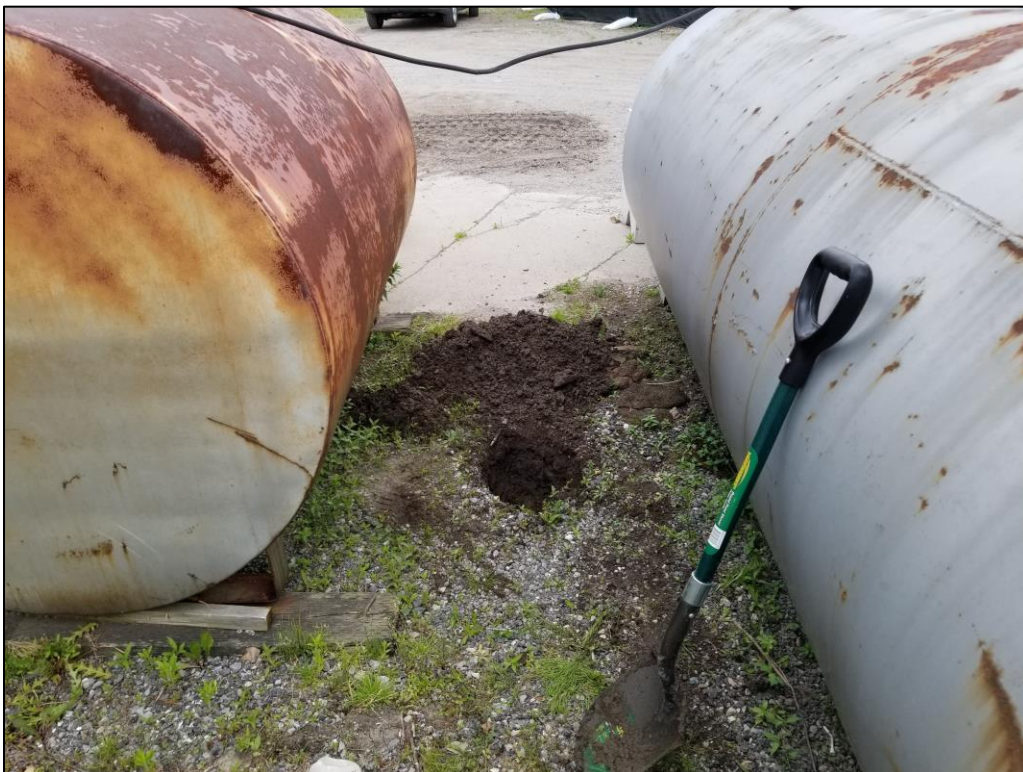
One (1) exceedance of applicable Standards, for F2 fraction of PHCs was reported in the samples collected in the vicinity of the ASTs. The sample collected from the location of TP8 (between the two (2) ASTs) from a depth of 0-0.6 mbgs was reported to contain 240 ug/g concentration of F2 PHCs, exceeding the applicable Standard of 150 ug/g, at this location. This sample also contained measurable concentrations of F3 and F4 PHCs at 950 ug/g and 680 ug/g, below the Standard value of 1,300 ug/g and 5,600 ug/g, respectively, for these parameters. Based on the nature of the PHCs identified in this sample, which was included heavier chain hydrocarbons (greater than Carbon-50), the laboratory also performed F4 PHC gravimetric analysis on this sample. The reported analytical result of 3,000 ug/g is below the applicable standard of F4 PHCs of 5,600 ug/g.

The reported analytical results meet the Standard at the locations sampled with the exception of F2 fraction of PHCs in the shallow fill/soils (0 – 0.6 mbgs) at TP8, located between the ASTs. Based on the field observations and results of selected soil samples, impacts related to fuel storage and handling appear to be limited to the near surface and were found above the criteria of the Standard at a single investigated location.

Photograph 8: Testhole TP8, located between the above ground fuel storage tanks.

Based on the limited concentration and extent of the detected F2 fraction of PHCs, a risk to human health and the environment is not expected. With such a limited area and degree of impact, it is recommended that remedial measures be implemented when (and if) tank removal/decommissioning occurs. Prior to remedial measures, additional sampling may be warranted to confirm the soil quality at that time.
