THE CORPORATION OF THE CITY OF SARNIA

FORMER MICHIGAN AVENUE LANDFILL

UPDATE ON LIGHT NON-AQUEOUS PHASE LIQUID (LNAPL) PLUME DELINEATION

RWDI #1801685

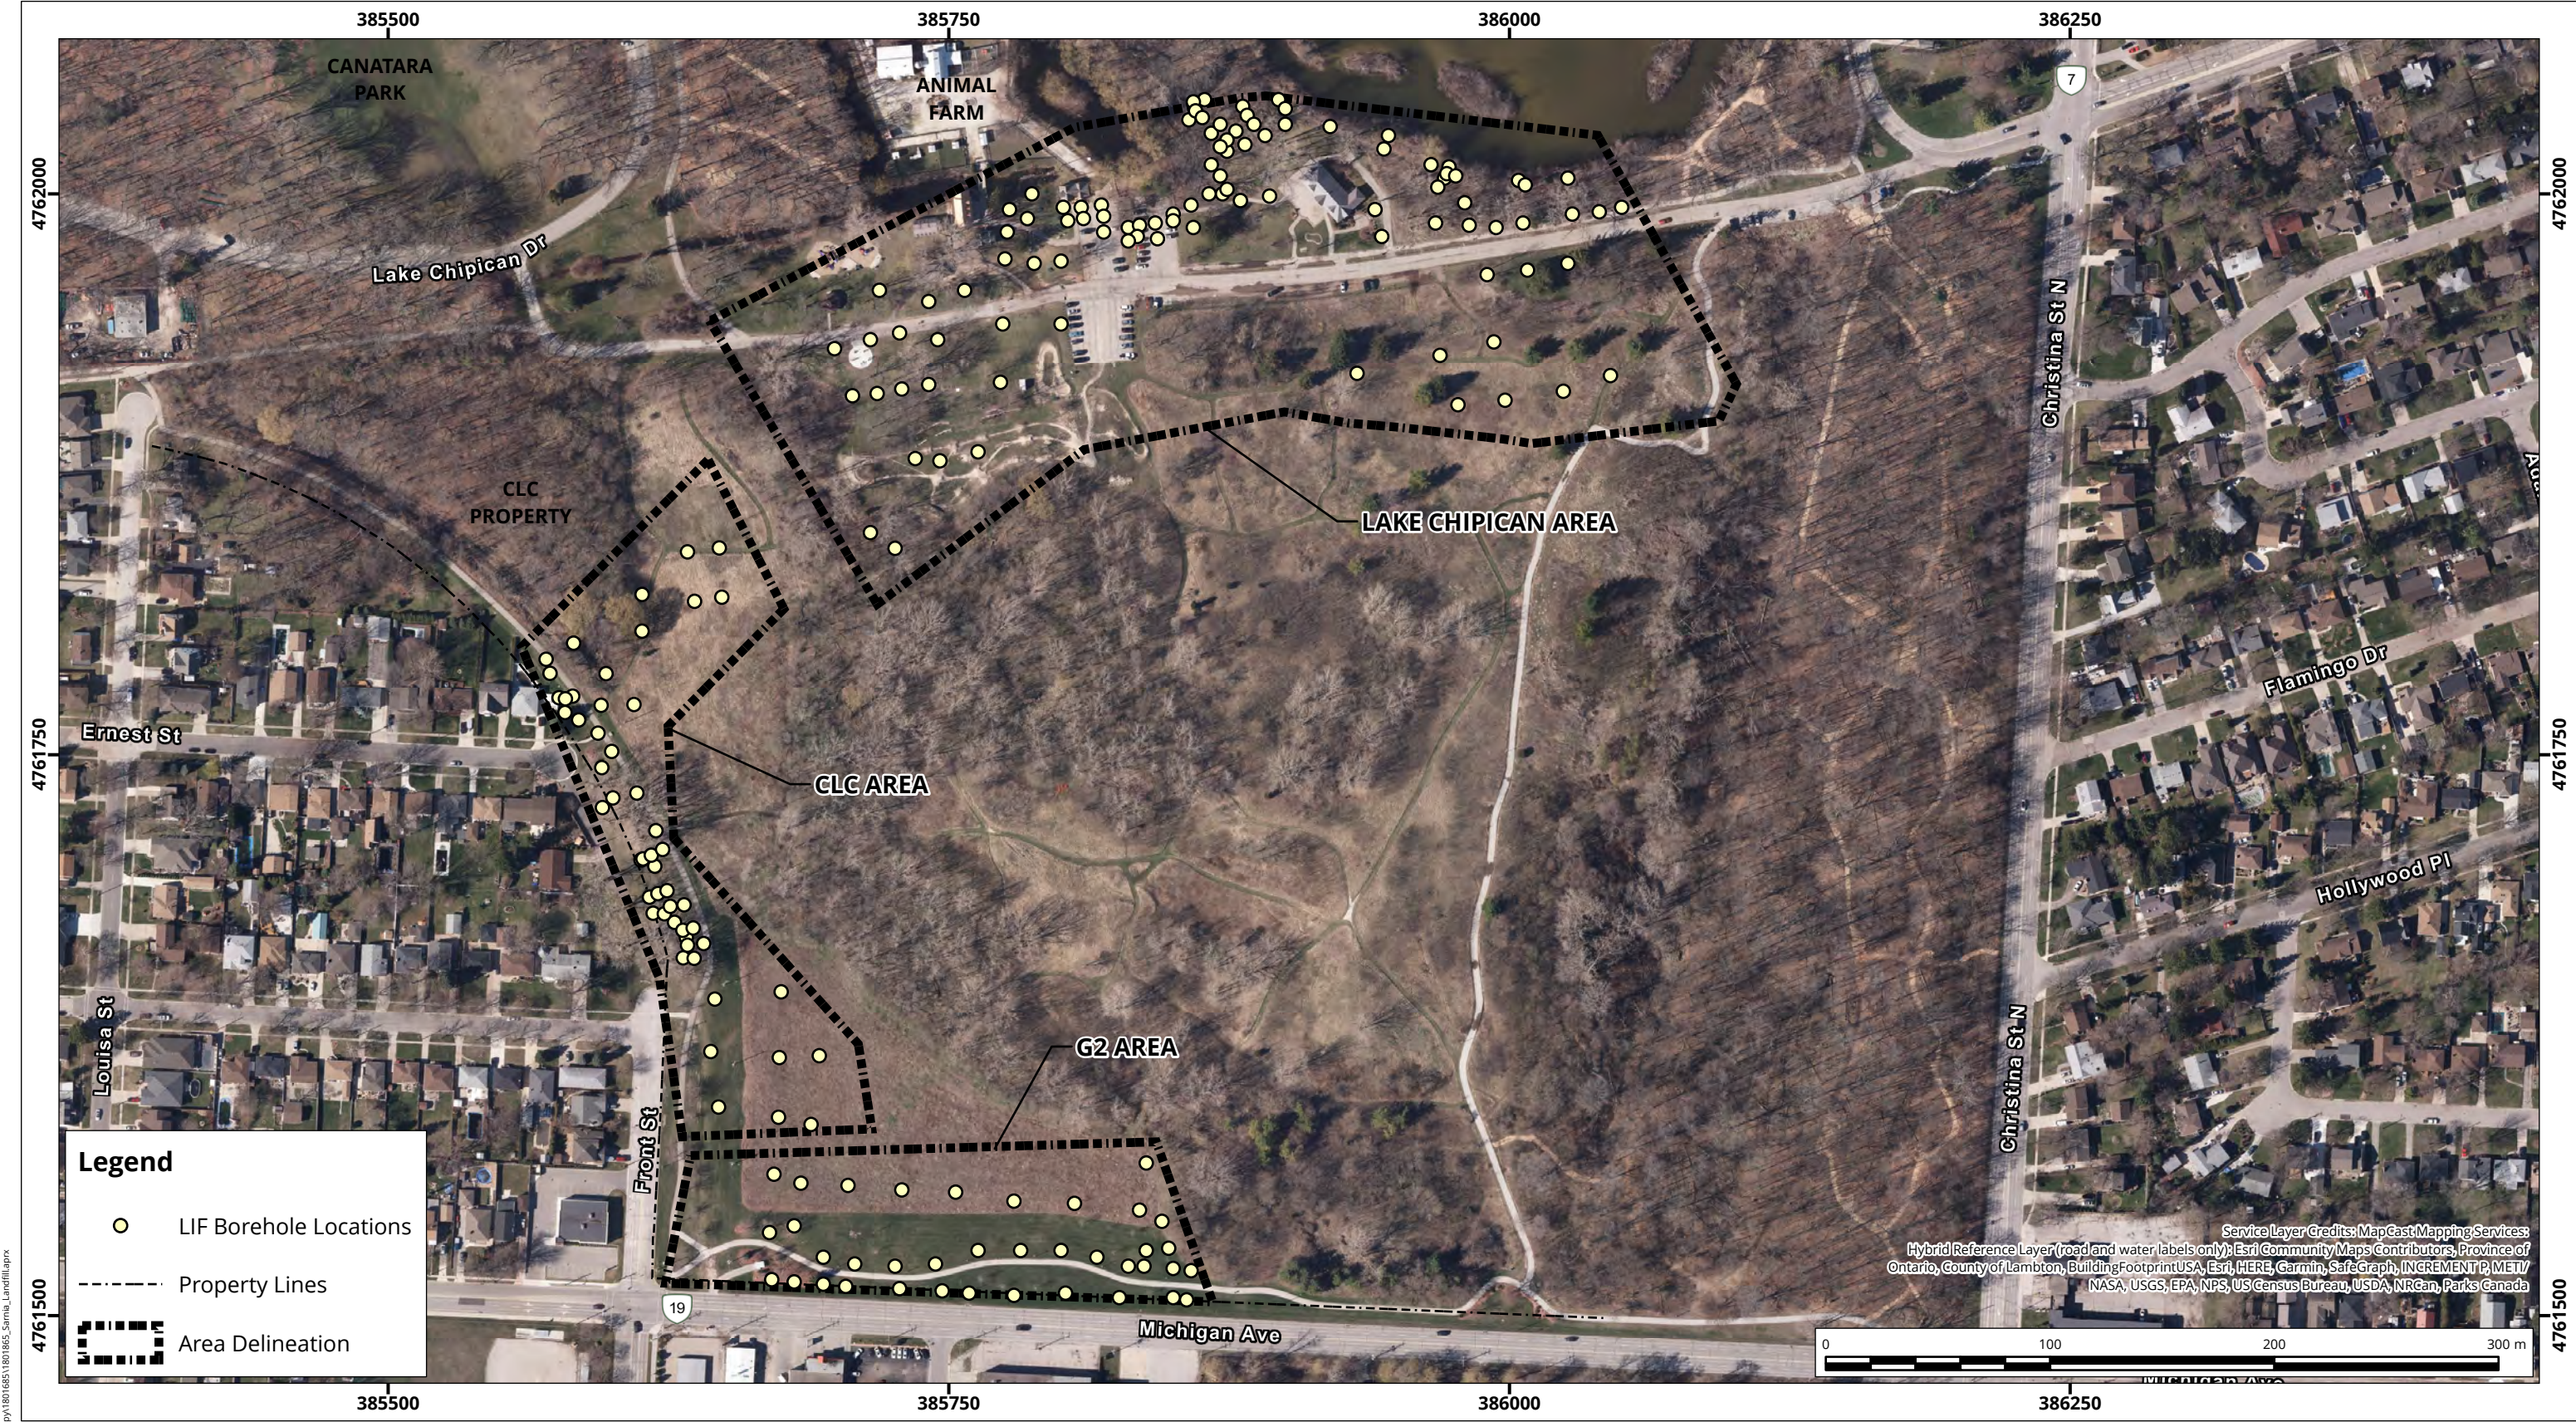
CLC Area Updated Inferred LNAPL Extent

The generalized interpretation of the results of the CLC Area 2020 LIF survey are illustrated on **Figure 3A** and provided in **Table 1**. Of the 52 LIF boreholes advances, the %RE ranged from 1.4 %RE to 648.3 %RE. The CLC Area had the highest positive responses observed on-site. The vertical responses ranged in thickness from 0 to approximately 3.5 m.

Based on the visualization results within the CLC Area, the higher LIF responses (≥ 44 %RE) are scattered in small clusters away from the western boundary of the LIF survey from LIF20159 in the northeast to LIF20026 south of monitoring well 705 (refer to **Table 1**). Another small cluster was noted in the area of LIF20149 just east of the residential property located at 720 Ernest Street. West of these LIF boreholes, near the perimeter of the surveyed area, the responses from LIF boreholes indicated trace or no presence of LNAPL. This is illustrated on **Figure 3A** by the LIF boreholes that are colour-coded blue or yellow.

As noted on **Figure 3A**, there are numerous LIF boreholes with relatively high %RE responses west and northwest of the 2017 inferred limit of LNAPL and which are closer to the Site boundary. This may be a result of plume migration in this direction; and was investigated as part of the subsequent subsurface characterization component of the study (**Section 3.4**). There are several LIF boreholes with relatively high %RE responses near groundwater monitoring wells where LNAPL was not present based on the 2019 monitoring program. Examples of this include LIF20014 and LIF20015 near monitoring wells 706 and 709, and LIF200020 near monitoring well 702. This was investigated as part of the subsequent monitoring well installation and monitoring component of the study (**Section 3.5**).
