THE CORPORATION OF THE CITY OF SARNIA

FORMER MICHIGAN AVENUE LANDFILL

UPDATE ON LIGHT NON-AQUEOUS PHASE LIQUID (LNAPL) PLUME DELINEATION

January 22, 2021

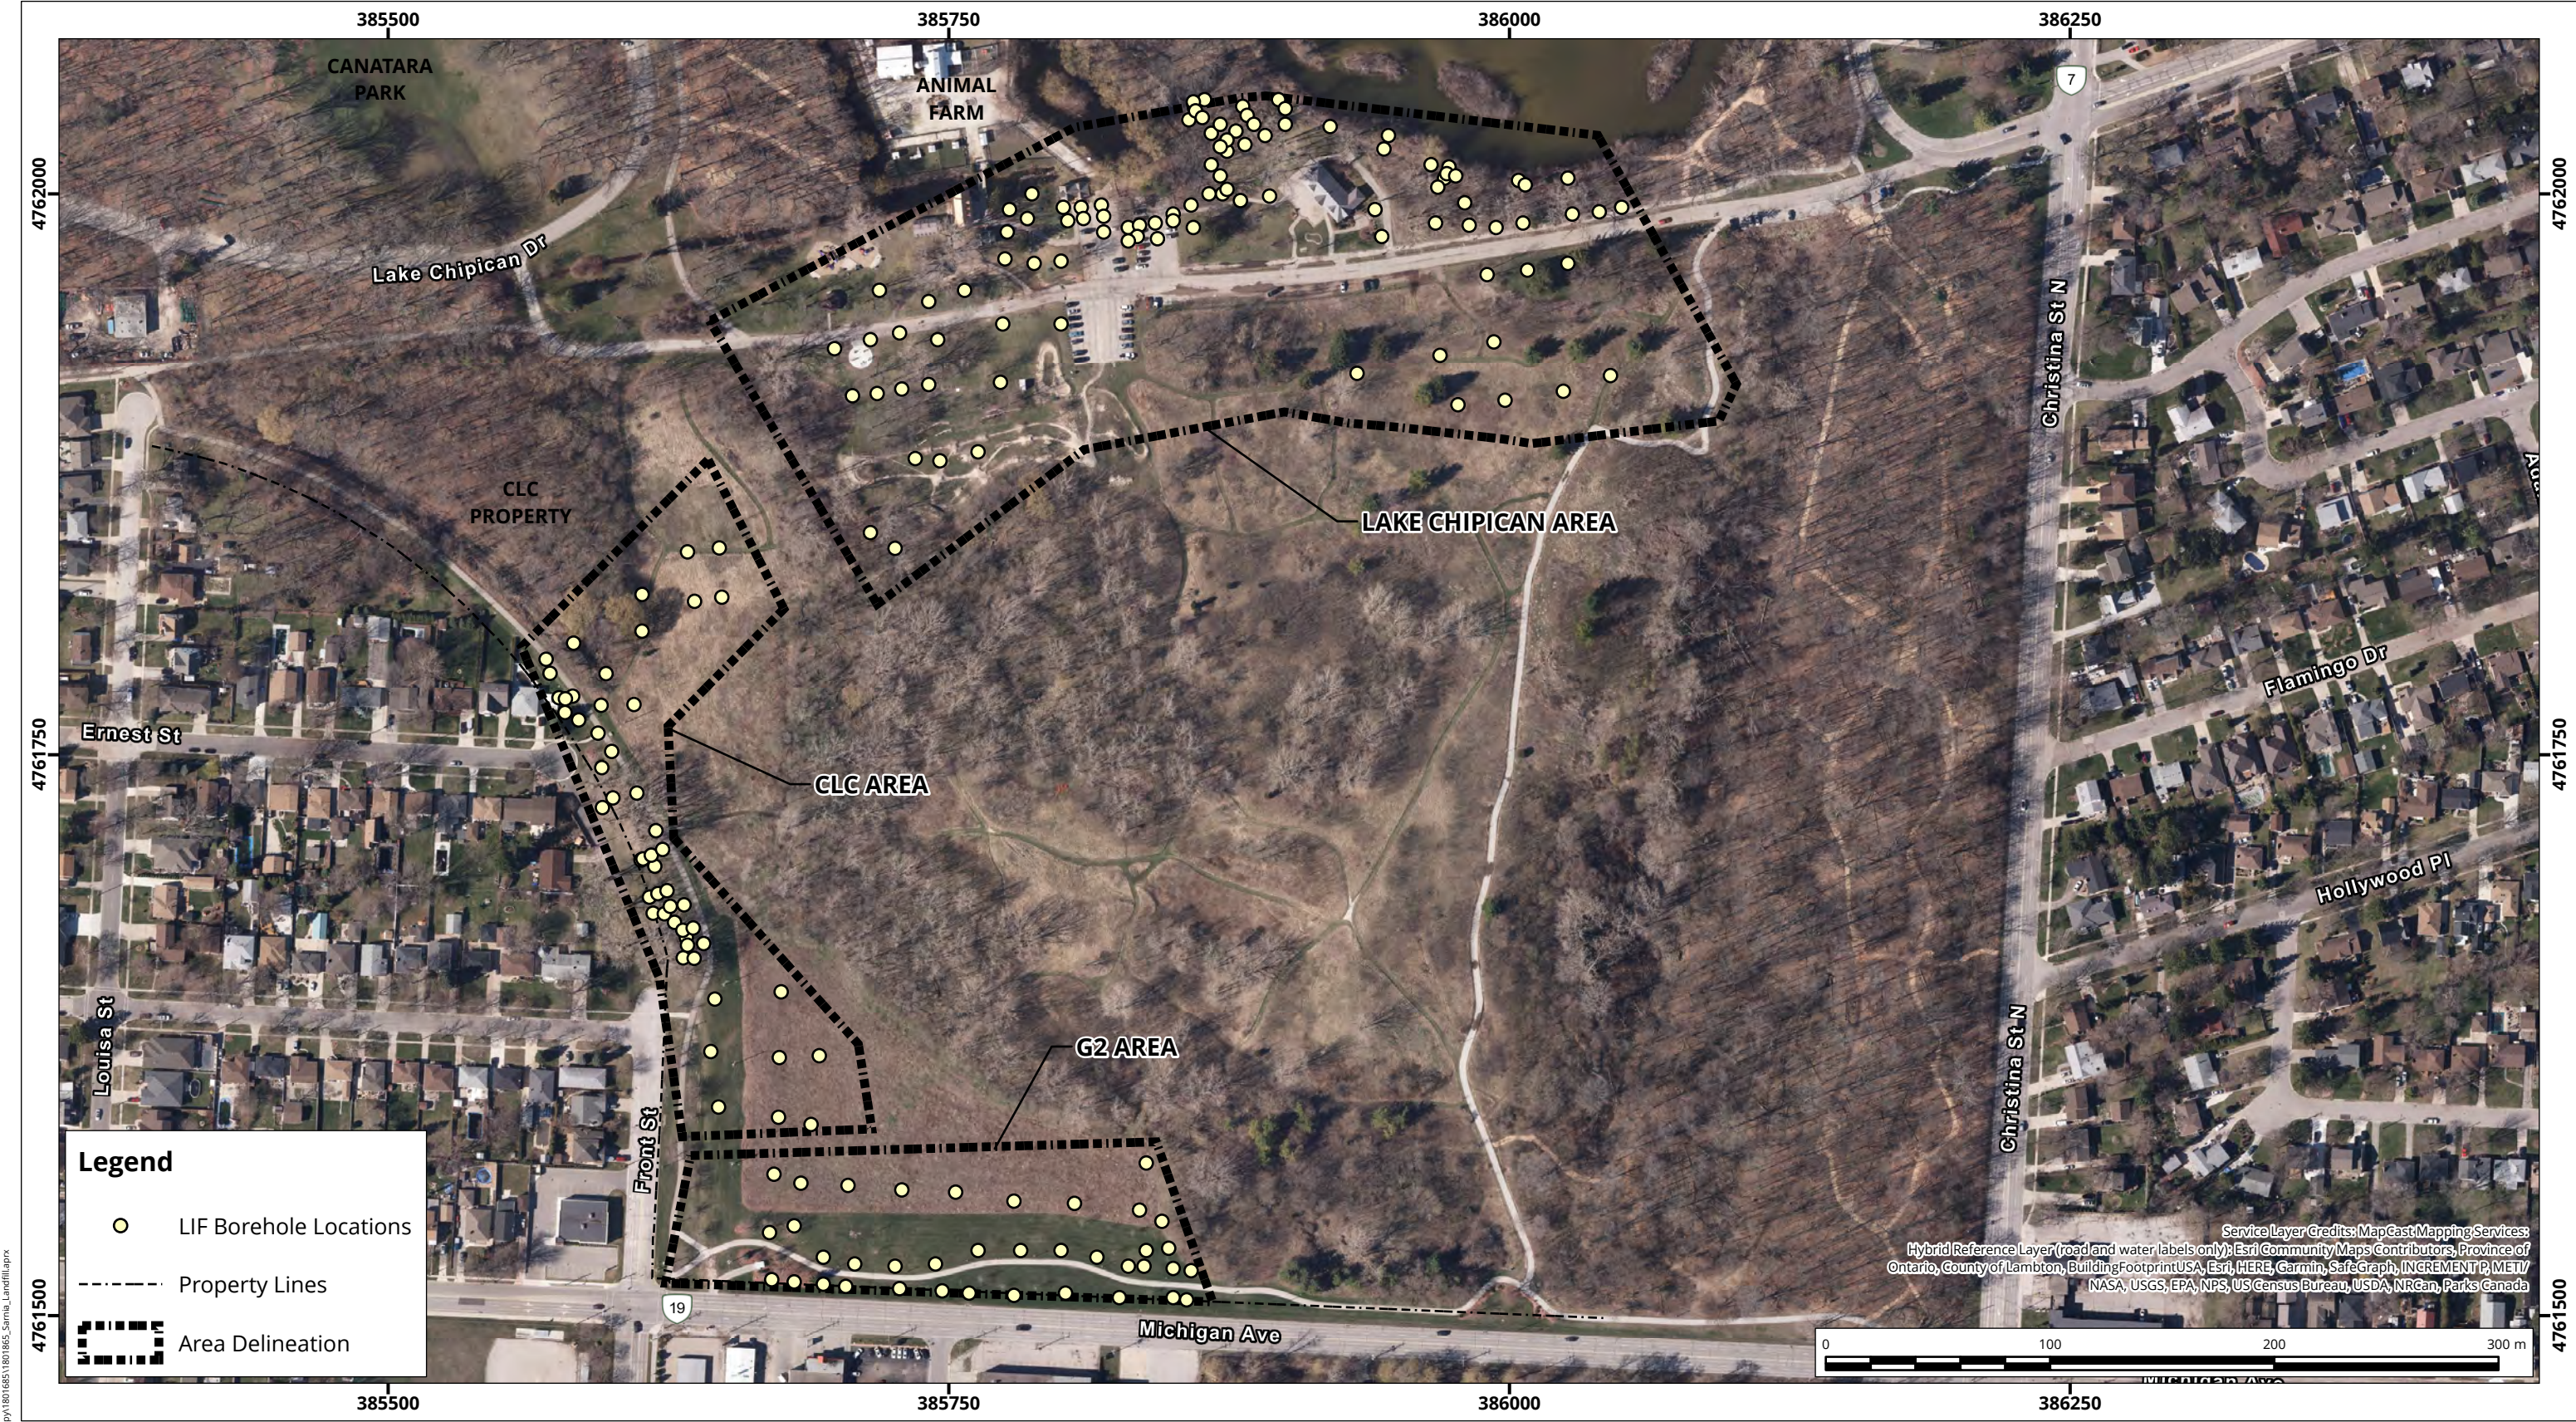
LIF Borehole Location Plan

The generalized interpretation of the results of the CLC Area 2020 LIF survey are illustrated on **Figure 3A** and provided in **Table 1**. Of the 52 LIF boreholes advances, the %RE ranged from 1.4 %RE to 648.3 %RE. The CLC Area had the highest positive responses observed on-site. The vertical responses ranged in thickness from 0 to approximately 3.5 m.

Based on the visualization results within the CLC Area, the higher LIF responses (≥ 44 %RE) are scattered in small clusters away from the western boundary of the LIF survey from LIF20159 in the northeast to LIF20026 south of groundwater monitoring well 705 (refer to **Table 1**). Another small cluster was noted in the area of LIF20149 just east of the residential property located at 720 Ernest Street. West of these LIF boreholes, near the perimeter of the surveyed area, the responses from LIF boreholes indicated trace or no presence of LNAPL. This is illustrated on **Figure 3A** by the LIF boreholes that are colour-coded blue or yellow.

As noted on **Figure 3A**, there are numerous LIF boreholes with relatively high %RE responses west and northwest of the 2017 inferred limit of LNAPL and which are closer to the Site boundary. This may be a result of plume migration in this direction; and was investigated as part of the subsequent subsurface characterization component of the study (**Section 3.4**). There are several LIF boreholes with relatively high %RE responses near groundwater monitoring wells where LNAPL was not present based on the 2019 monitoring program. Examples of this include LIF20014 and LIF20015 near groundwater monitoring wells 706 and 709, and LIF200020 near groundwater monitoring well 702. This was investigated as part of the subsequent groundwater monitoring well installation and monitoring component of the study (**Section 3.5**).

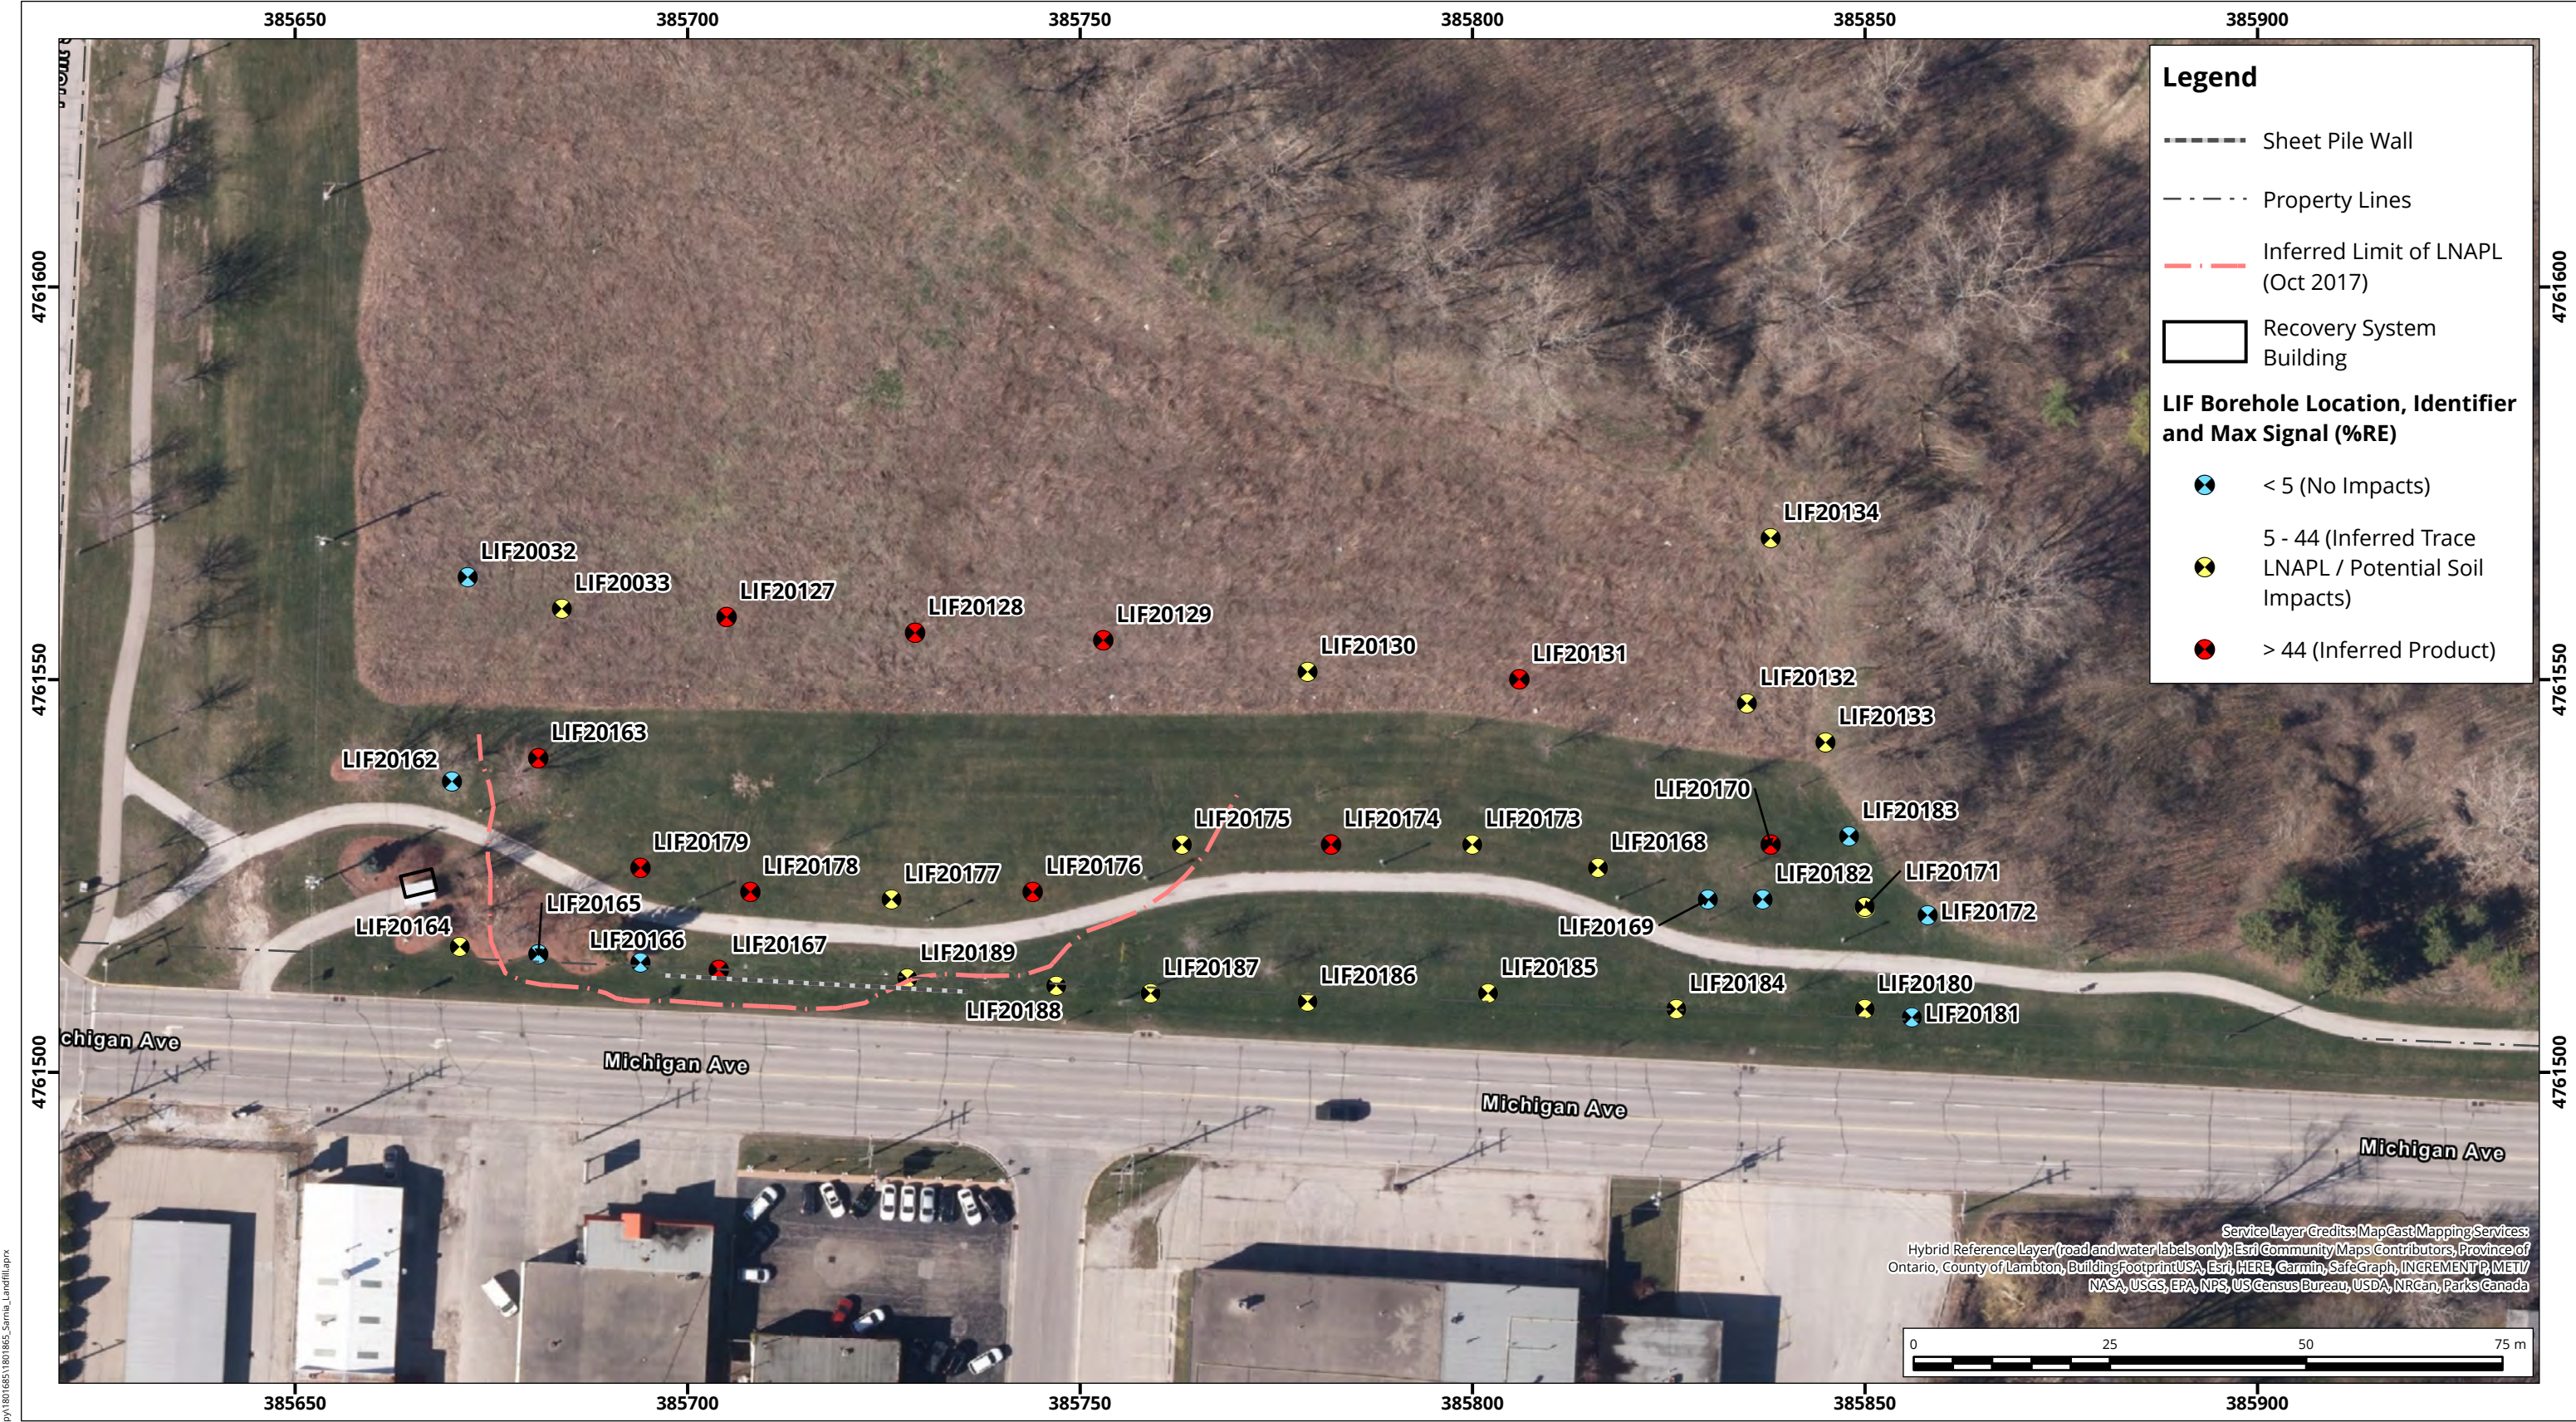
G2 Area LIF Borehole Location Plan

Based on the results within the G2 Area, 11 LIF boreholes had LIF %RE responses ≥ 44 %RE, as outlined in **Table 2**. Of these, three (3) (LIF20131, LIF20174, and LIF20170) were in the area east and north of the sheet-pile barrier wall in an area where LNAPL had not previously been noted. Moderate %RE responses representing potential trace LNAPL and/or soil impacts (ranging between 5 and 44 %RE and denoted by yellow borehole symbols on **Figure 4A**) were noted immediately north and east of the sheet-pile barrier wall. The LIF boreholes north of the sheet-pile barrier wall occur in an area of known LNAPL based on the 2019 routine FMAL monitoring findings and may correspond to the actual presence of subsurface LNAPL.

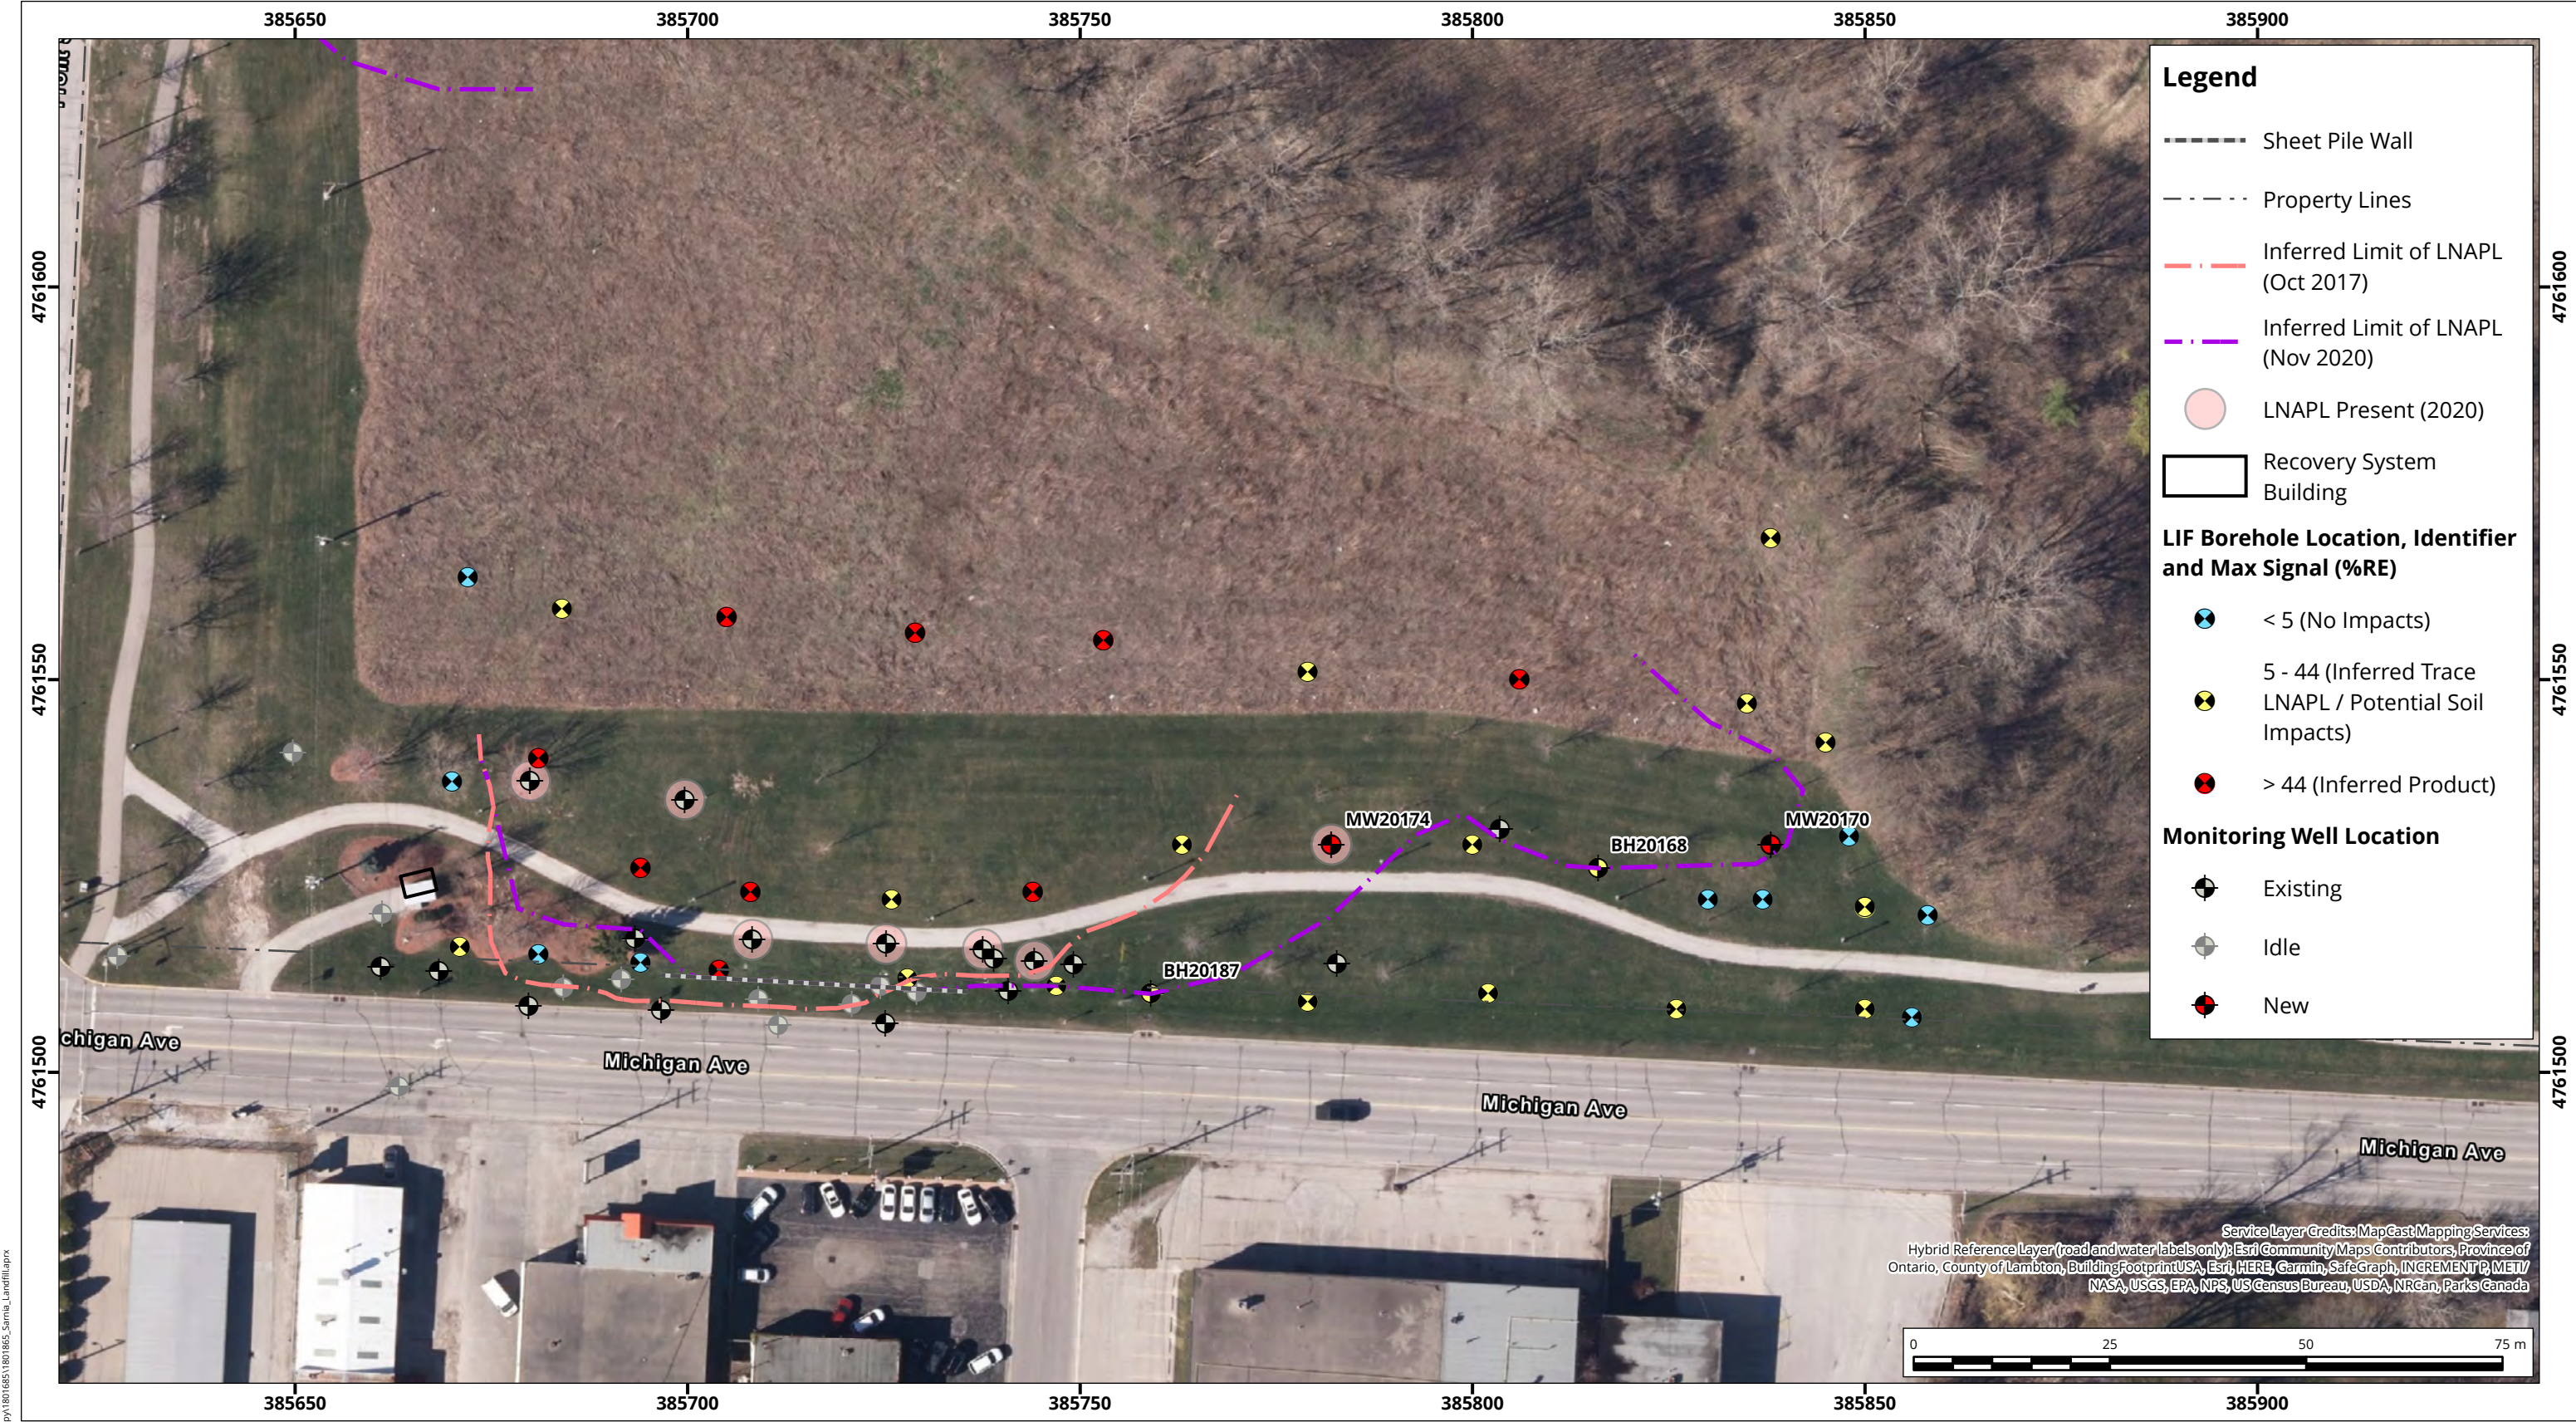
G2 Area Updated Inferred LNAPL Extent

As noted in the 2019 RWDI annual monitoring report (RWDI, 2020), LNAPL was detected within the G2 Area in groundwater monitoring wells 801, 802, and 803, MW1403, MW1403, and recovery wells RW1, RW1a, and RW2. These locations are north of the sheet-pile barrier wall, which was installed in 2000 in response to floating oil being noted in well G2 just north of Michigan Ave. LNAPL was not present in groundwater monitoring wells 606, 611, and 612, which are located on the non-landfill side of the sheet-pile barrier wall based on the 2019 monitoring data.
