THE CORPORATION OF THE CITY OF SARNIA

FORMER MICHIGAN AVENUE LANDFILL

2020 LIF REPORT RWDI #1801685 July 31, 2020

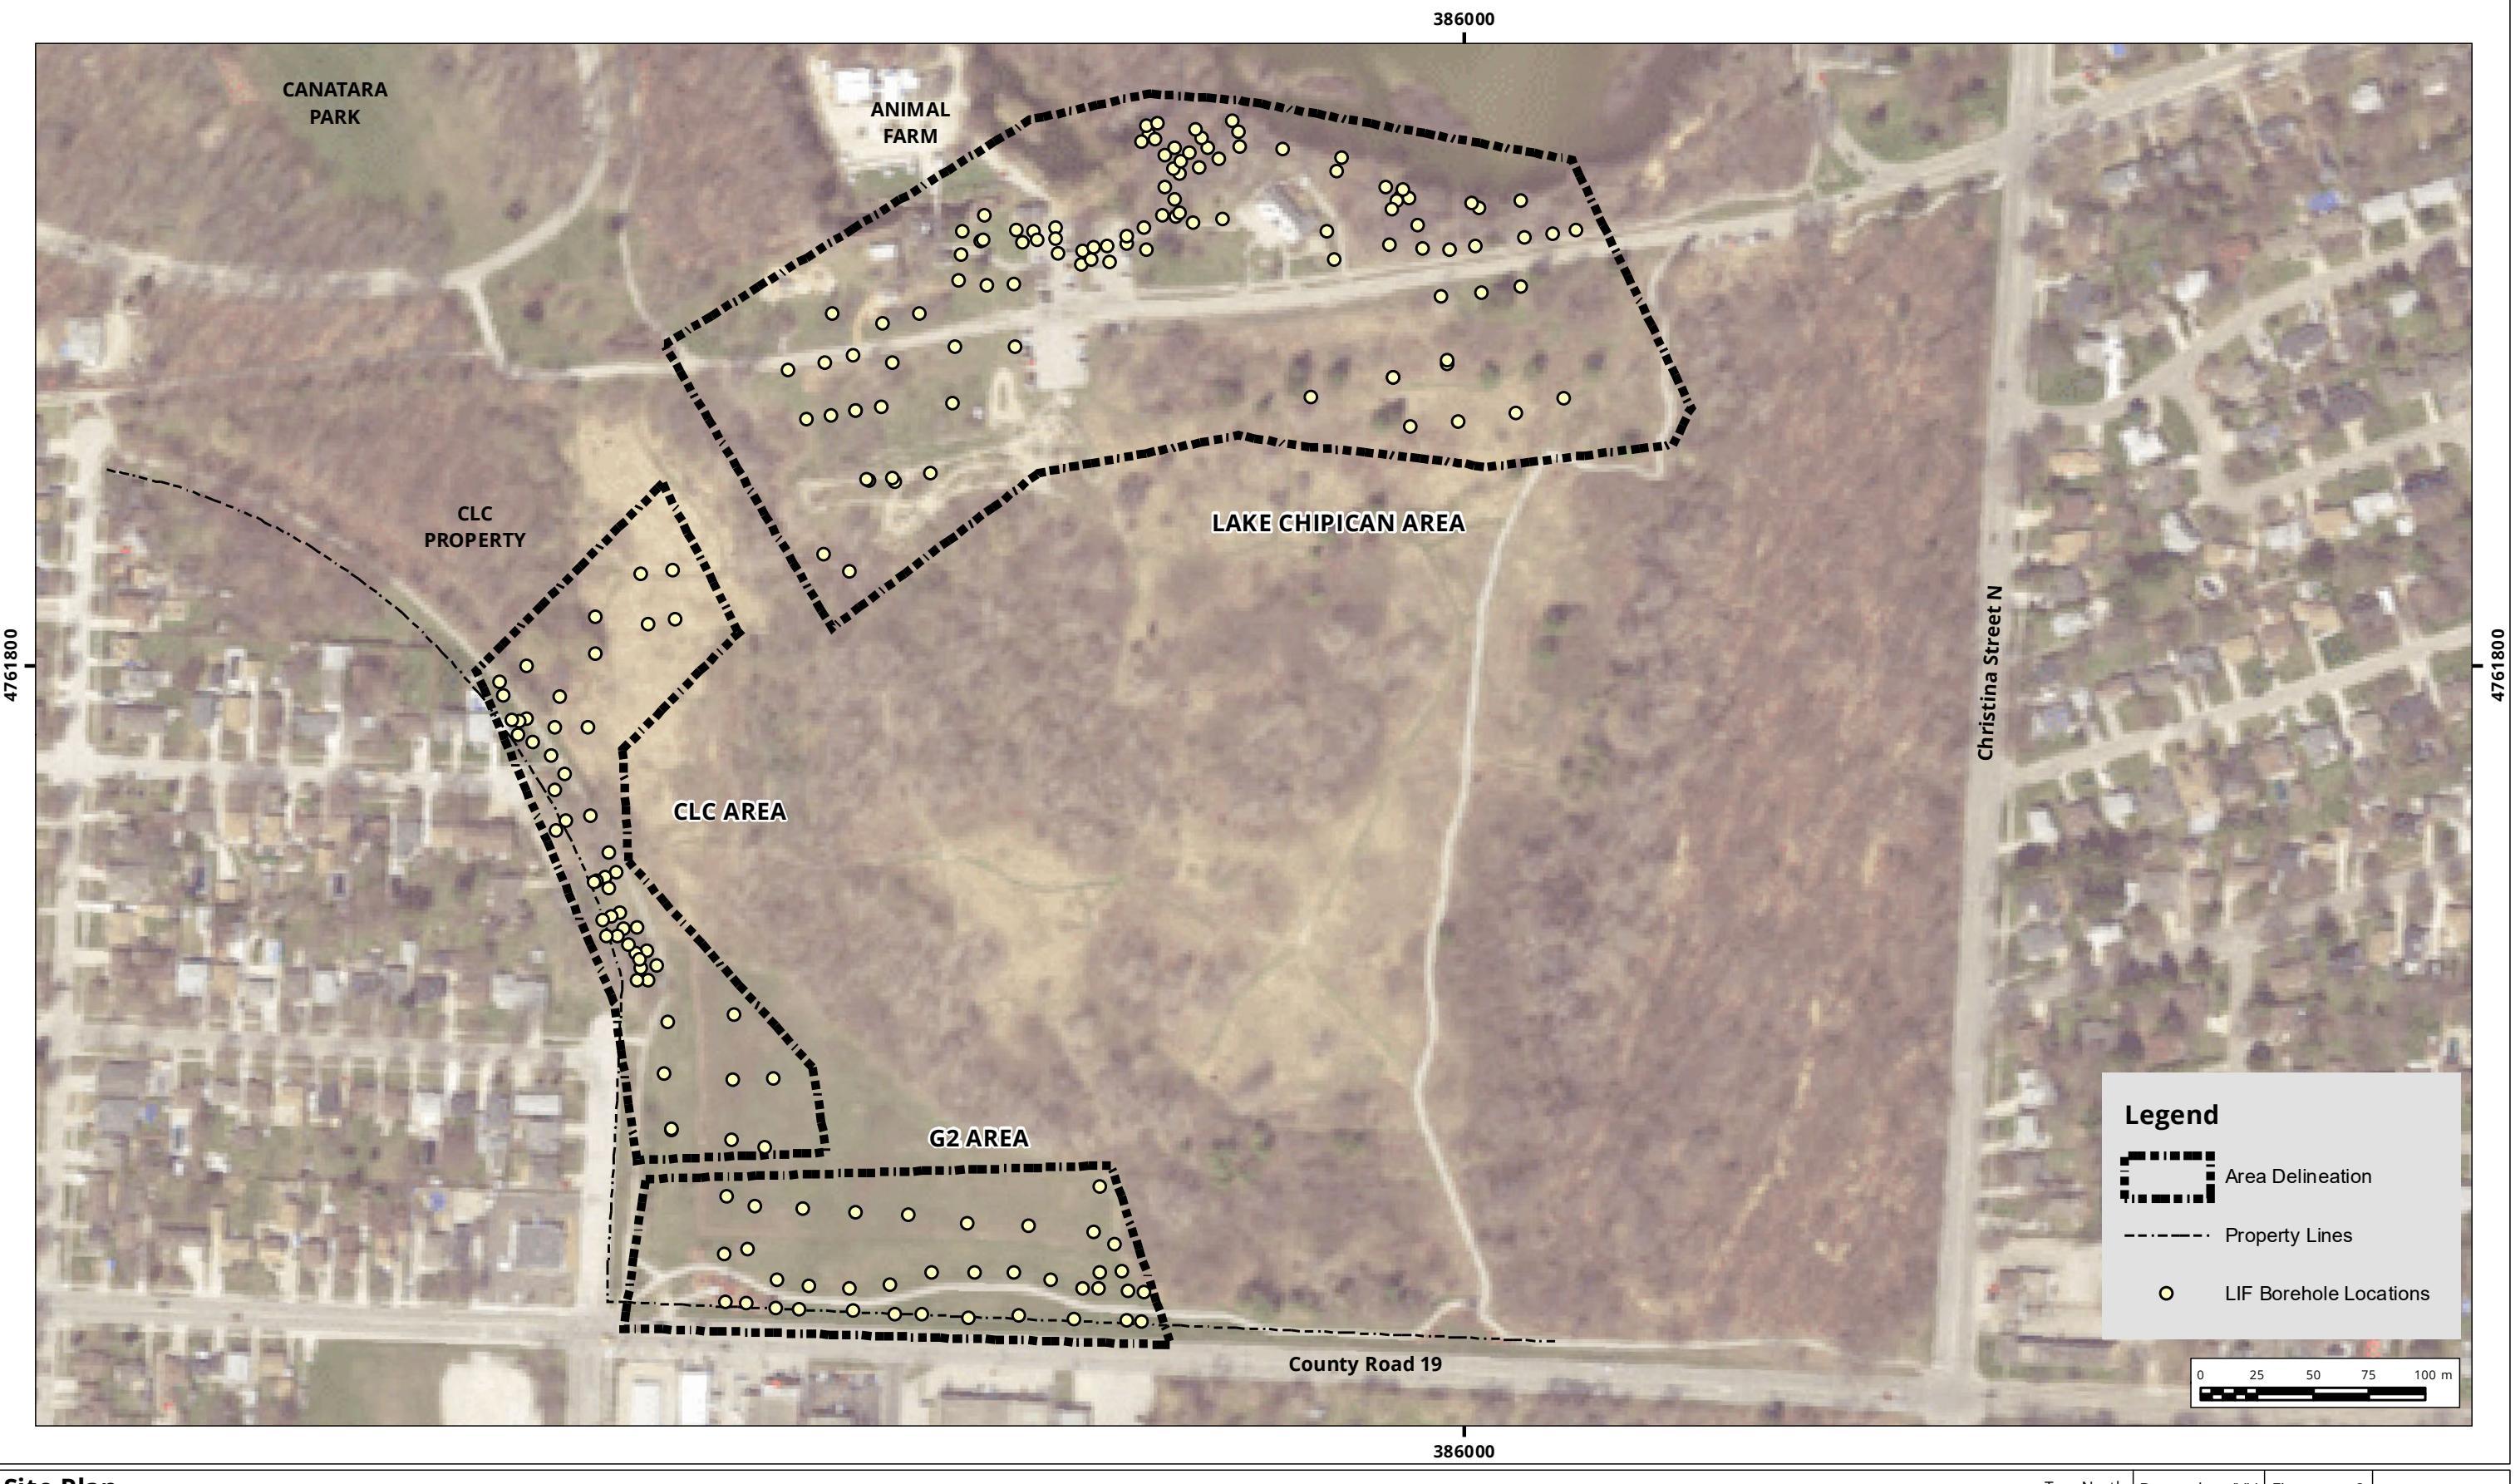
Site Plan Former Michigan Avenue Landfill, Point Edward, Ontario

LIF borehole locations for each of the three (3) areas are illustrated on **Figure 2.** Additional details for the CLC Area, the G2 Area, and the Lake Chipican Area are provided on **Figures 3**, **4**, and **5**, respectively.

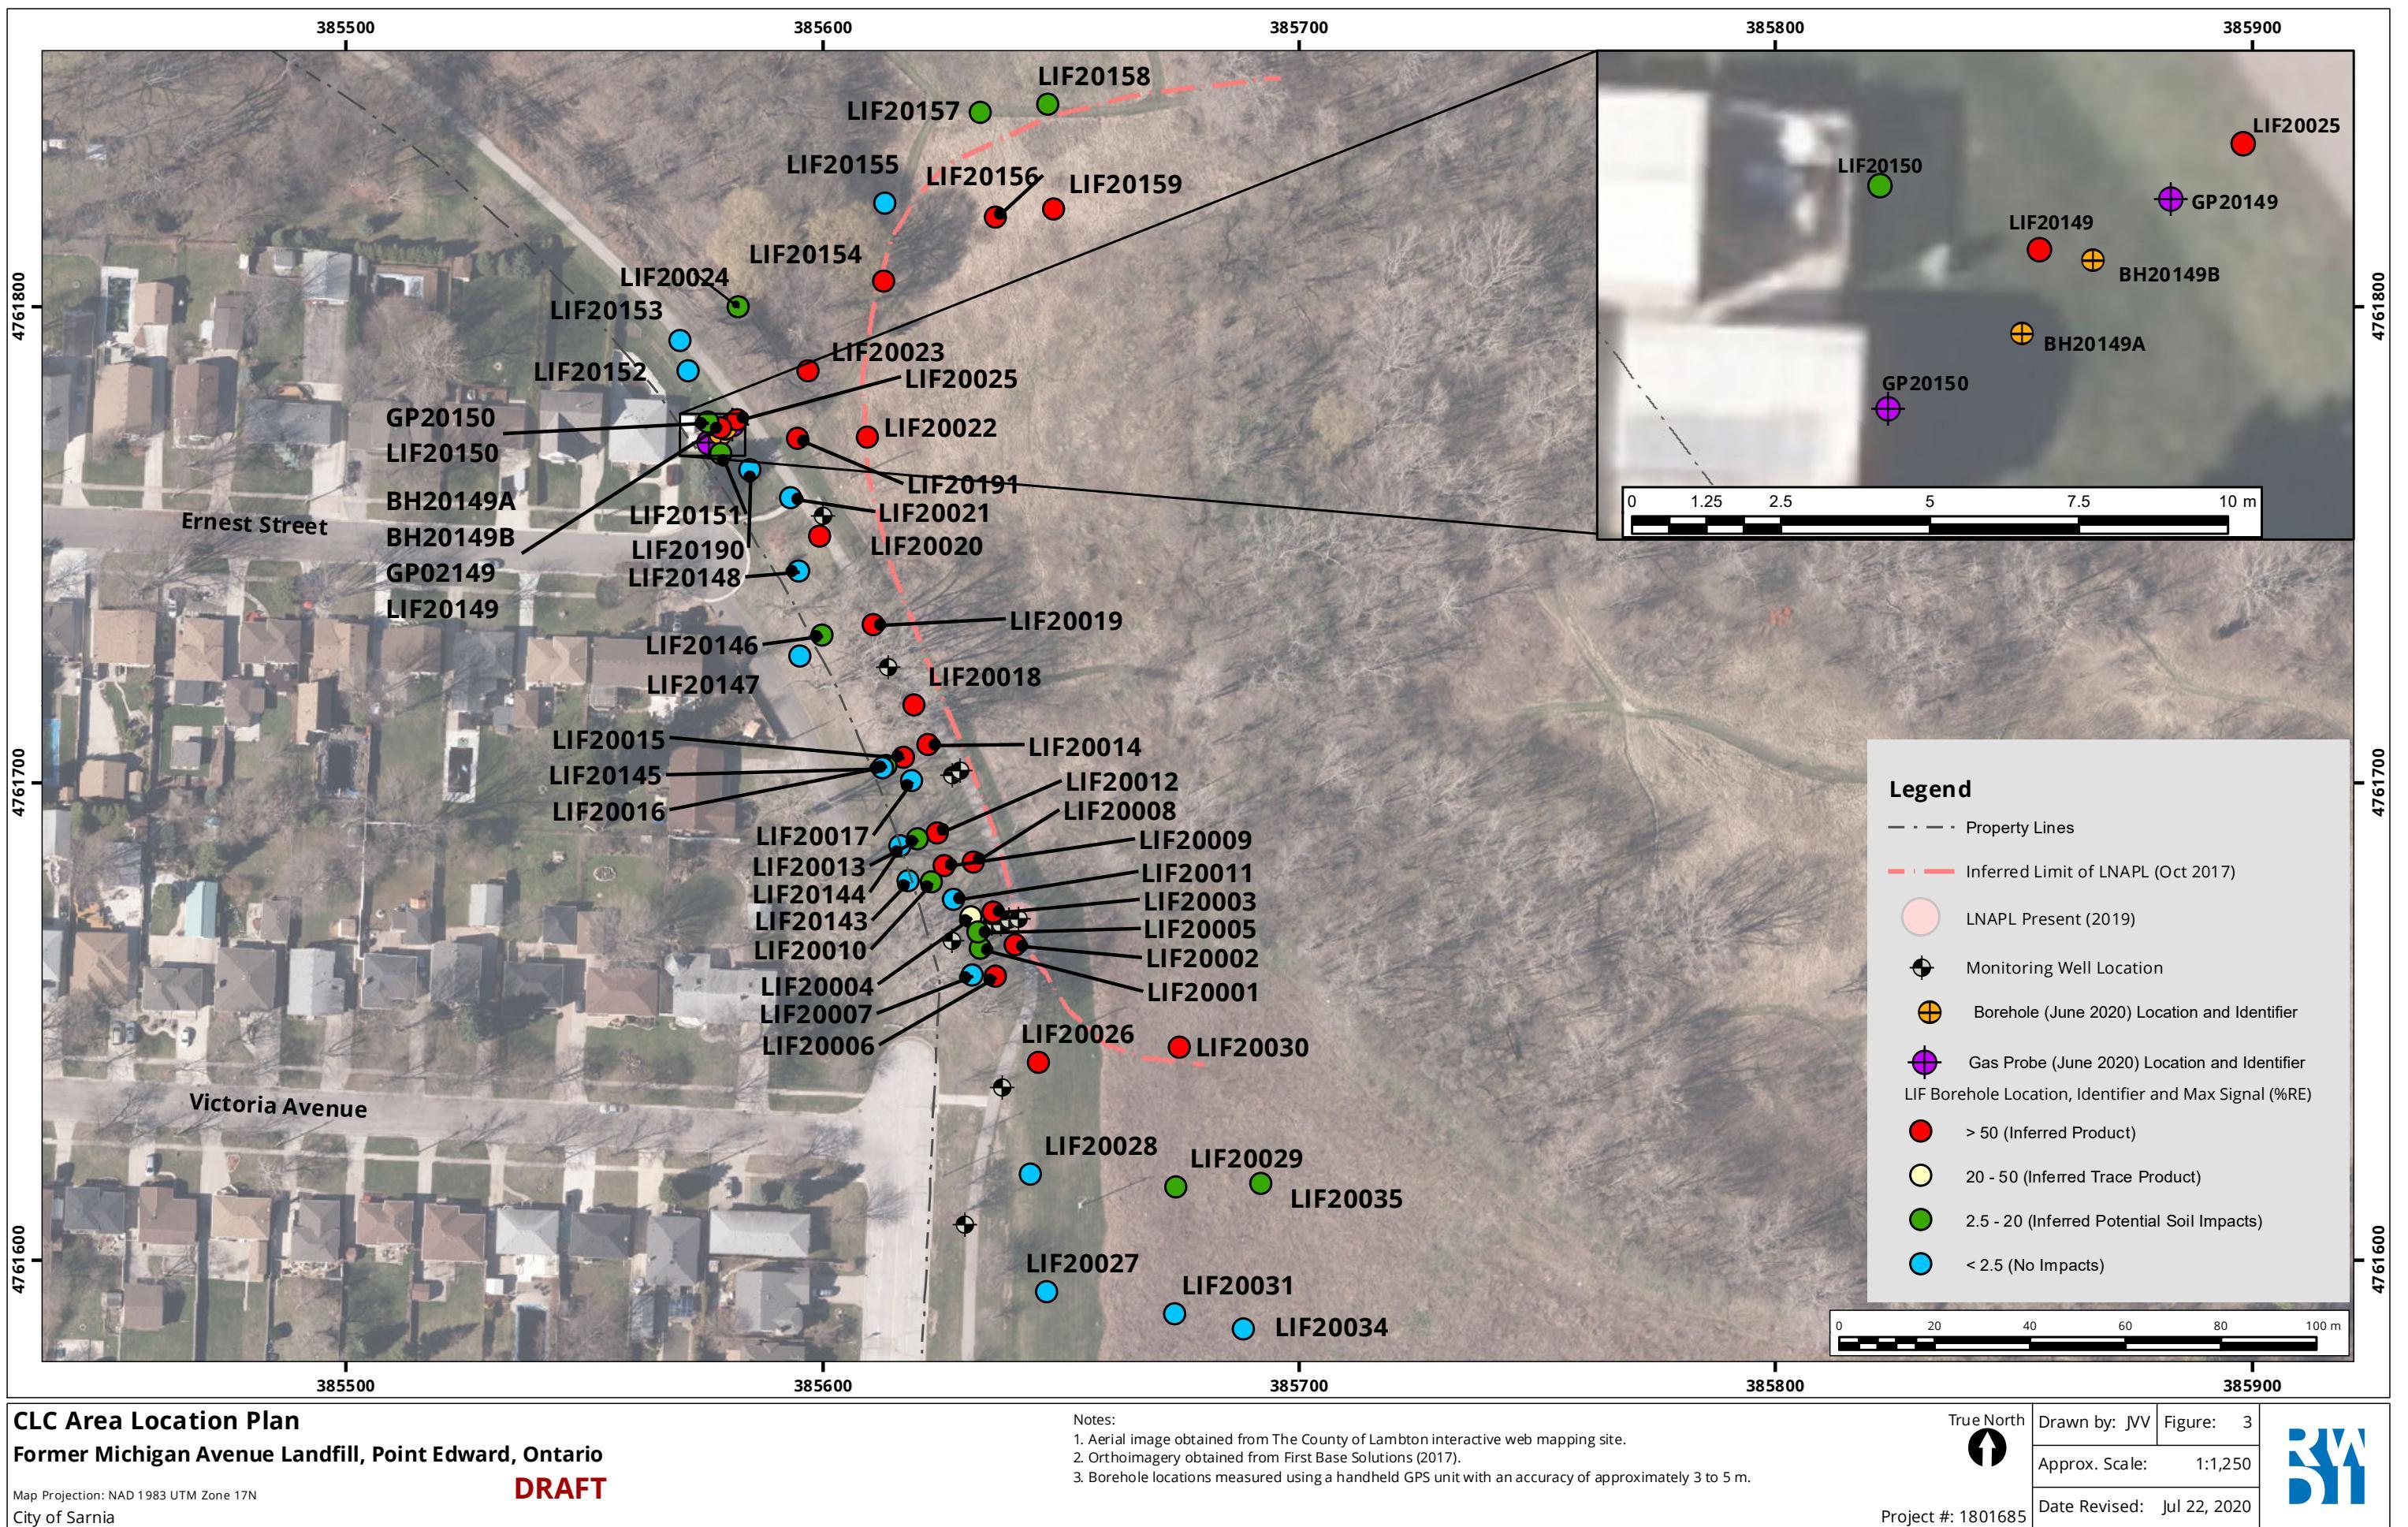
The results of the CLC Area LIF survey are illustrated on **Figure 3** and provided in **Table 1**. Of the 52 LIF boreholes advances, the %RE ranged from 1.4 %RE to 648.3 %RE. The CLC Area had the highest positive responses observed on-site. The vertical responses ranged in thickness from 0 to approximately 3.5 m.

Based on the visualization results within the CLC Area, the higher LIF responses (≥50 %RE) are scattered in small clusters away from the western boundary of the LIF survey from LIF20159 in the northeast to LIF20026 south of monitoring well 705 (refer to **Table 1**). Another small cluster was noted in the area of LIF20149 just east of the residential property located at 720 Ernest Street. West of these LIF boreholes, near the perimeter of the surveyed area, the responses from LIF boreholes indicated little or no presence of LNAPL. This is illustrated on **Figure 3** by the LIF boreholes that are colour-coded blue or green.

As noted on **Figure 3**, there are numerous LIF boreholes with relatively high %RE responses west and northwest of the 2017 inferred limit of LNAPL and which are closer to the Site boundary. This may be a result of plume migration in this direction; however, additional subsurface sampling and testing would be required to confirm this interpretation. As highlighted on **Figure 3**, there are several LIF boreholes with relatively high %RE responses near groundwater monitoring wells where LNAPL was not present based on the 2019 monitoring program. Examples of this include LIF20014 and LIF20015 near monitoring wells 706 and 709, and LIF200020 near monitoring well 702. This demonstrates the need to conduct additional field characterization in areas where LNAPL may be present based on the %RE response.

The locations of these installations are illustrated in the inset box on Figure 3.

Generally, based on the LIF findings in the CLC Area, the LNAPL plume appeared to be similarly shaped as noted in 2017. The %RE responses indicated a potential plume edge that may have slightly shifted westward compared to 2017. Technical details are presented below.

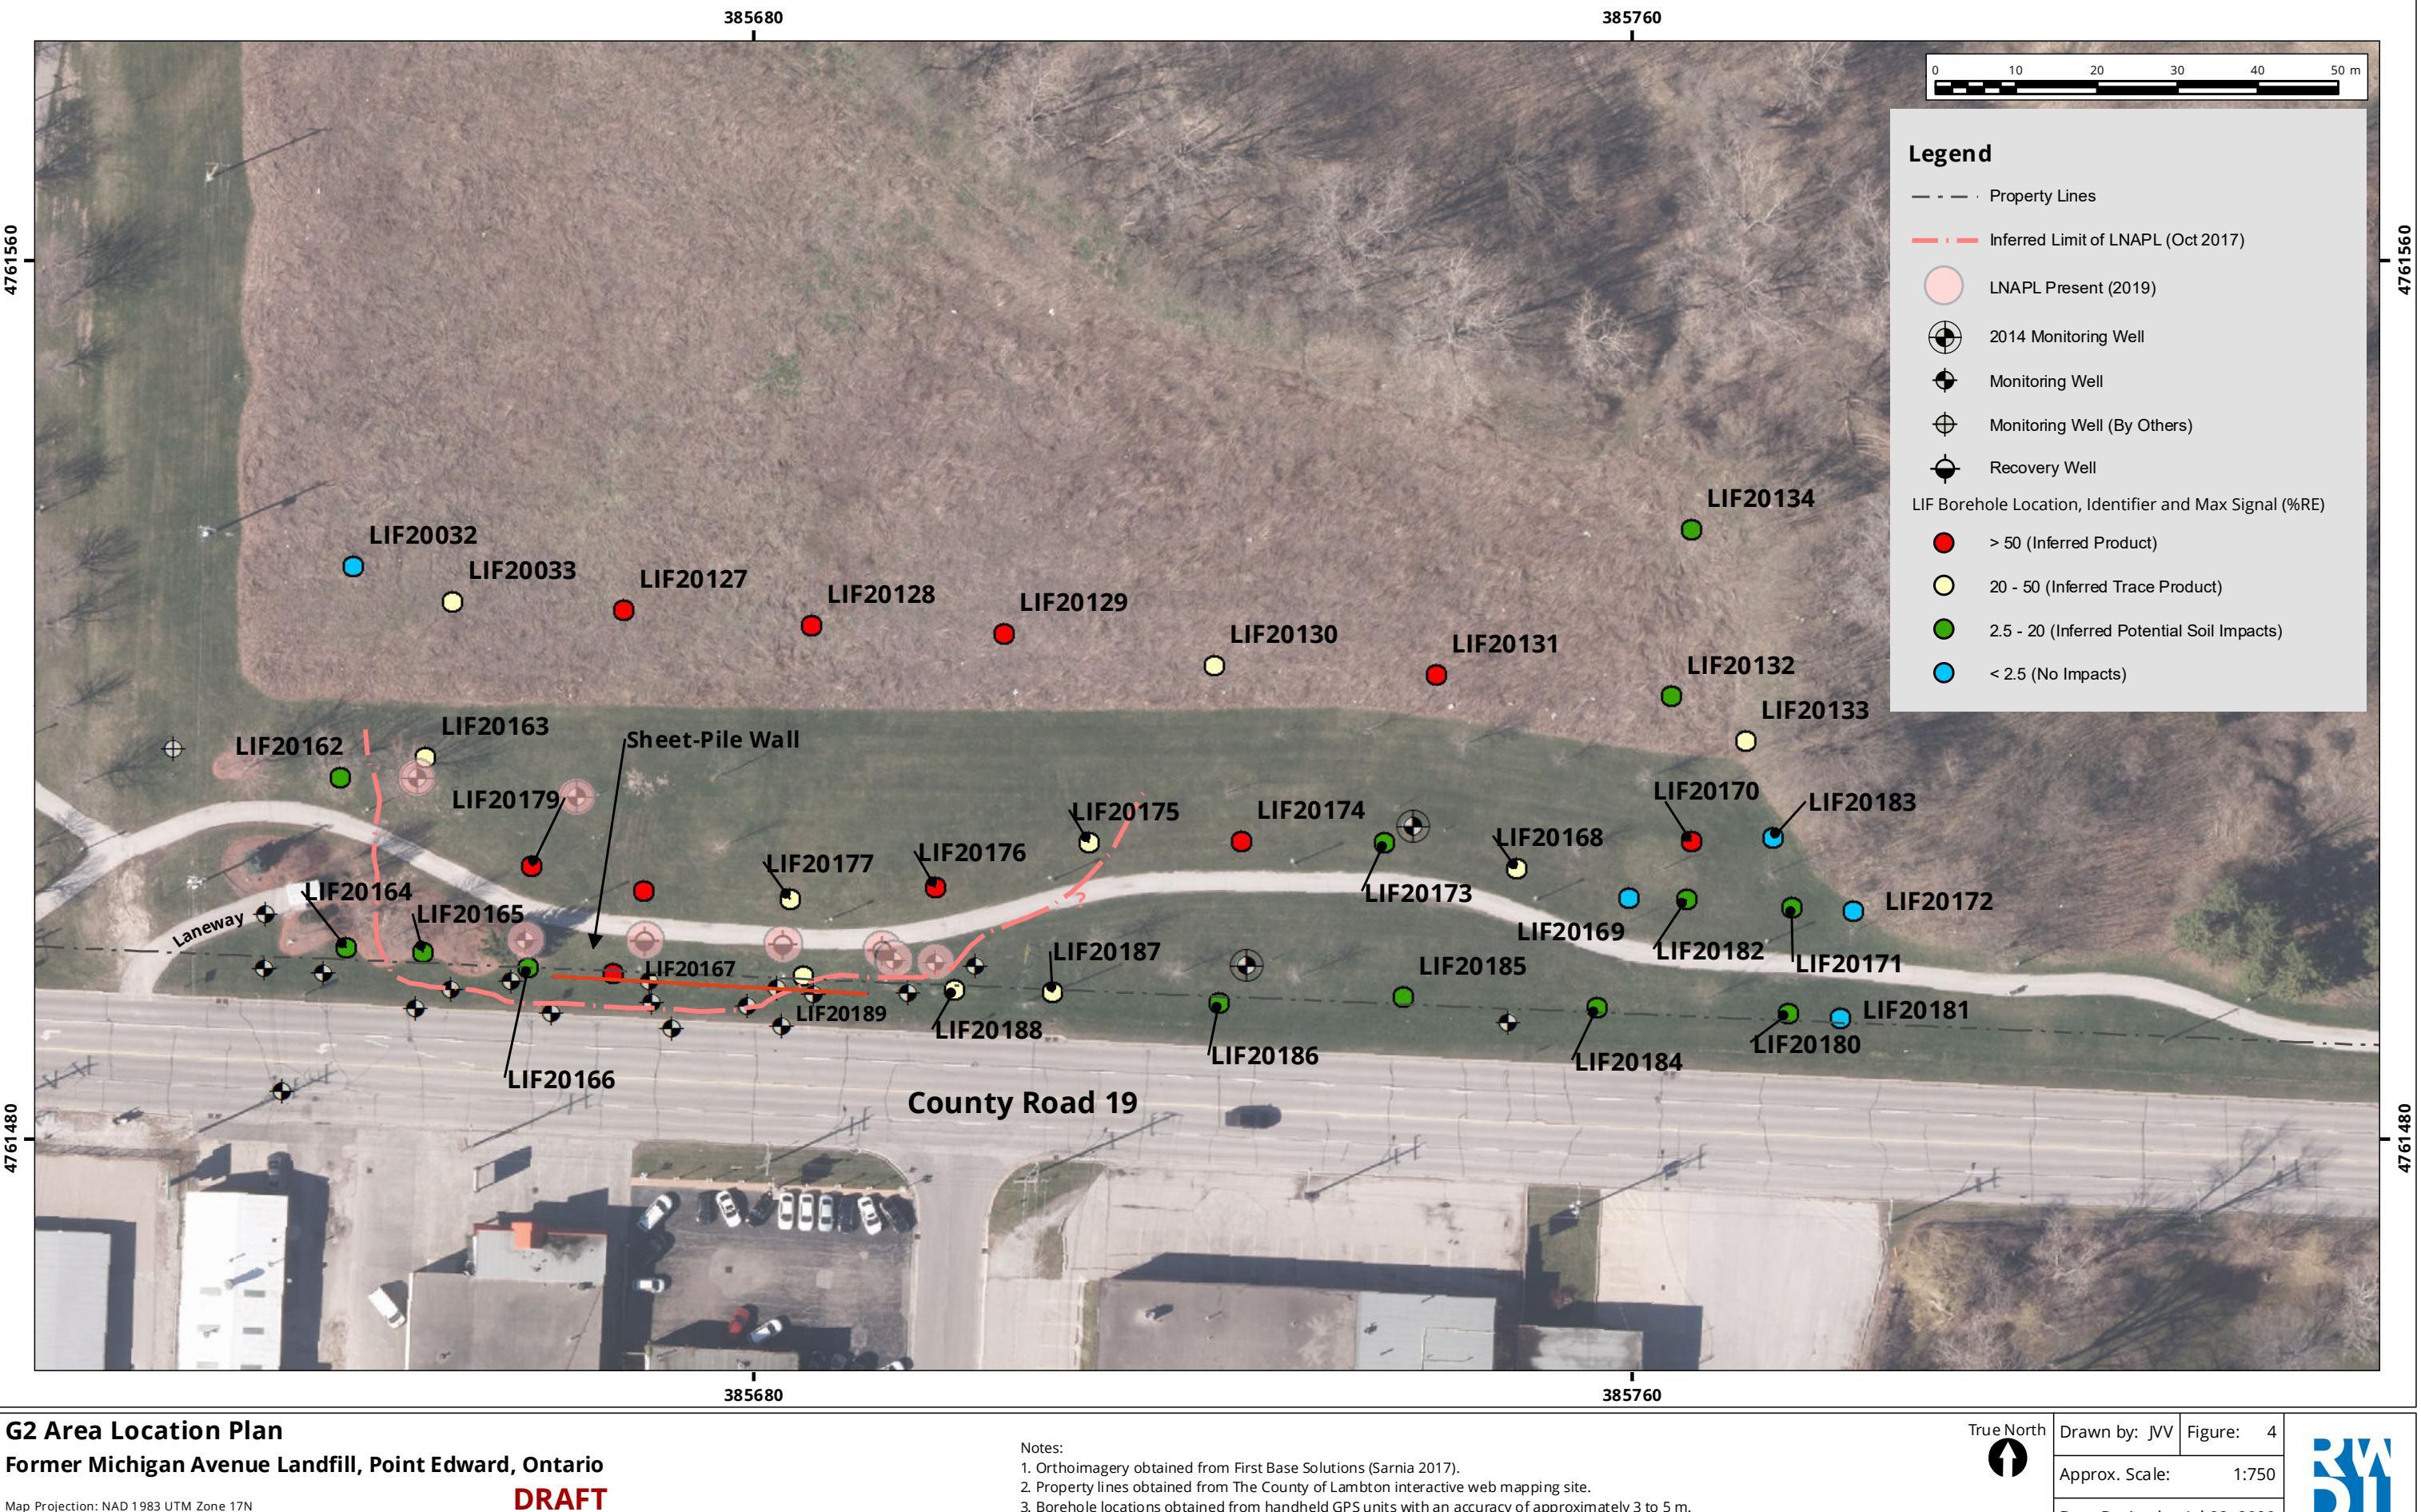
The results of the LIF survey are illustrated on **Figure 4** and summarized in **Table 2**. Of the 38 LIF boreholes advanced, the %RE ranged from 0 %RE to 168.3 %RE and were generally lower than the other two (2) areas (CLC and Lake Chipican areas) investigated for this study. The vertical responses ranged in thickness from 0 to approximately 4.6 m.

Based on the results within the G2 Area, 10 LIF boreholes had LIF %RE responses ≥50 %RE, as outlined in **Table 2**. Of these, three (3) (LIF20131, LIF20174, and LIF20170) were in the area east and north of the sheet-pile barrier wall in an area where LNAPL had not previously been noted. Moderate %RE responses representing potential trace LNAPL (ranging between 20 and 50 %RE and denoted by yellow borehole symbols on **Figure 4**) were noted immediately north and east of the sheet-pile barrier wall. The LIF boreholes north of the sheet-pile barrier wall occur in an area of know LNAPL based on the 2019 monitoring and may correspond to the actual presence of subsurface LNAPL.

The LIF boreholes (LIF20187 and LIF20188) with moderate %RE responses east of the sheet-pile barrier wall and north of Michigan Avenue occur in an area where LNAPL had not previously been detected and represents a risk of potential off-site migration. No LIF boreholes were advanced immediately south of the sheet-pile barrier wall near Michigan Avenue due to concerns of an unmarkable utility. Additional field characterization should be completed in areas where LNAPL may be present based on the %RE responses.

- Ten LIF boreholes had relatively high %RE (>50 %RE) responses indicative of potential LNAPL impacts. Of these, three (3) (LIF20121, LIF20174, and LIF20170) were in the area east and north of the sheet-pile barrier wall in an area where LNAPL had not previously been noted. Moderate %RE responses (ranging between 20 and 50 %RE) were noted immediately north of the sheet-pile barrier wall in areas with known LNAPL presence based on the 2019 monitoring program findings.

- Moderate responses (10 25 %RE) indicative of potential trace LNAPL were noted north and east of the sheet-pile barrier wall. The LIF boreholes with moderate %RE responses east of the sheet-pile barrier wall and north of Michigan Avenue occur in an area where LNAPL had not previously been detected and represent a risk of potential off-site migration.

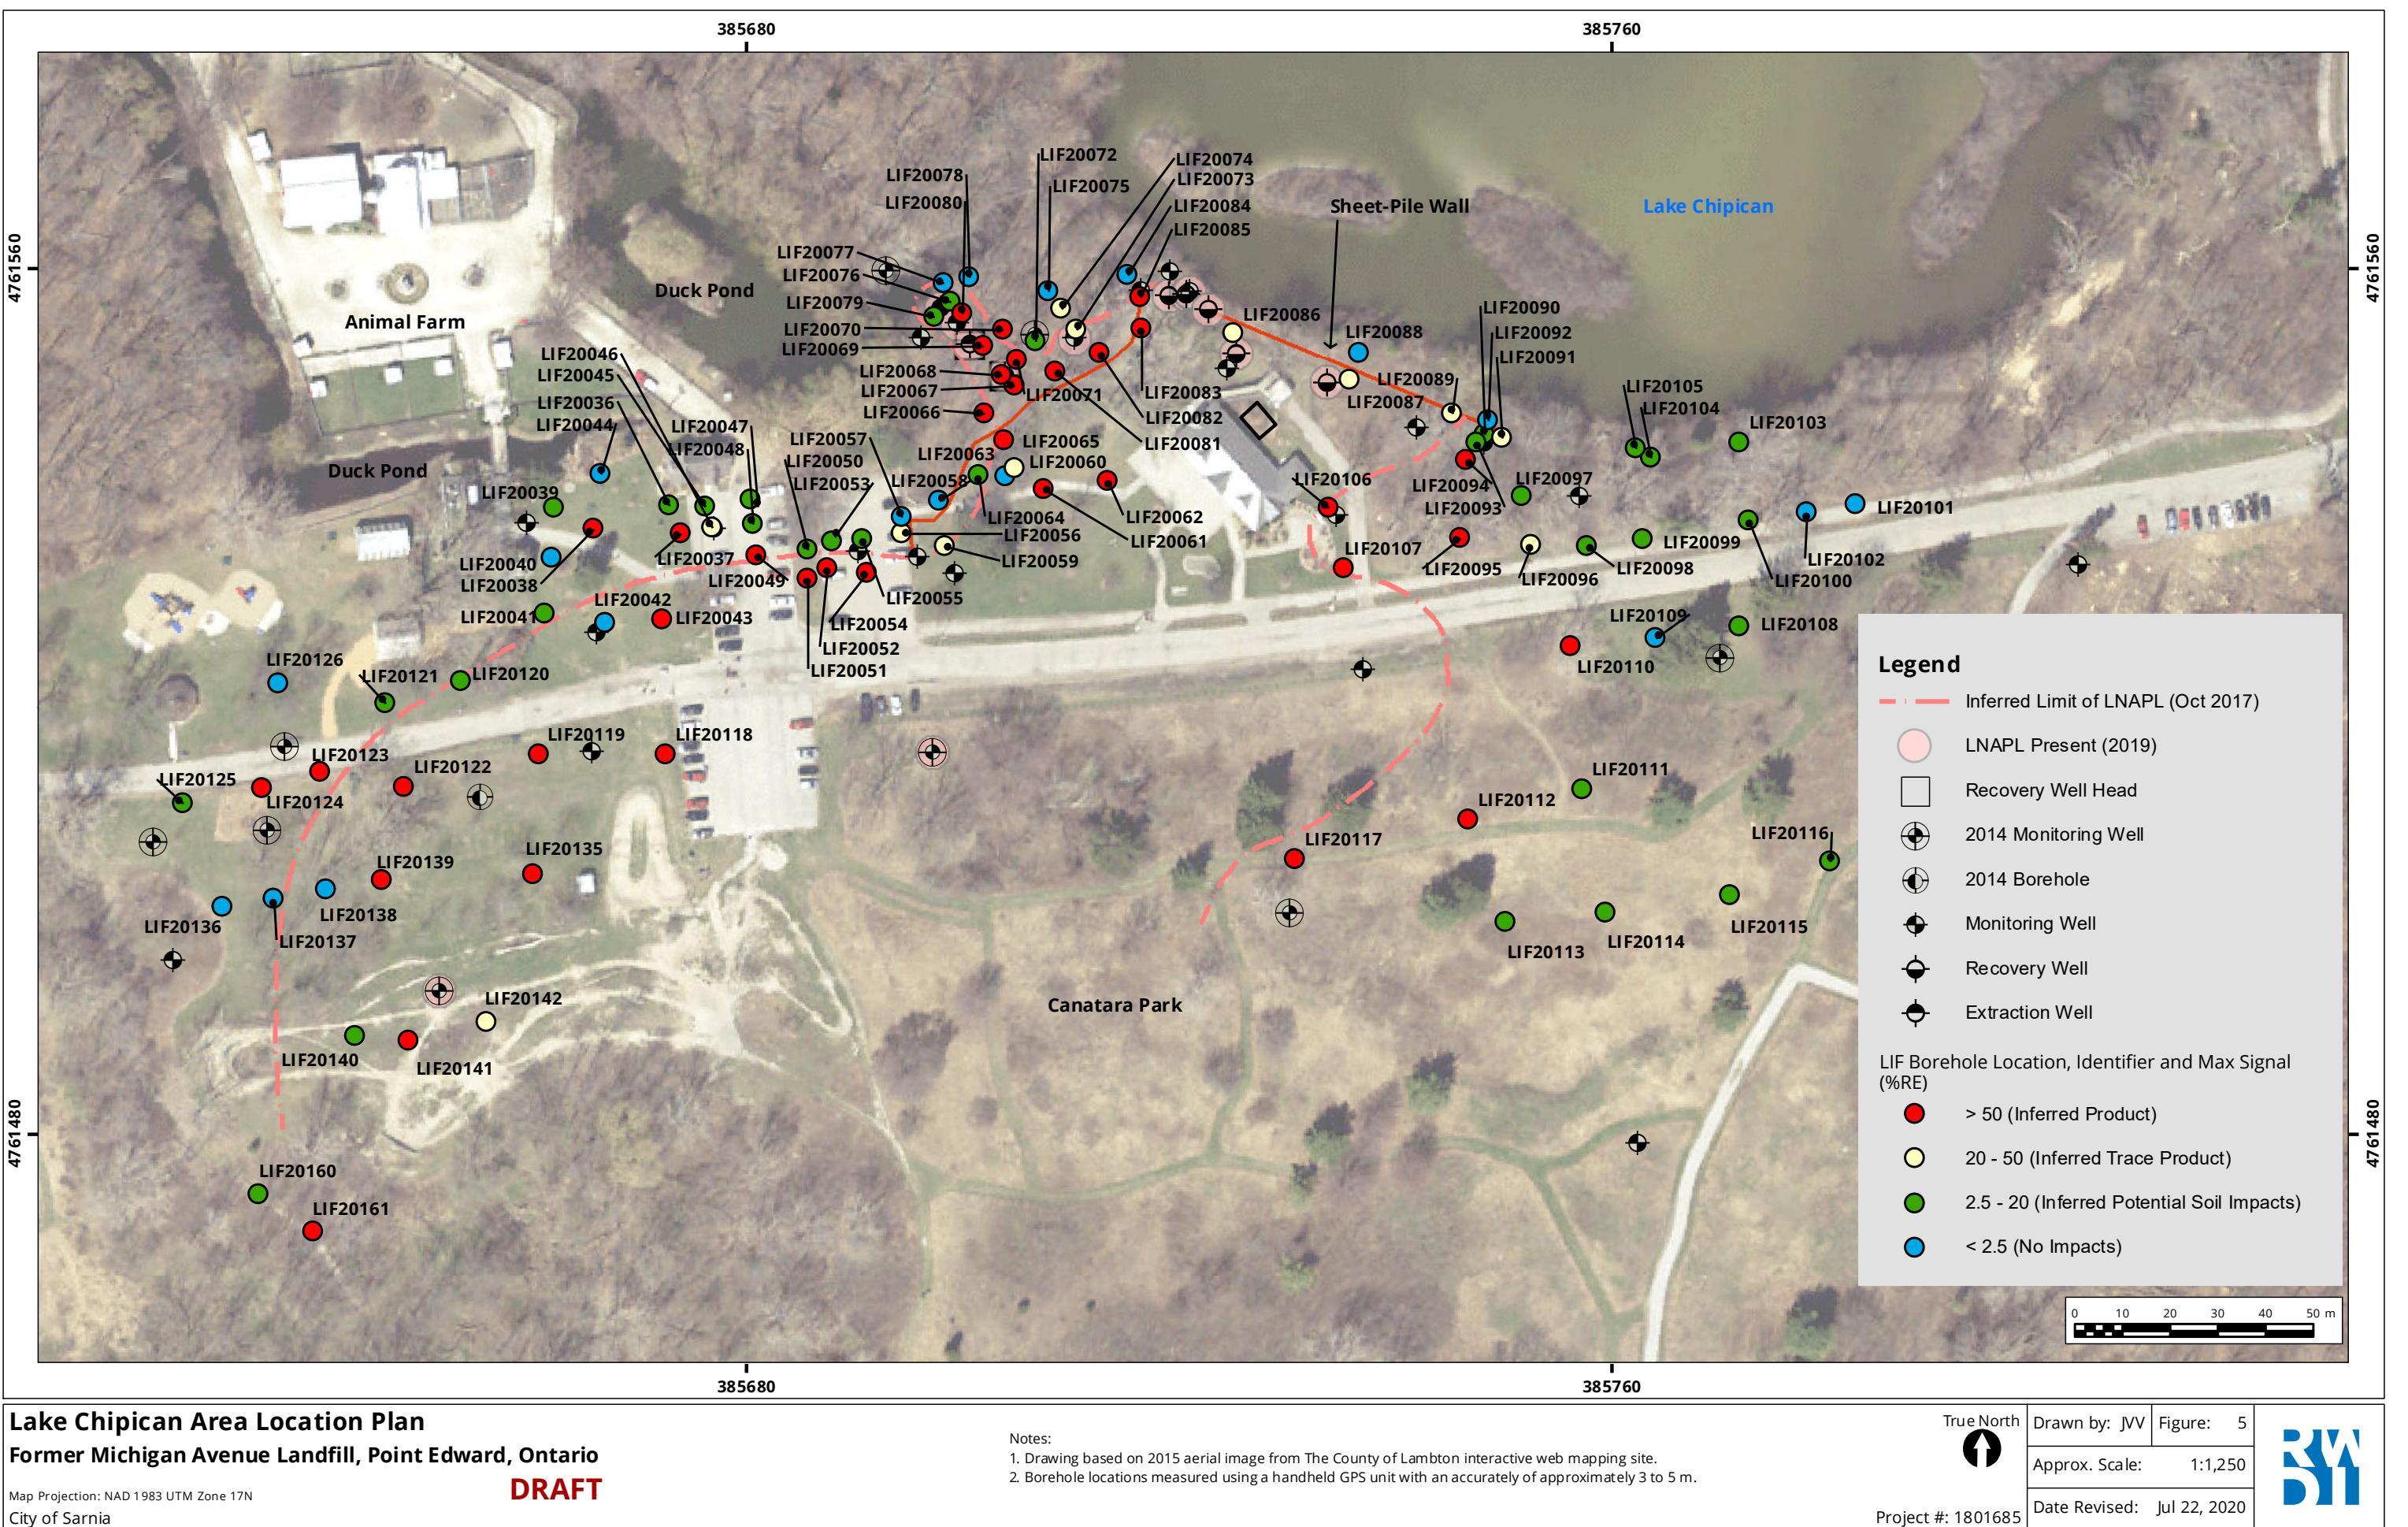
Map Document: K:\1801685\6. Delkerables\LIF Report\Figures\Working Files\F05_Lake Chipican Area Location Plan.n

The results of the LIF survey are illustrated on **Figure 5** and summarized in **Table 3**. Of the 101 LIF boreholes advanced, the %RE ranged from 1.2 %RE to 403 %RE. The vertical responses ranged in thickness from 0 to approximately 5 m.

- LIF20123 and LIF20134 were located slightly west of the western extent of the 2017 inferred delineated plume;
- LIF20037, LIF20038 and LIF20049 were located slightly north of the 2017 inferred delineated plume in the parking lot area south of the Animal Farm;
- LIF20070 was located just east of the historically identified plume "finger" of LNAPL near Recovery Wells EW1 and EW2;
- LIF20106, LIF20107, LIF20094 and LIF20095 located north of Cathcart Blvd. and east of the 2017 inferred delineated plume. It should be noted that LIF20094 is within approximately 20 m of Lake Chipican, but appears to be in line with the edge of the sheet-pile barrier wall; and
- LIF20110, LIF20112. and LIF20117 located south of Cathcart Blvd. and east of 2017 inferred delineated plume.

Moderate responses indicating the potential for the presence of trace subsurface LNAPL (20-50 %RE) were also noted northwest of the sheet-pile barrier wall and east of the historically identified LNAPL "finger" (LIF20073 and LIF20074).

As noted in the inset box on **Figure 5**, the gas probe boreholes were completed from GP20149 in a southwest linear direction to GP0150 located within 3 m of the approximate property line and shed at 720 Ernest Street. GP20149 was intended to be in the vicinity of LIF20149, which had a %RE response of 187.8 %RE and, as such, interpreted to be within the LNAPL plume. GP20150 was intended to be in the vicinity of LIF20150, which had a %RE response of 2.8 %RE and interpreted to be outside of the plume.

- LIF20110, LIF20112 and LIF20117 located south of Cathcart Blvd. and east of the 2017 inferred delineated plume.
- Moderate responses indicative of potential trace LNAPL (20-50 %RE) were noted north of Cathcart Blvd. east of the 2017 inferred delineated plume (LIF20096 and LIF20091). LIF20091 is in the same vicinity as LIF20094 referenced above and is relatively close to Lake Chipican.

- Moderate responses indicative of potential trace LNAPL (20-50 %RE) were also noted northwest of the sheet-pile barrier wall and east of the LNAPL "finger" (LIF20073 and LIF20074).
