# **Attachment B**

## **LIF Logs**

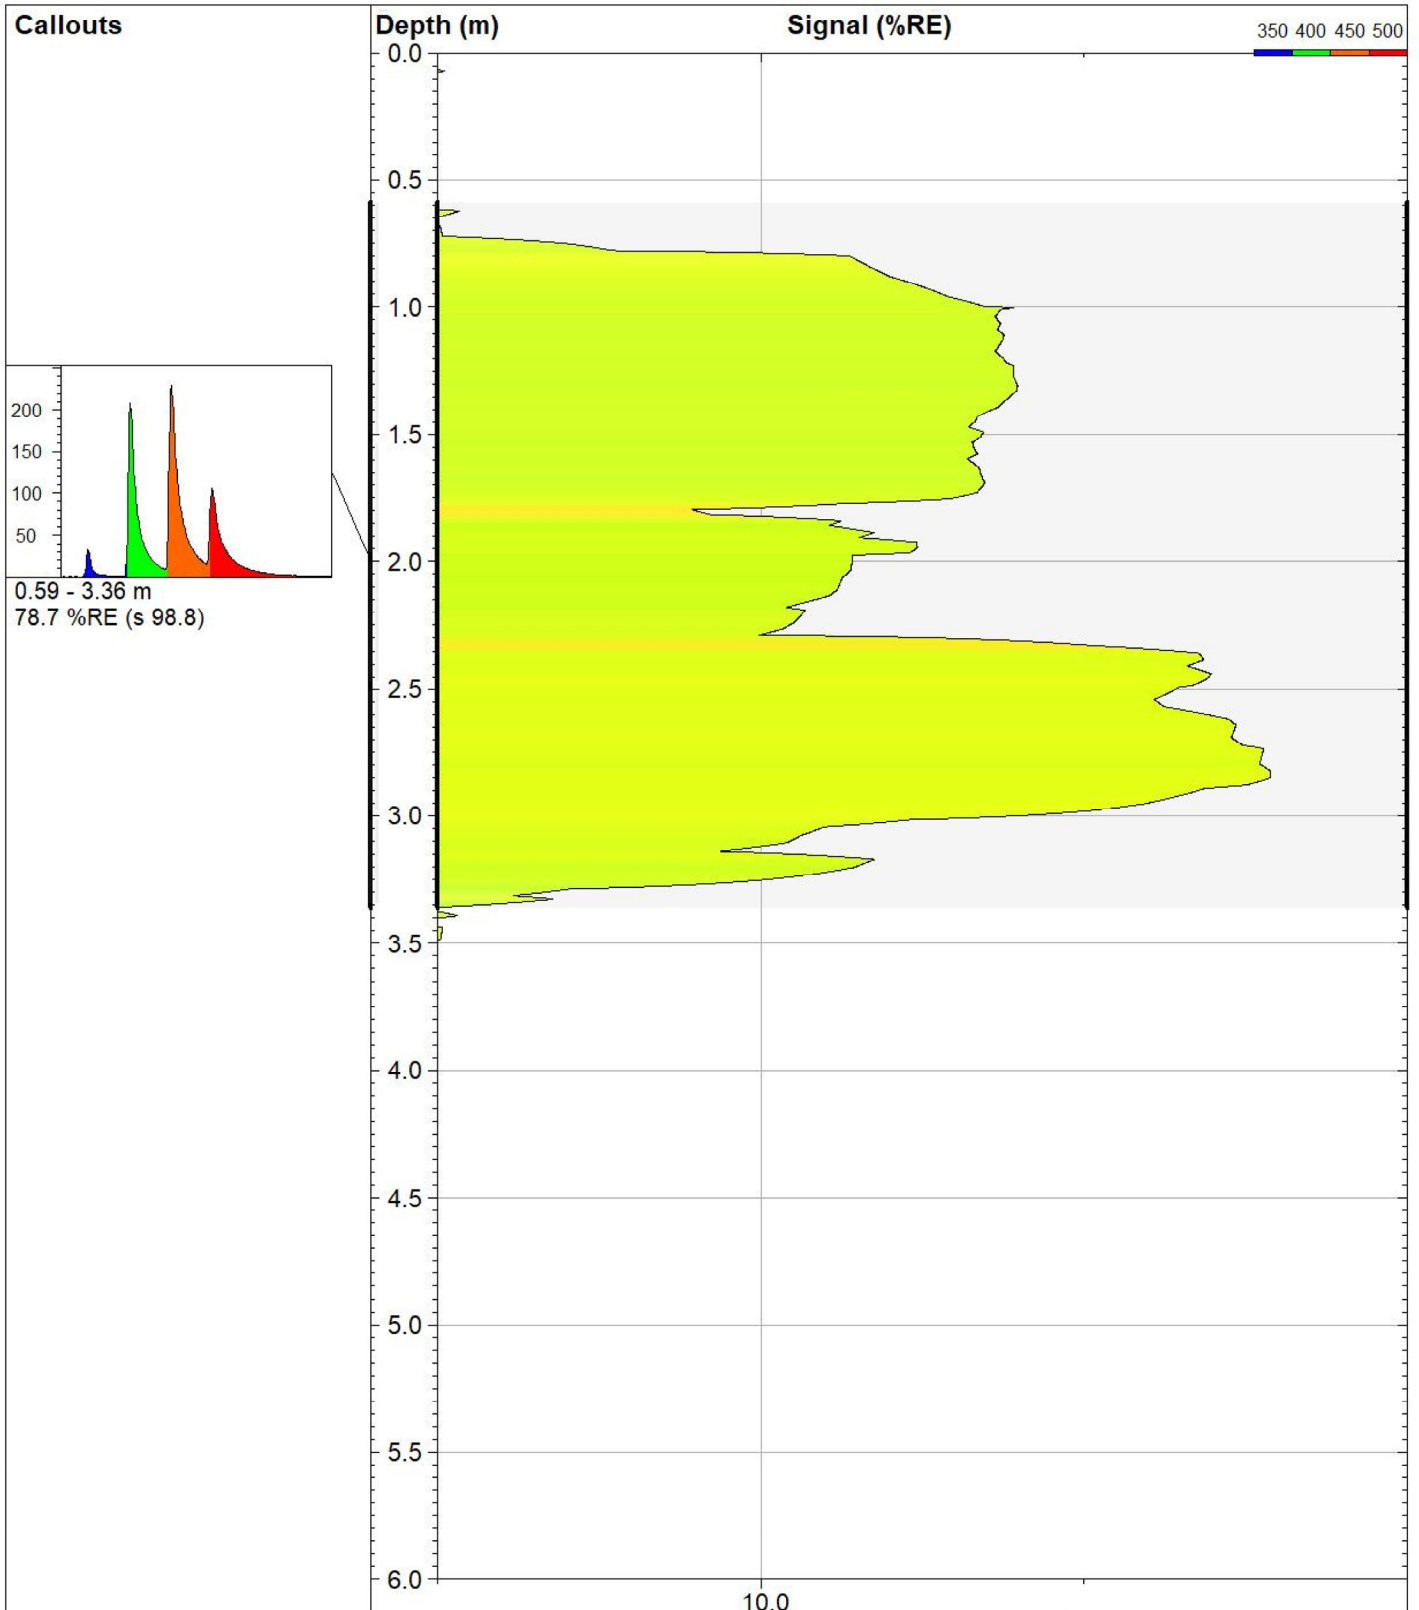
**LIF20002**

*Final depth:*  
**4.49 m**

*Max signal:*  
**265.0 %RE @ 2.97 m**

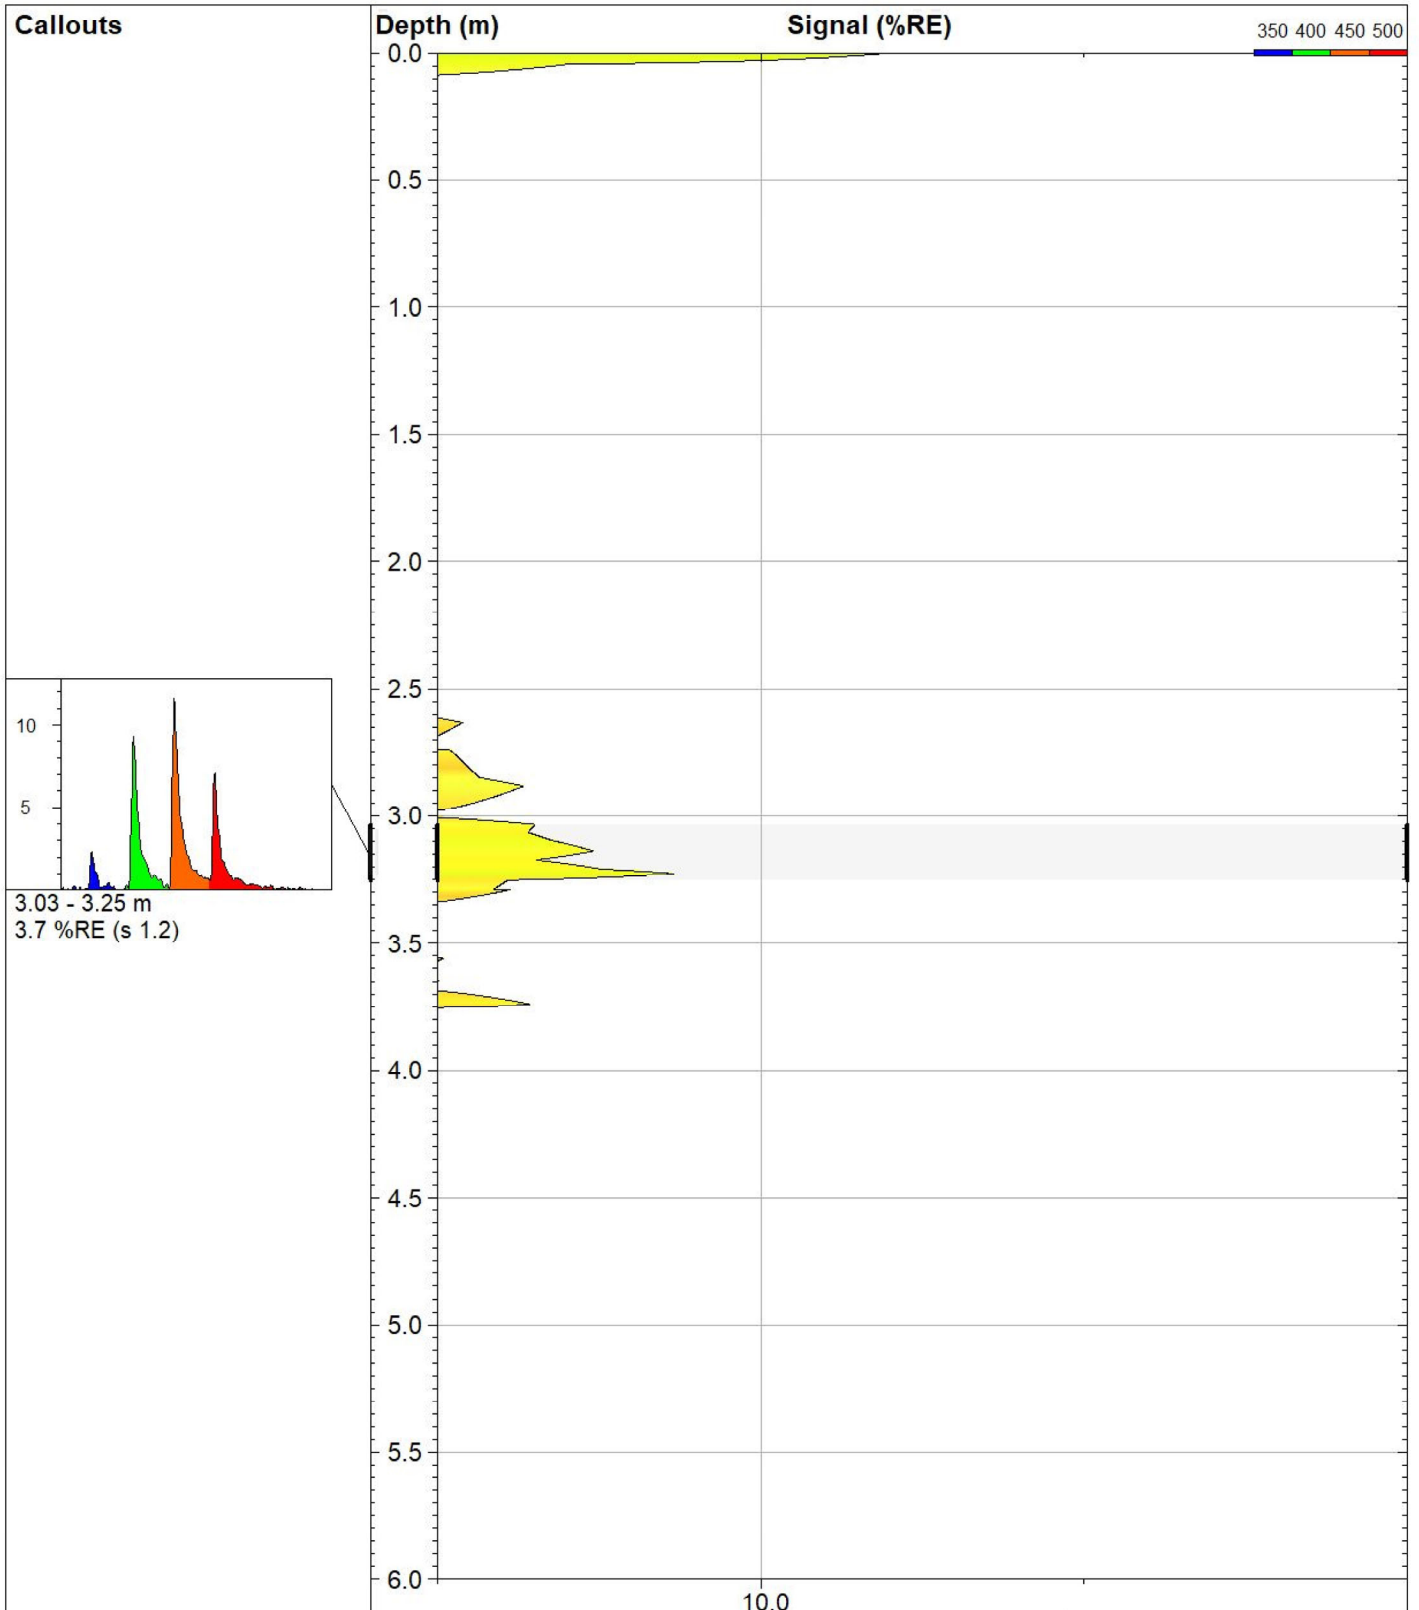
**LIF20003**

*Final depth:*  
**3.71 m**

*Max signal:*  
**377.9 %RE @ 2.85 m**

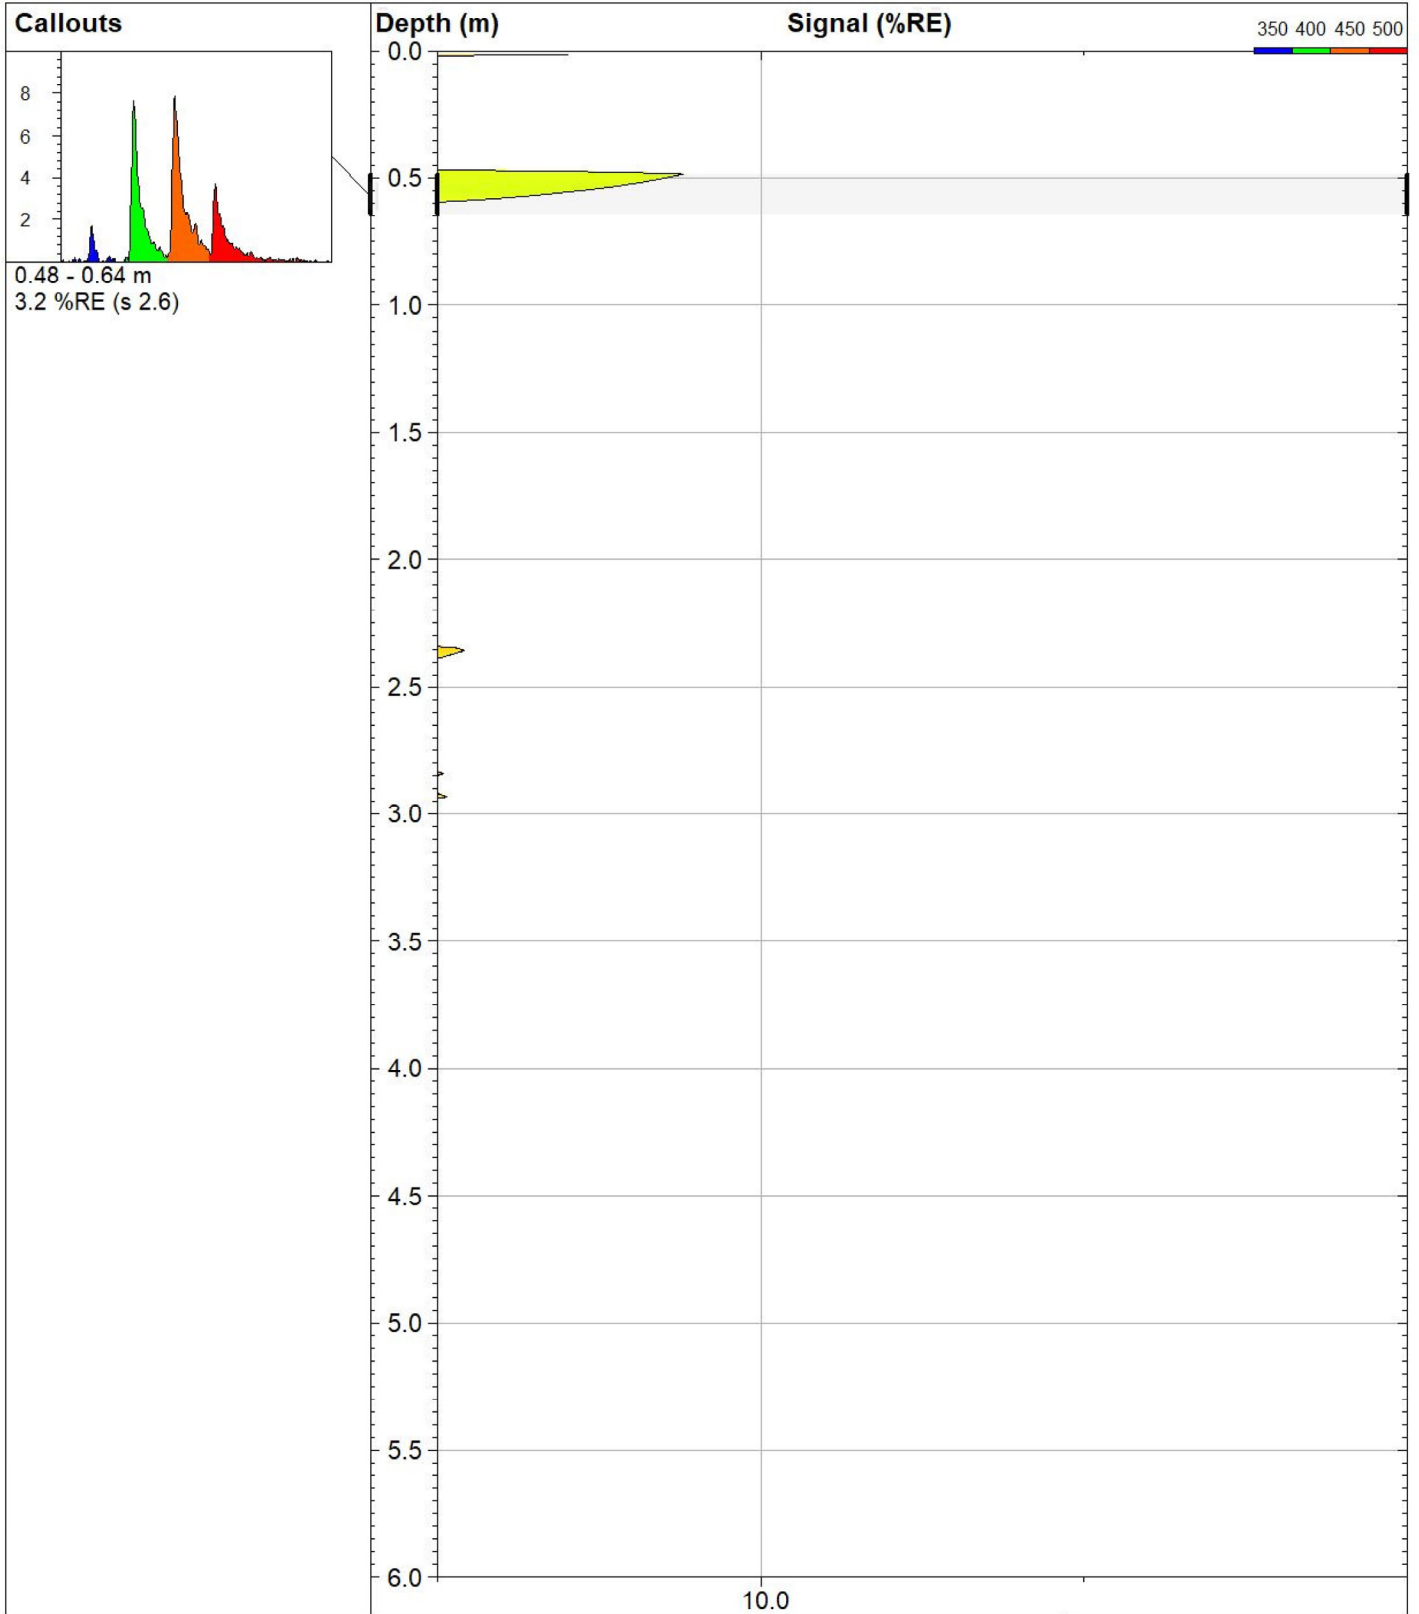
**LIF20004**

**Final depth:**  
3.77 m

**Max signal:**  
27.1 %RE @ 0.00 m

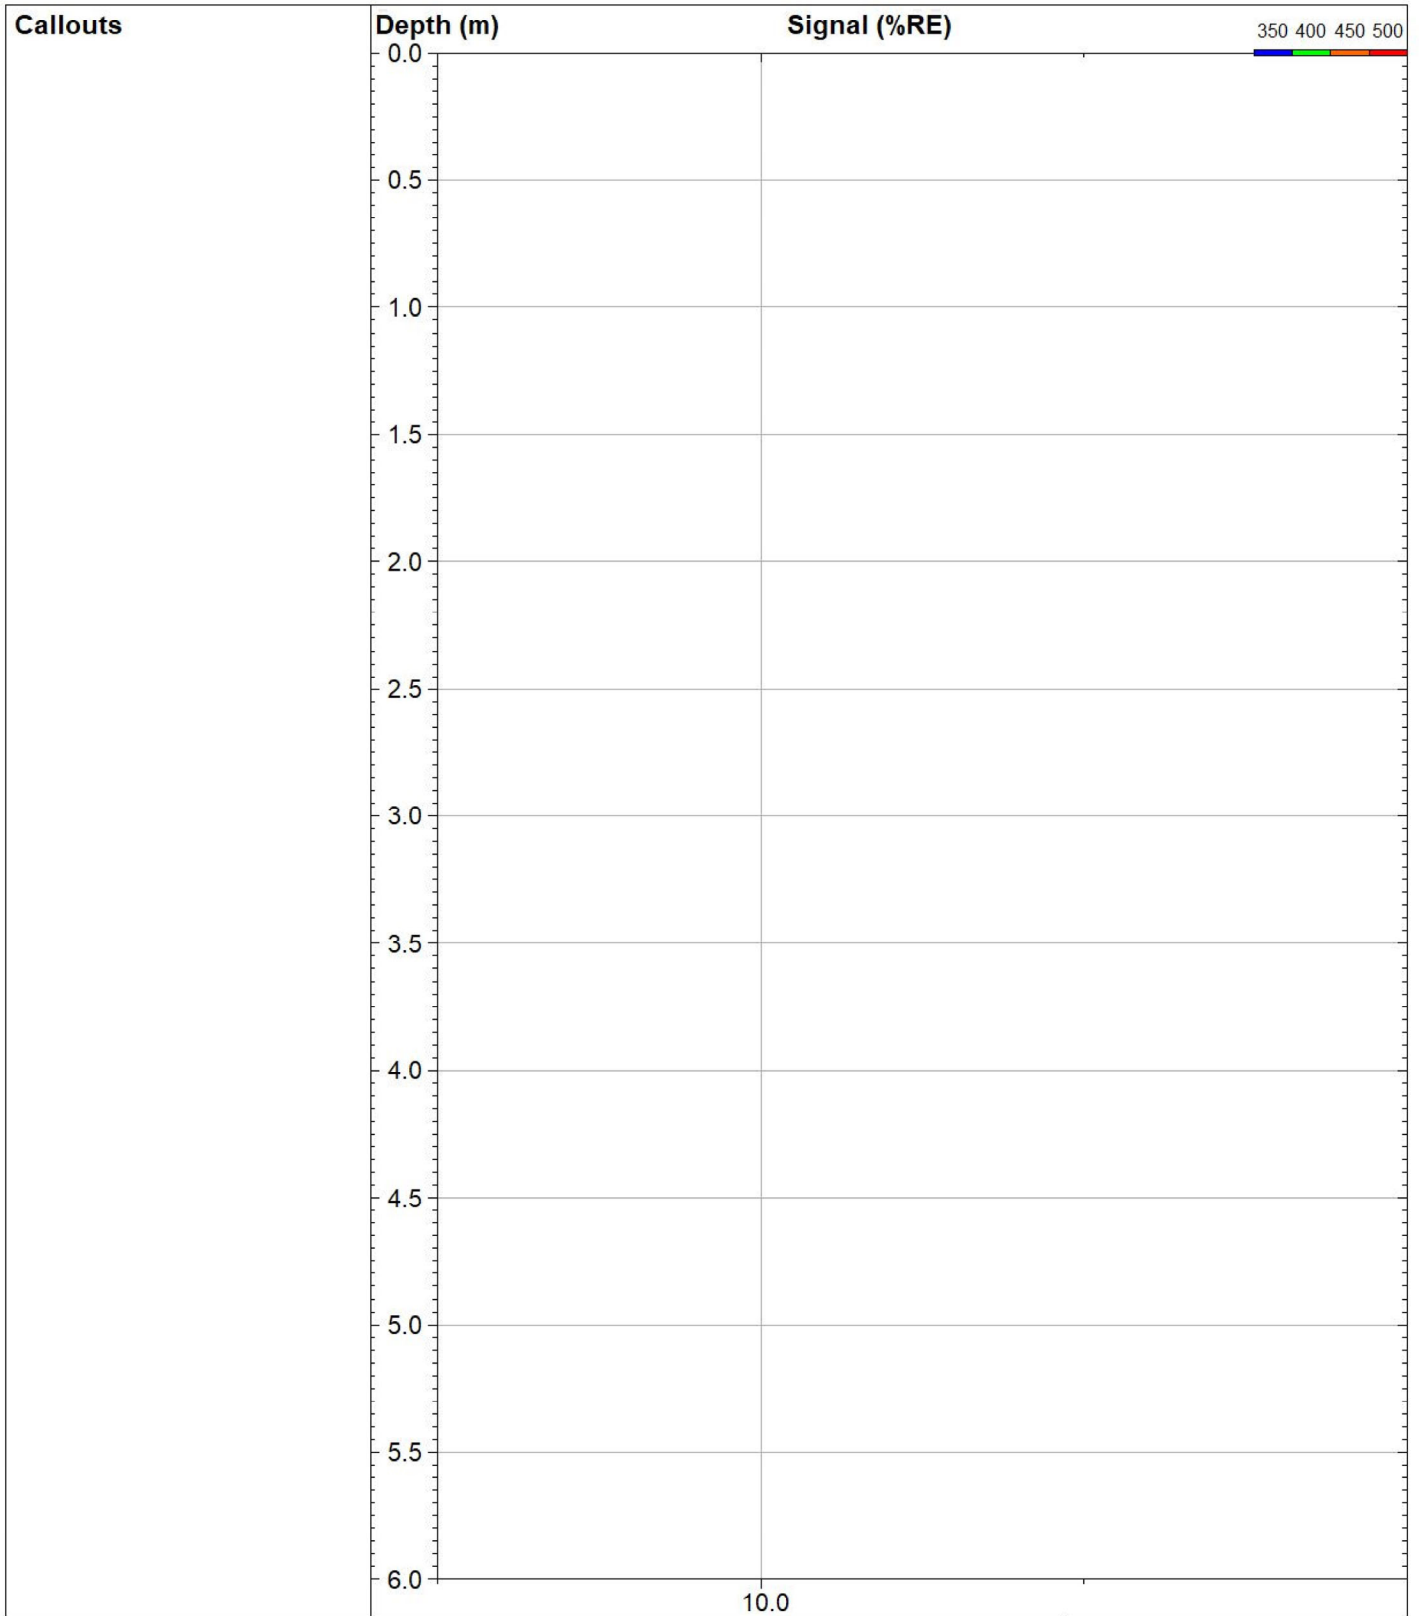
**LIF20006**

*Final depth:*  
**3.17 m**

*Max signal:*  
**55.7 %RE @ 2.03 m**

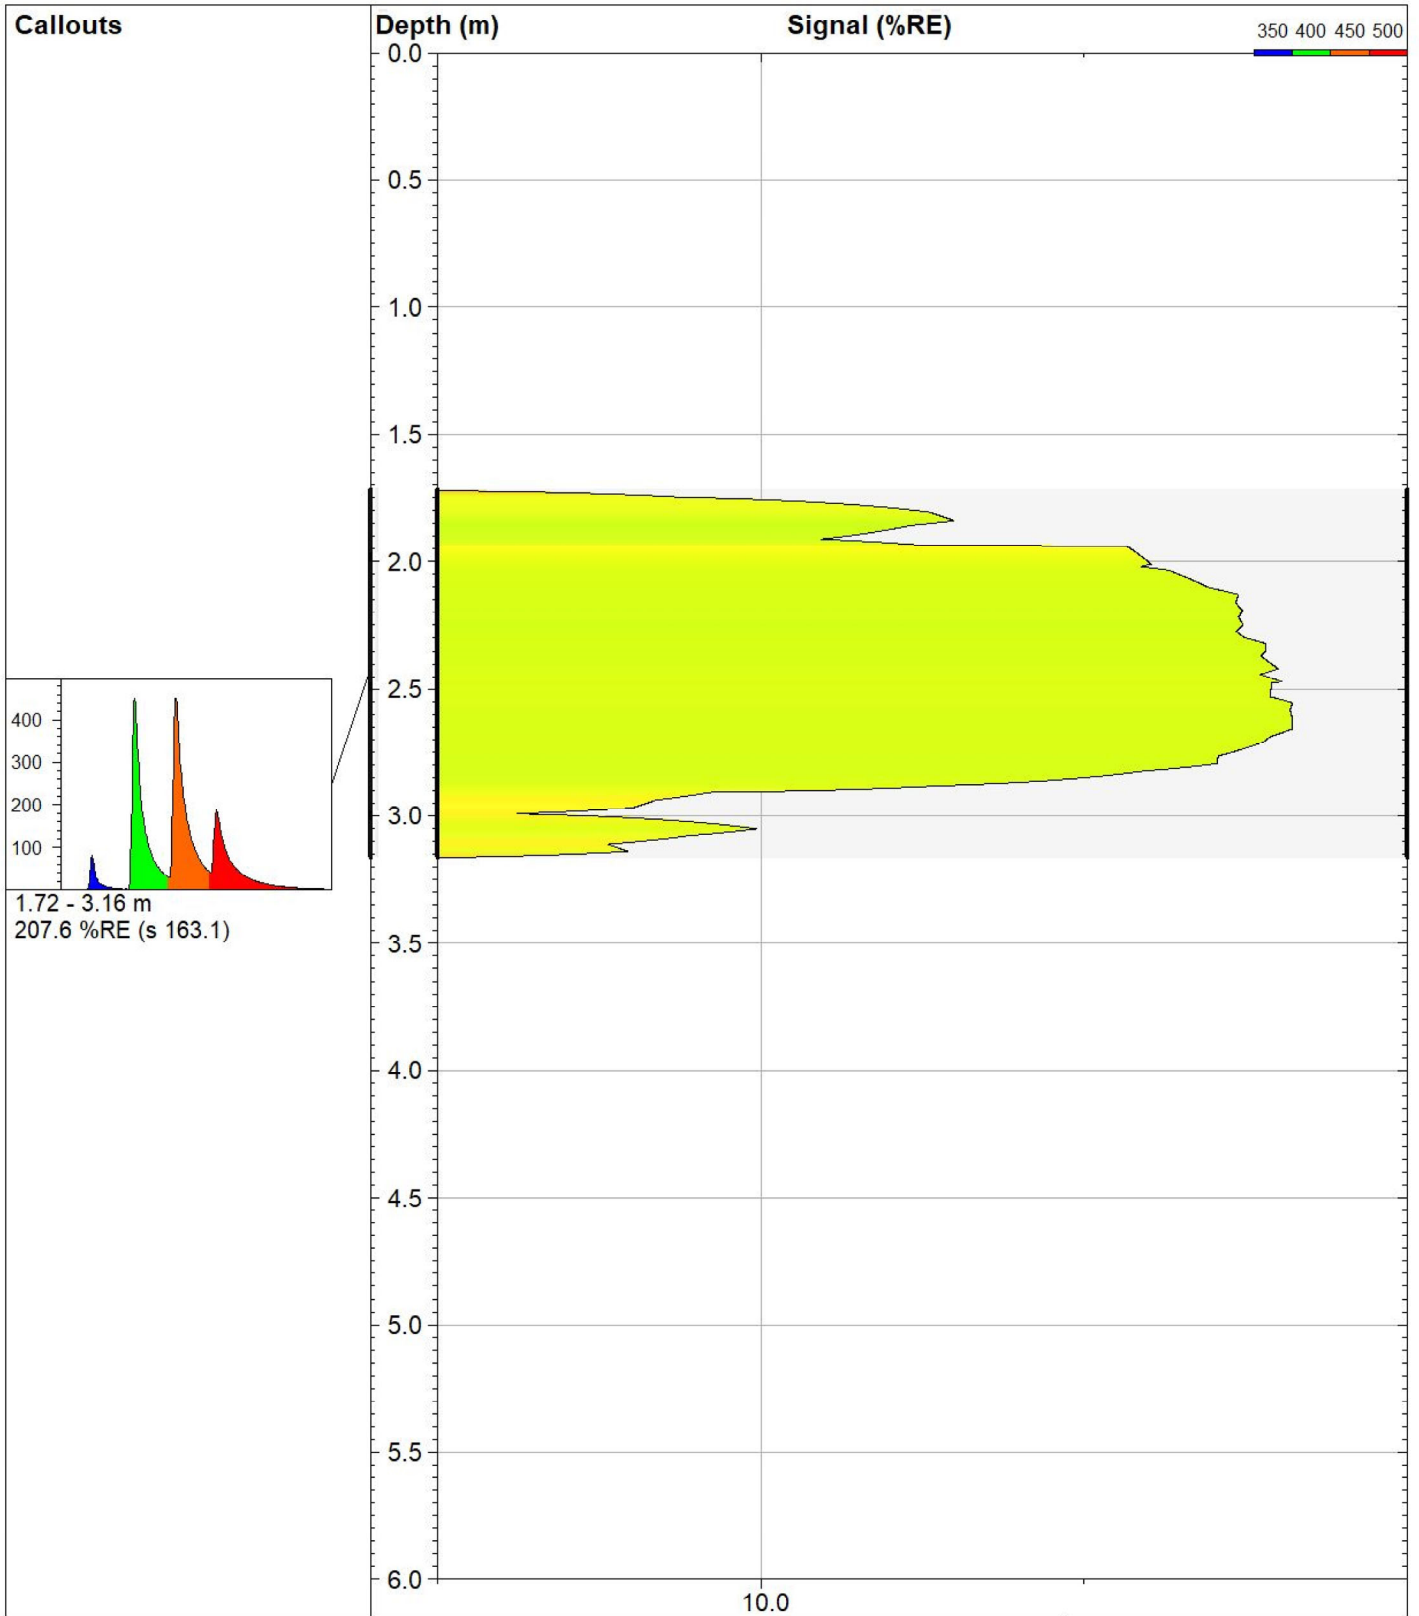
**LIF20007**

*Final depth:*  
**3.08 m**

*Max signal:*  
**1.9 %RE @ 2.24 m**

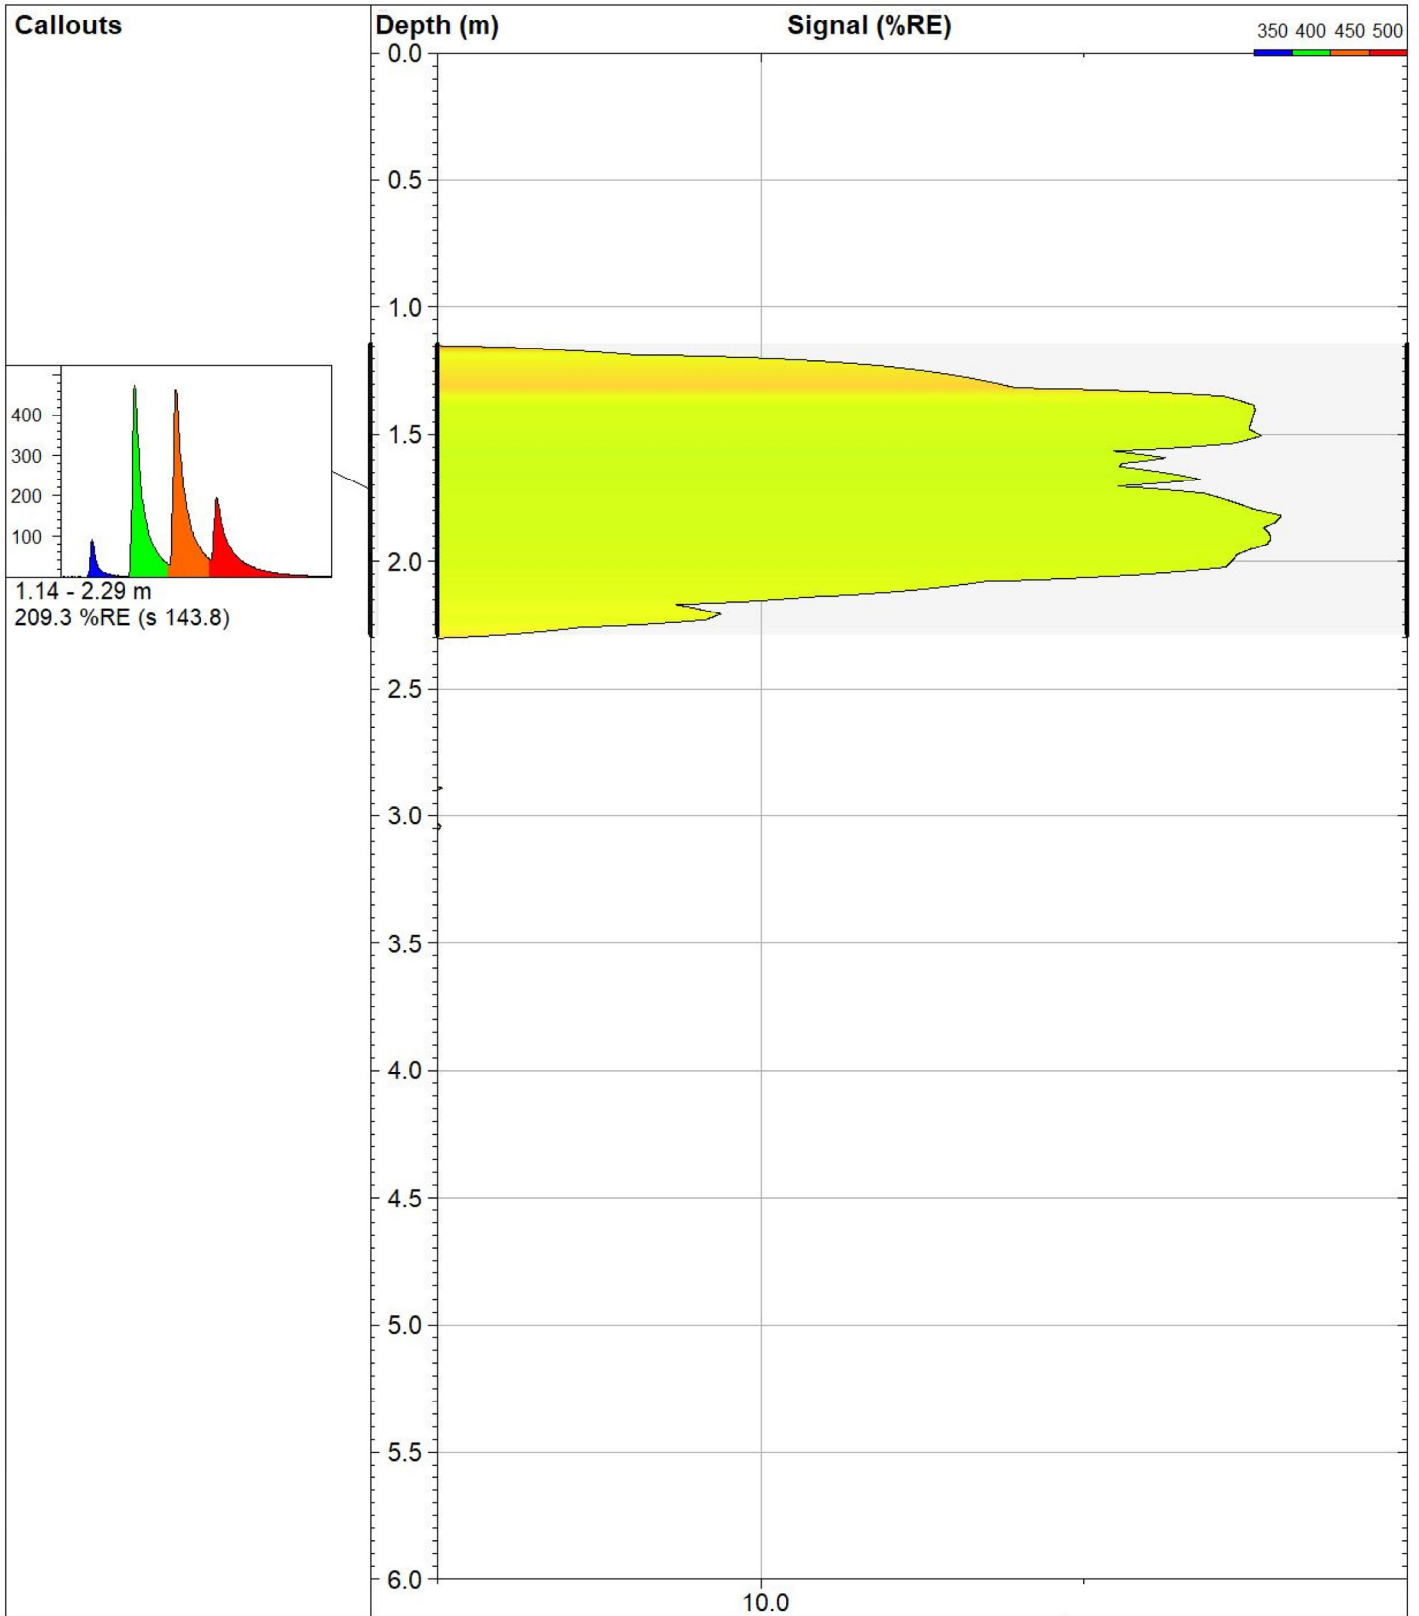
**LIF20008**

**Final depth:**  
3.70 m

**Max signal:**  
443.1 %RE @ 2.66 m

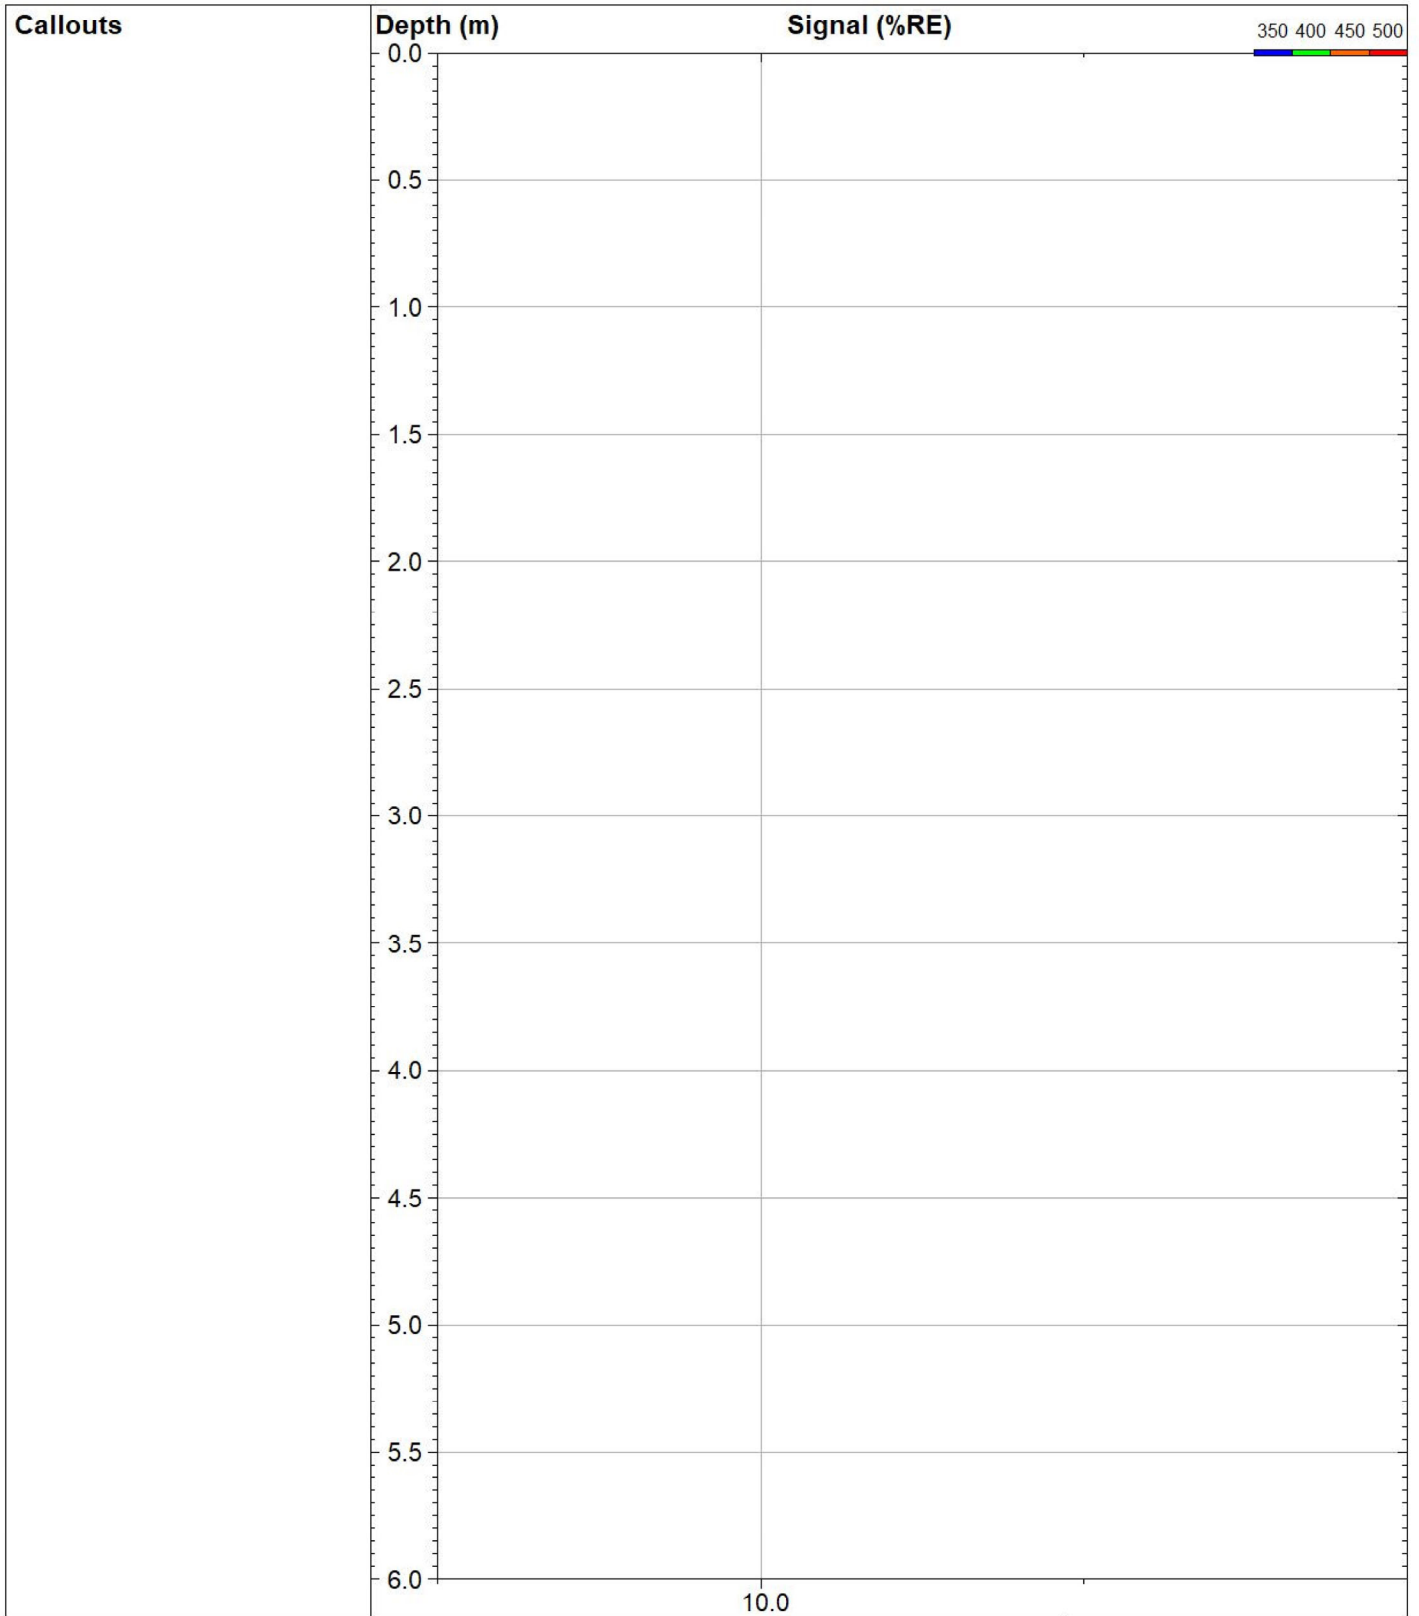
**LIF20010**

*Final depth:*  
**3.23 m**

*Max signal:*  
**15.6 %RE @ 0.71 m**

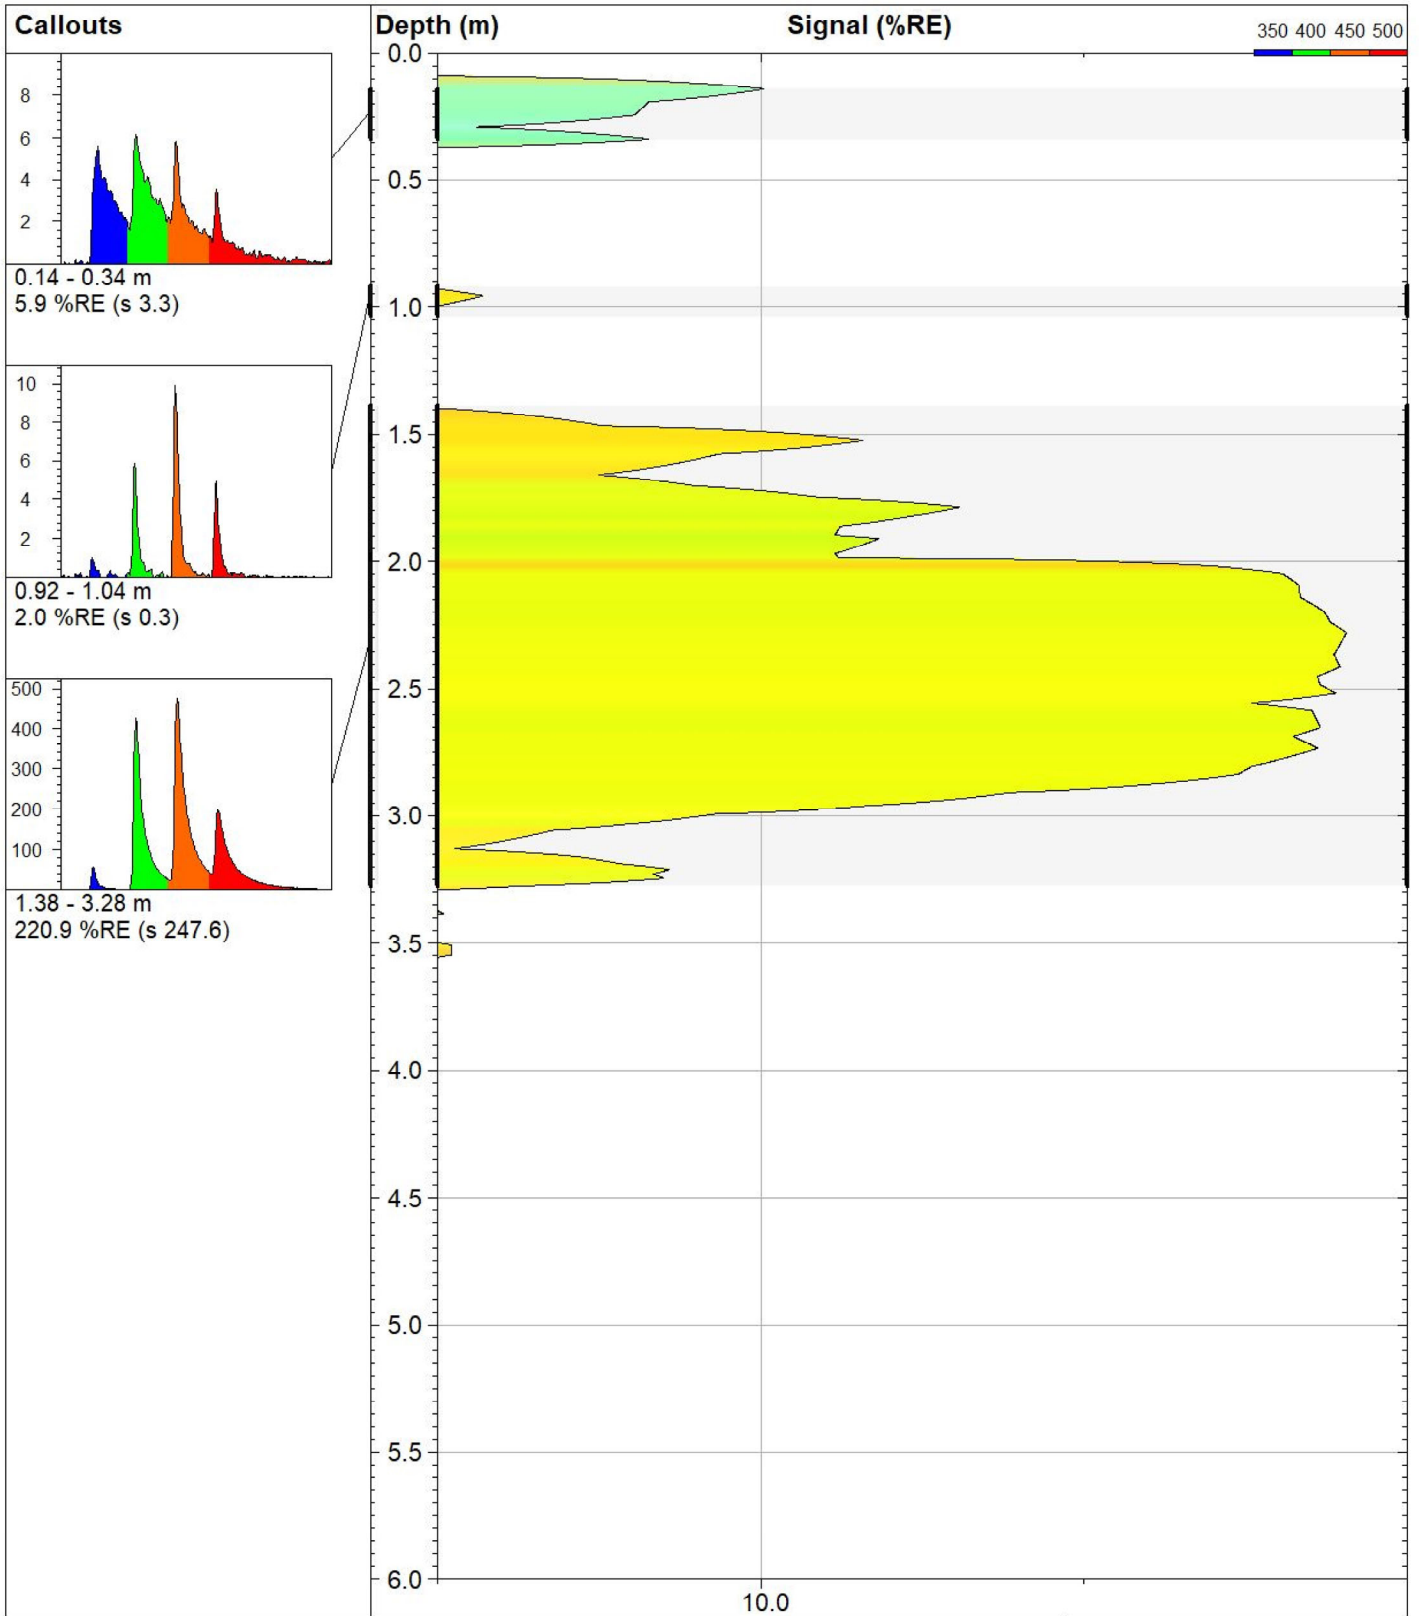
**LIF20013**

*Final depth:*  
**3.16 m**

*Max signal:*  
**3.5 %RE @ 0.36 m**

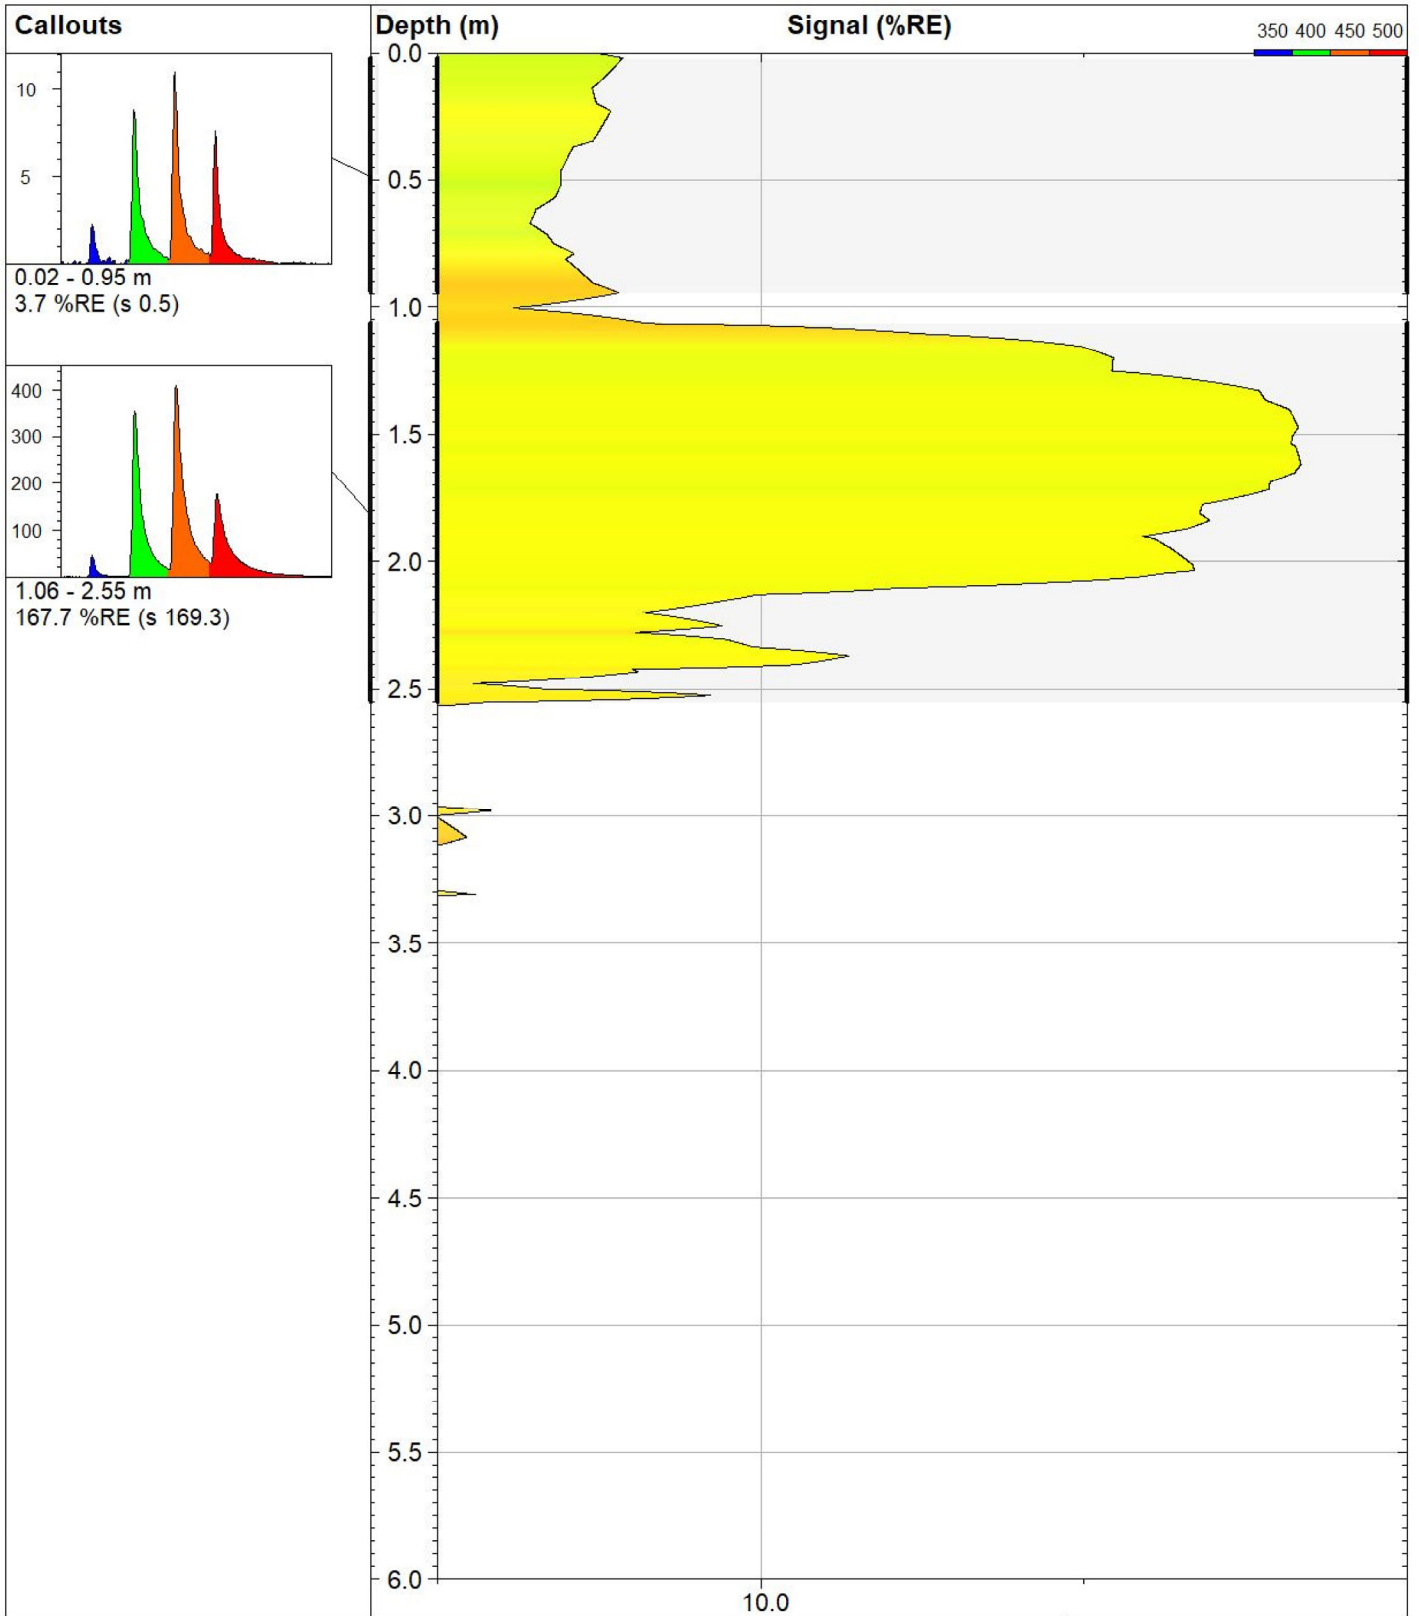
**LIF20014**

Final depth:  
**3.74 m**

Max signal:  
**648.3 %RE @ 2.28 m**

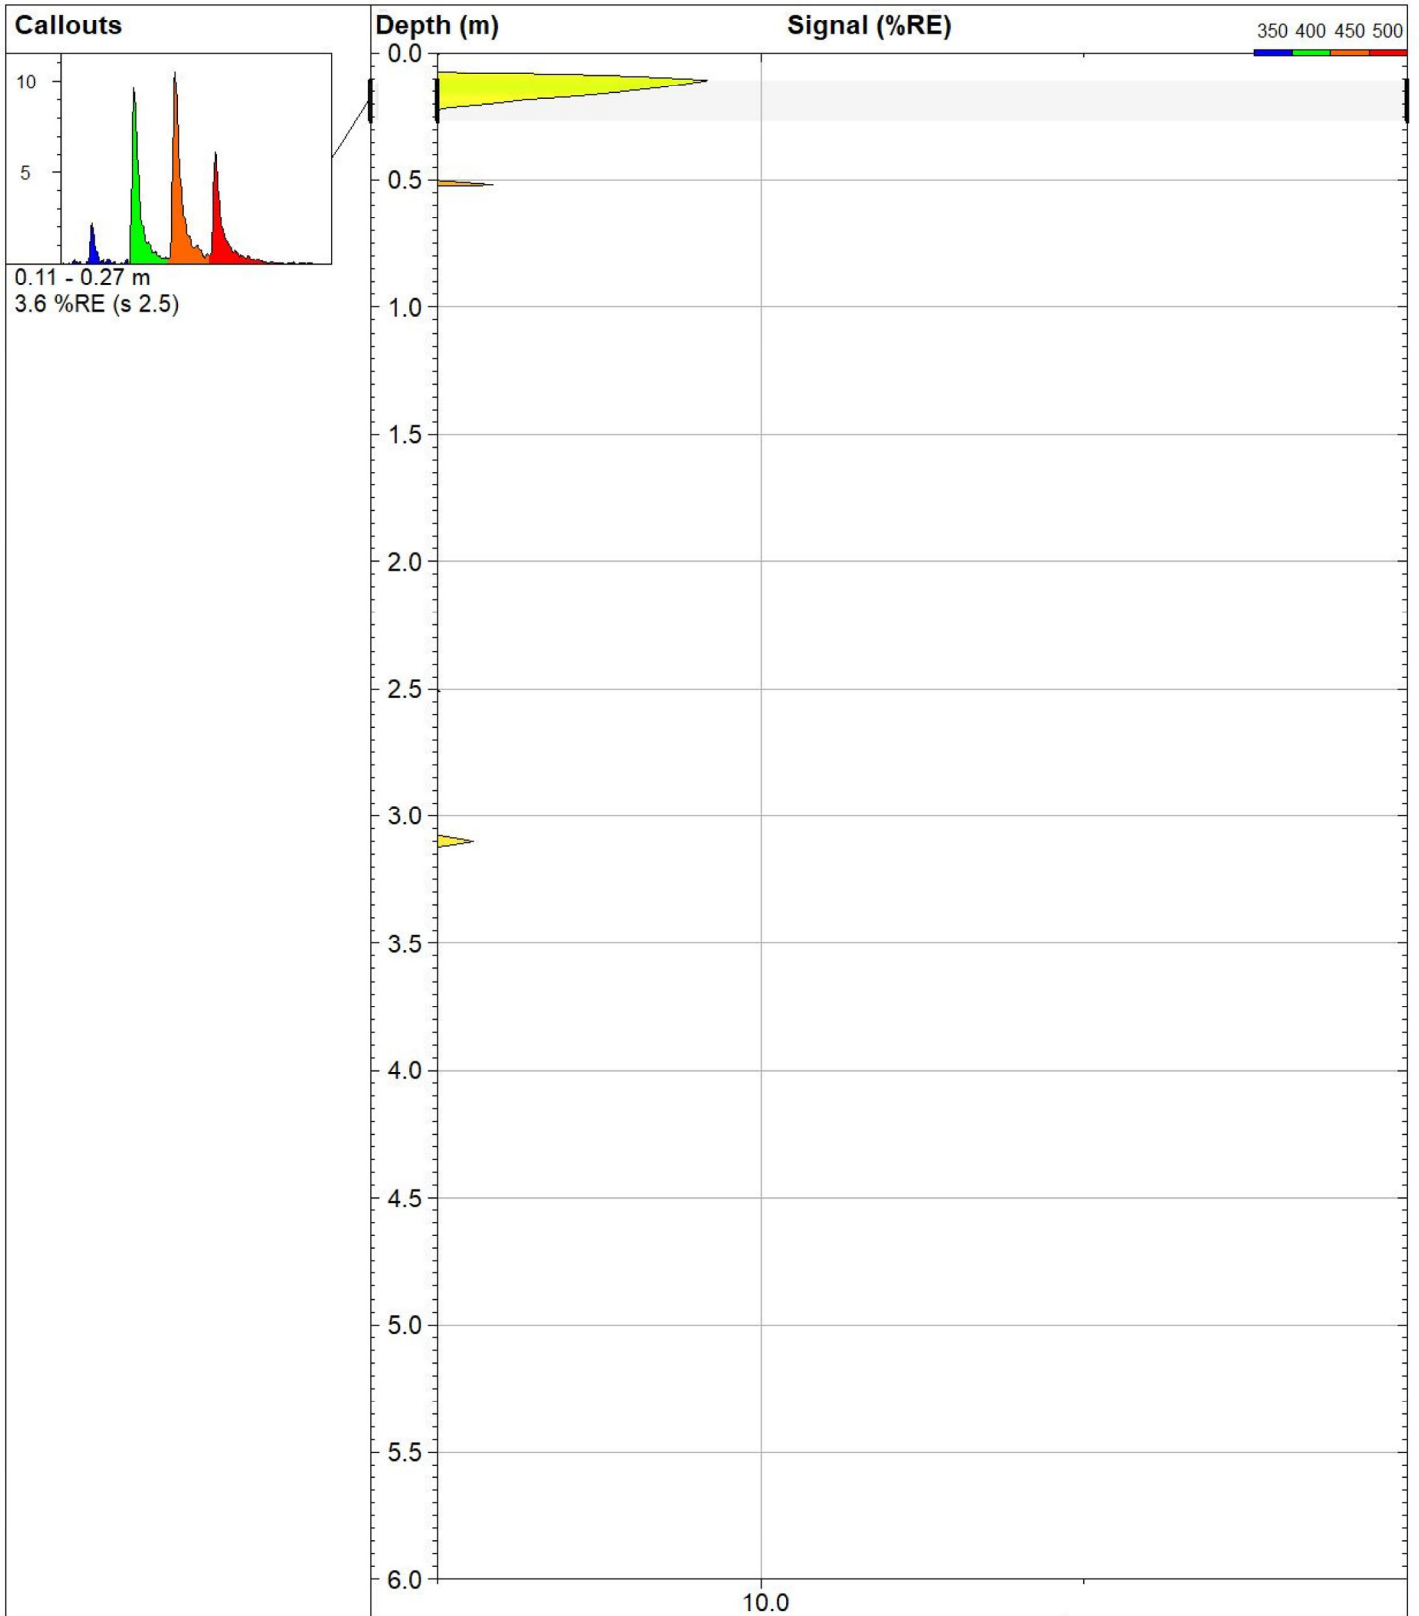
**LIF20015**

*Final depth:*  
**3.31 m**

*Max signal:*  
**469.6 %RE @ 1.62 m**
