**LIF20065**

*Site:*  
**Canatara Park**

*Client / Job:*  
**RWDI / VE848**

**UVOST® By Dakota**  
www.DakotaTechnologies.com

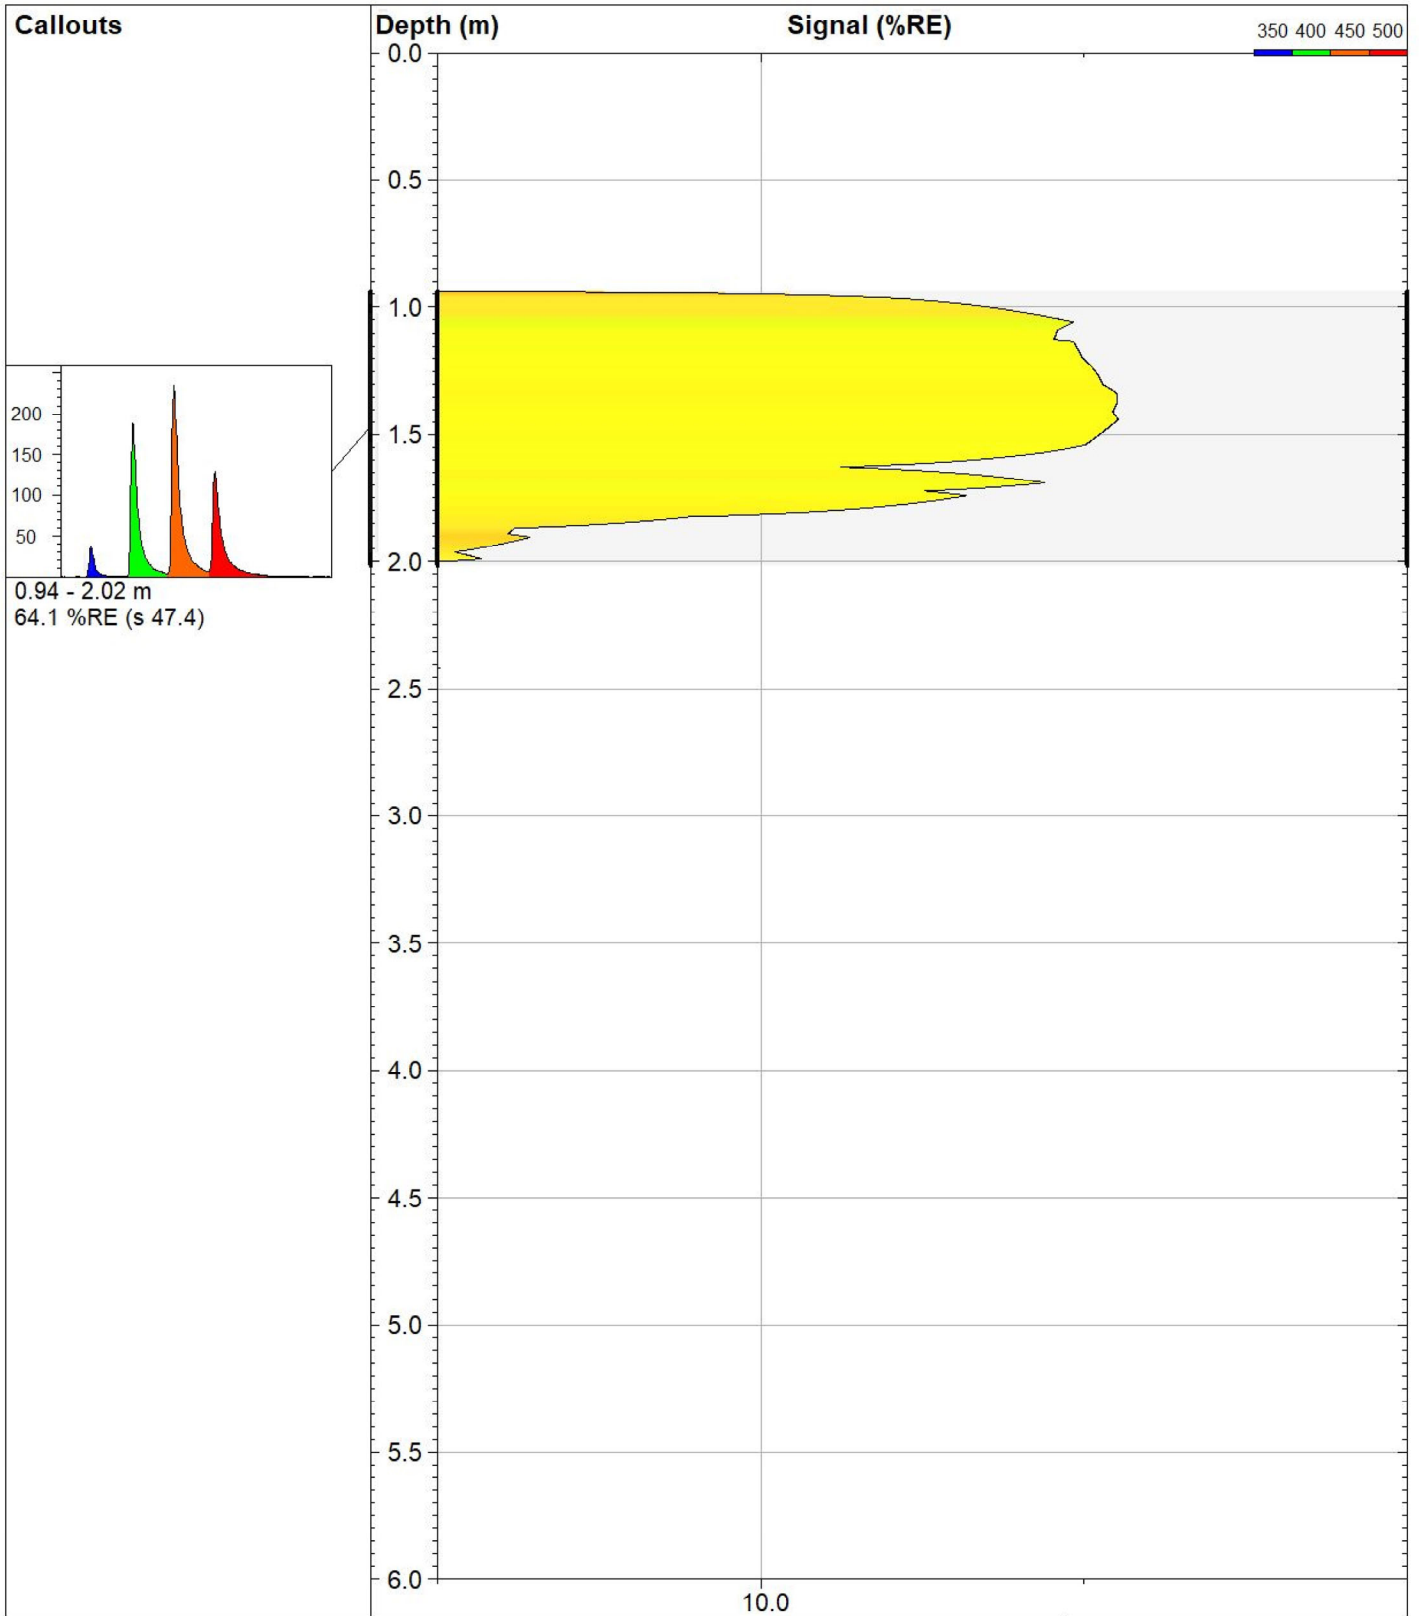
*Final depth:*  
**3.09 m**

*Max signal:*  
**128.7 %RE @ 1.44 m**

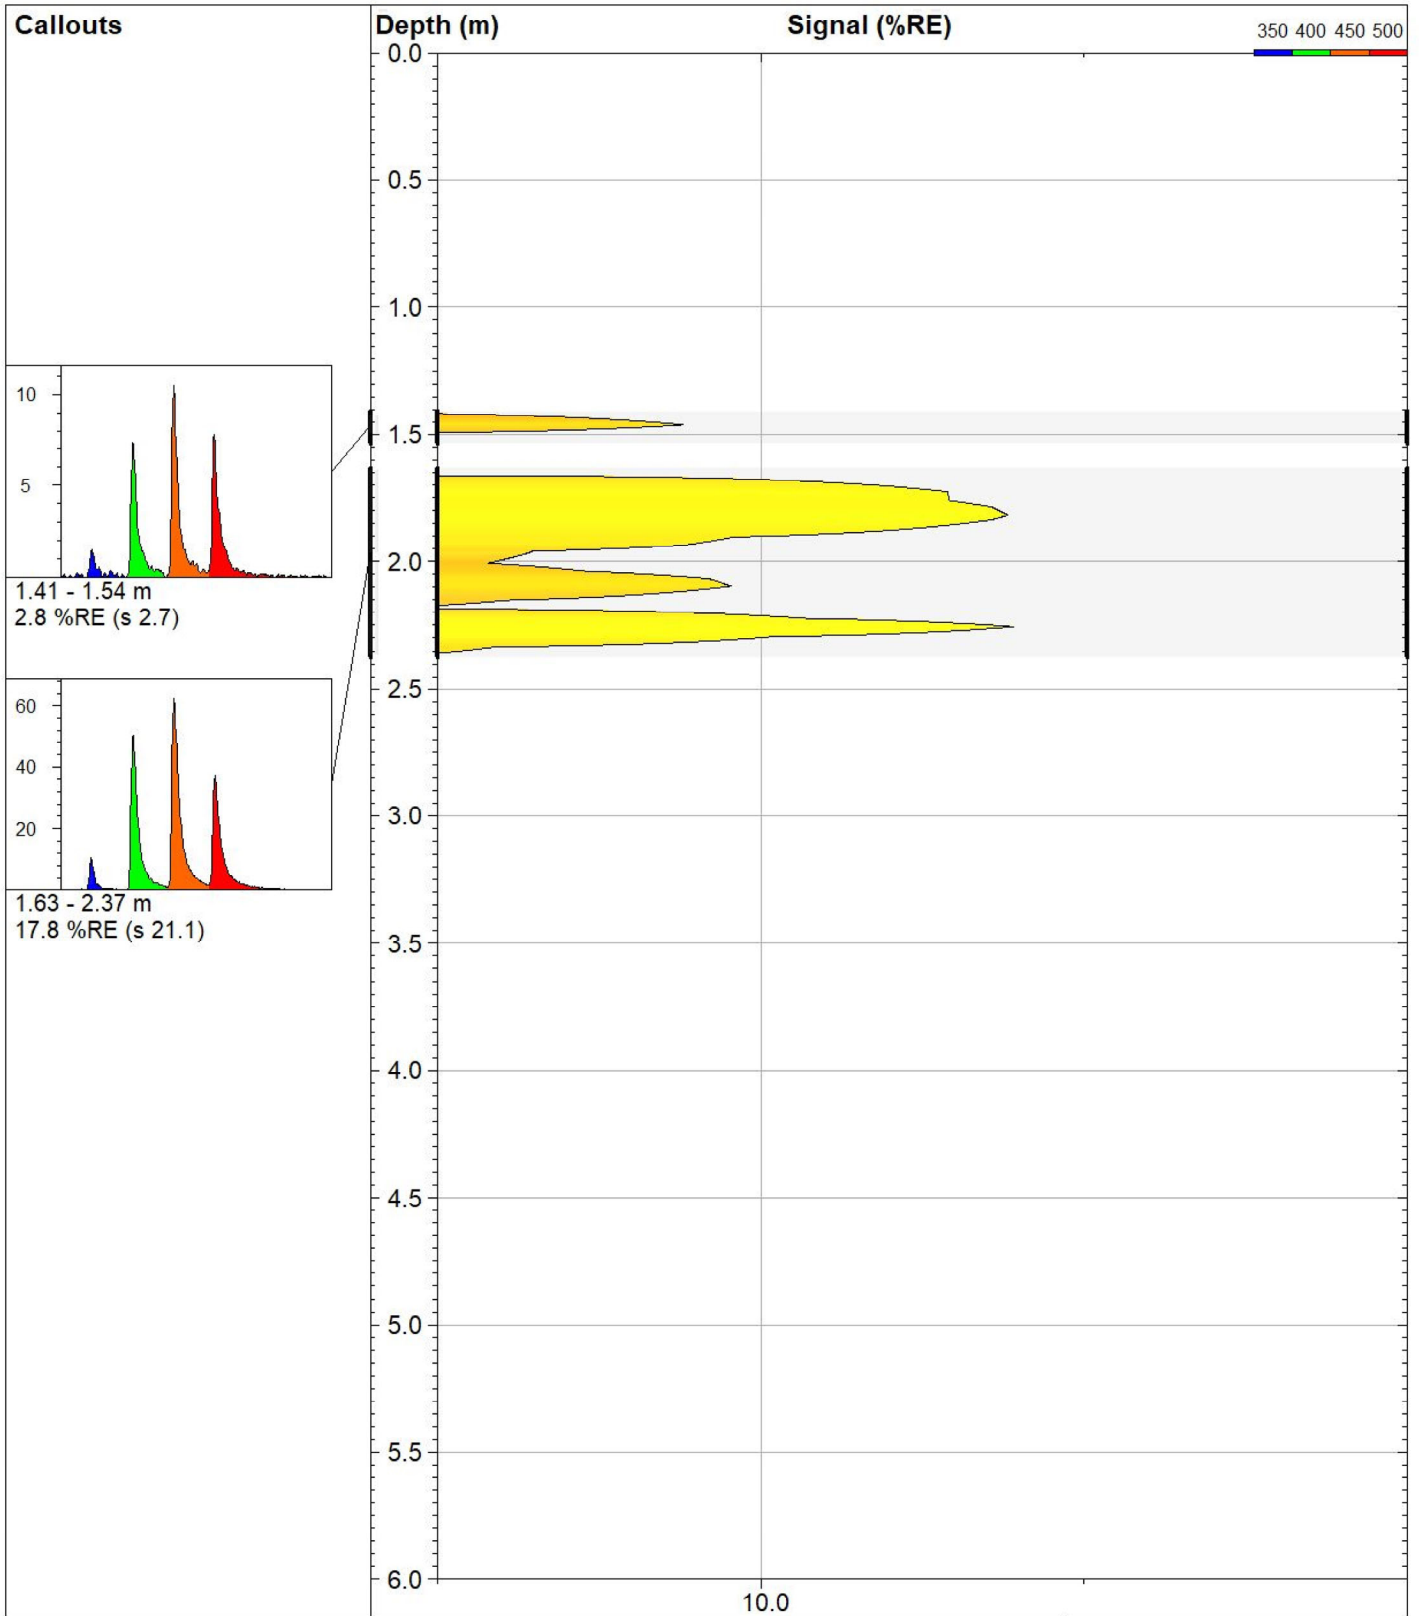
**LIF20066**

*Final depth:*  
**3.08 m**

*Max signal:*  
**61.3 %RE @ 2.26 m**

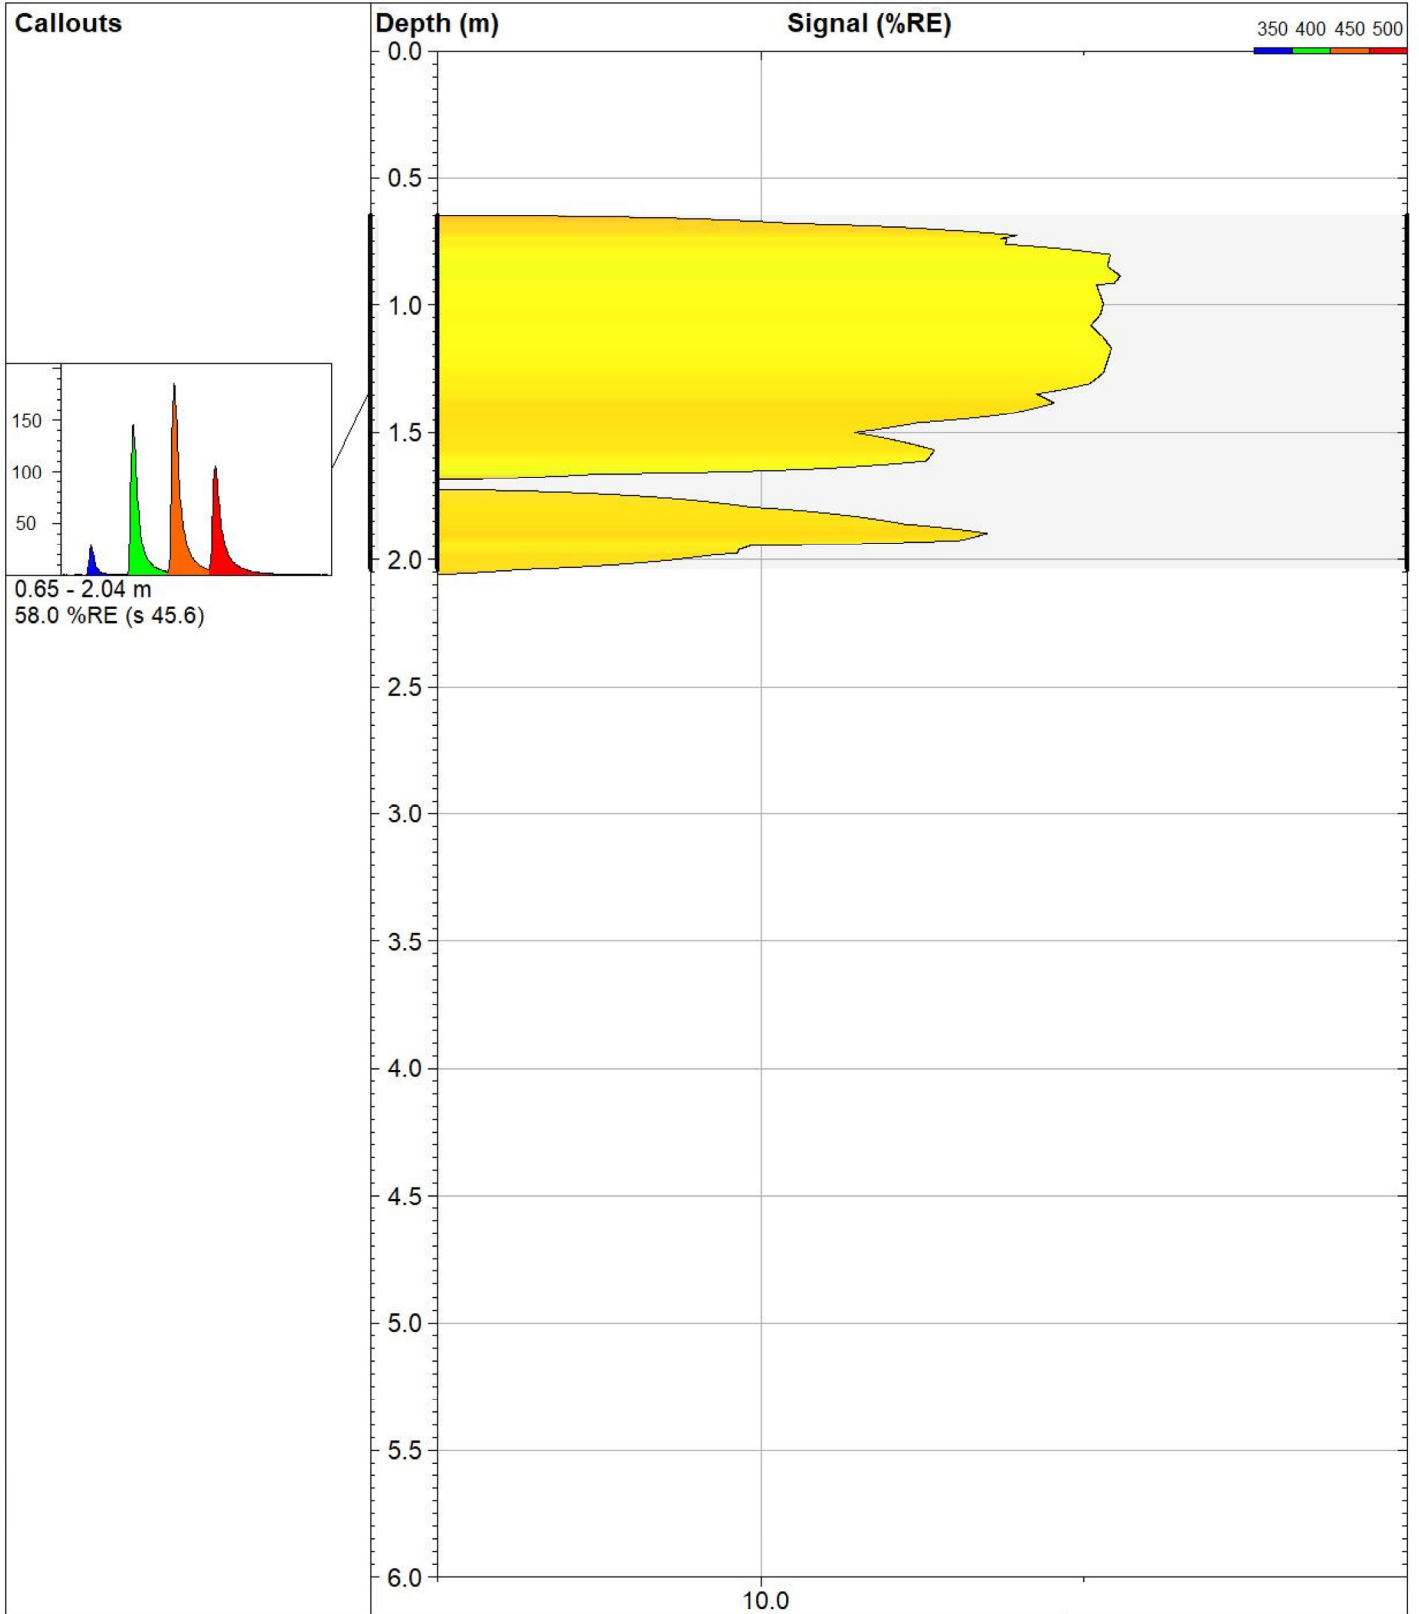
**LIF20067**

**Final depth:**  
3.10 m

**Max signal:**  
130.4 %RE @ 0.88 m

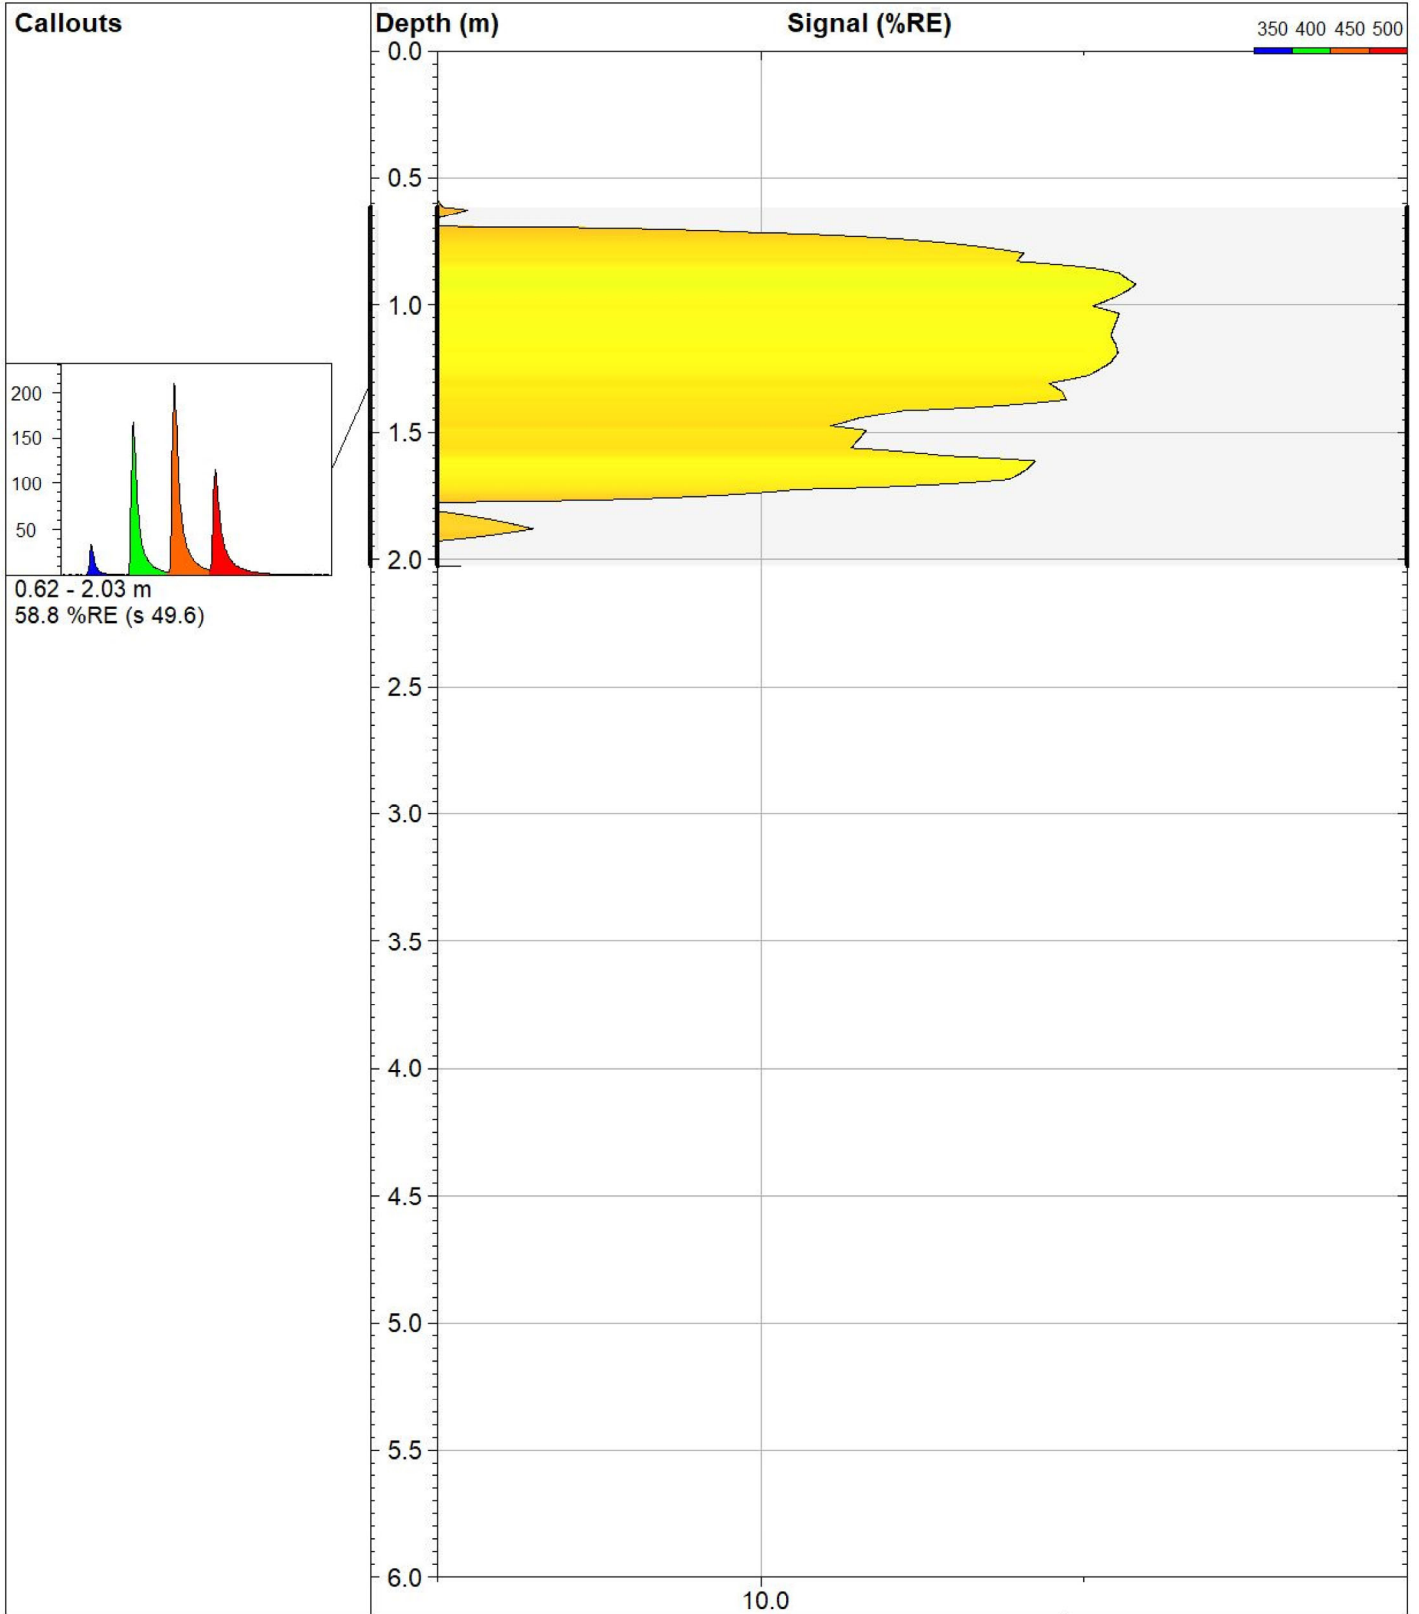
**LIF20068**

*Final depth:*  
**3.07 m**

*Max signal:*  
**145.2 %RE @ 0.92 m**

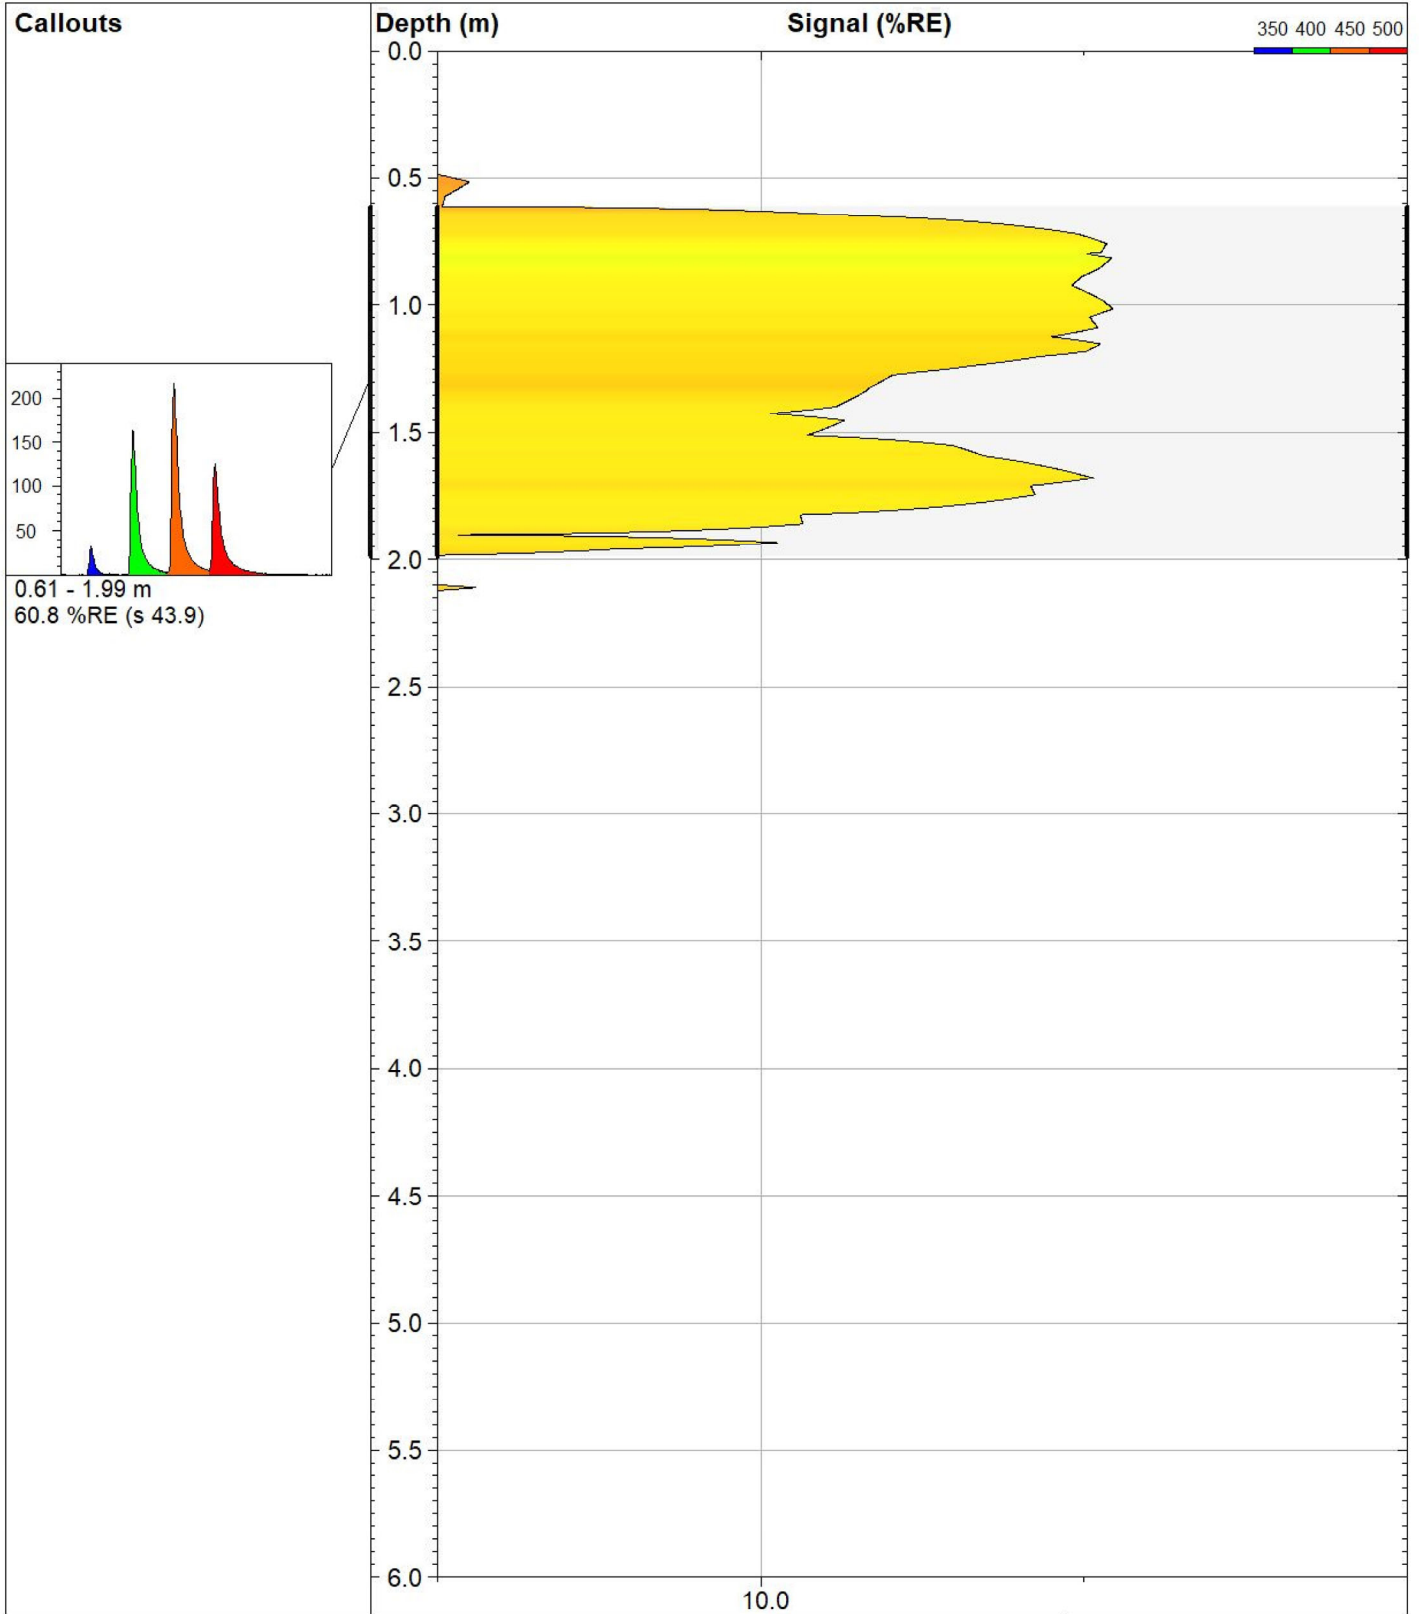
**LIF20069**

*Final depth:*  
**3.07 m**

*Max signal:*  
**123.8 %RE @ 1.01 m**

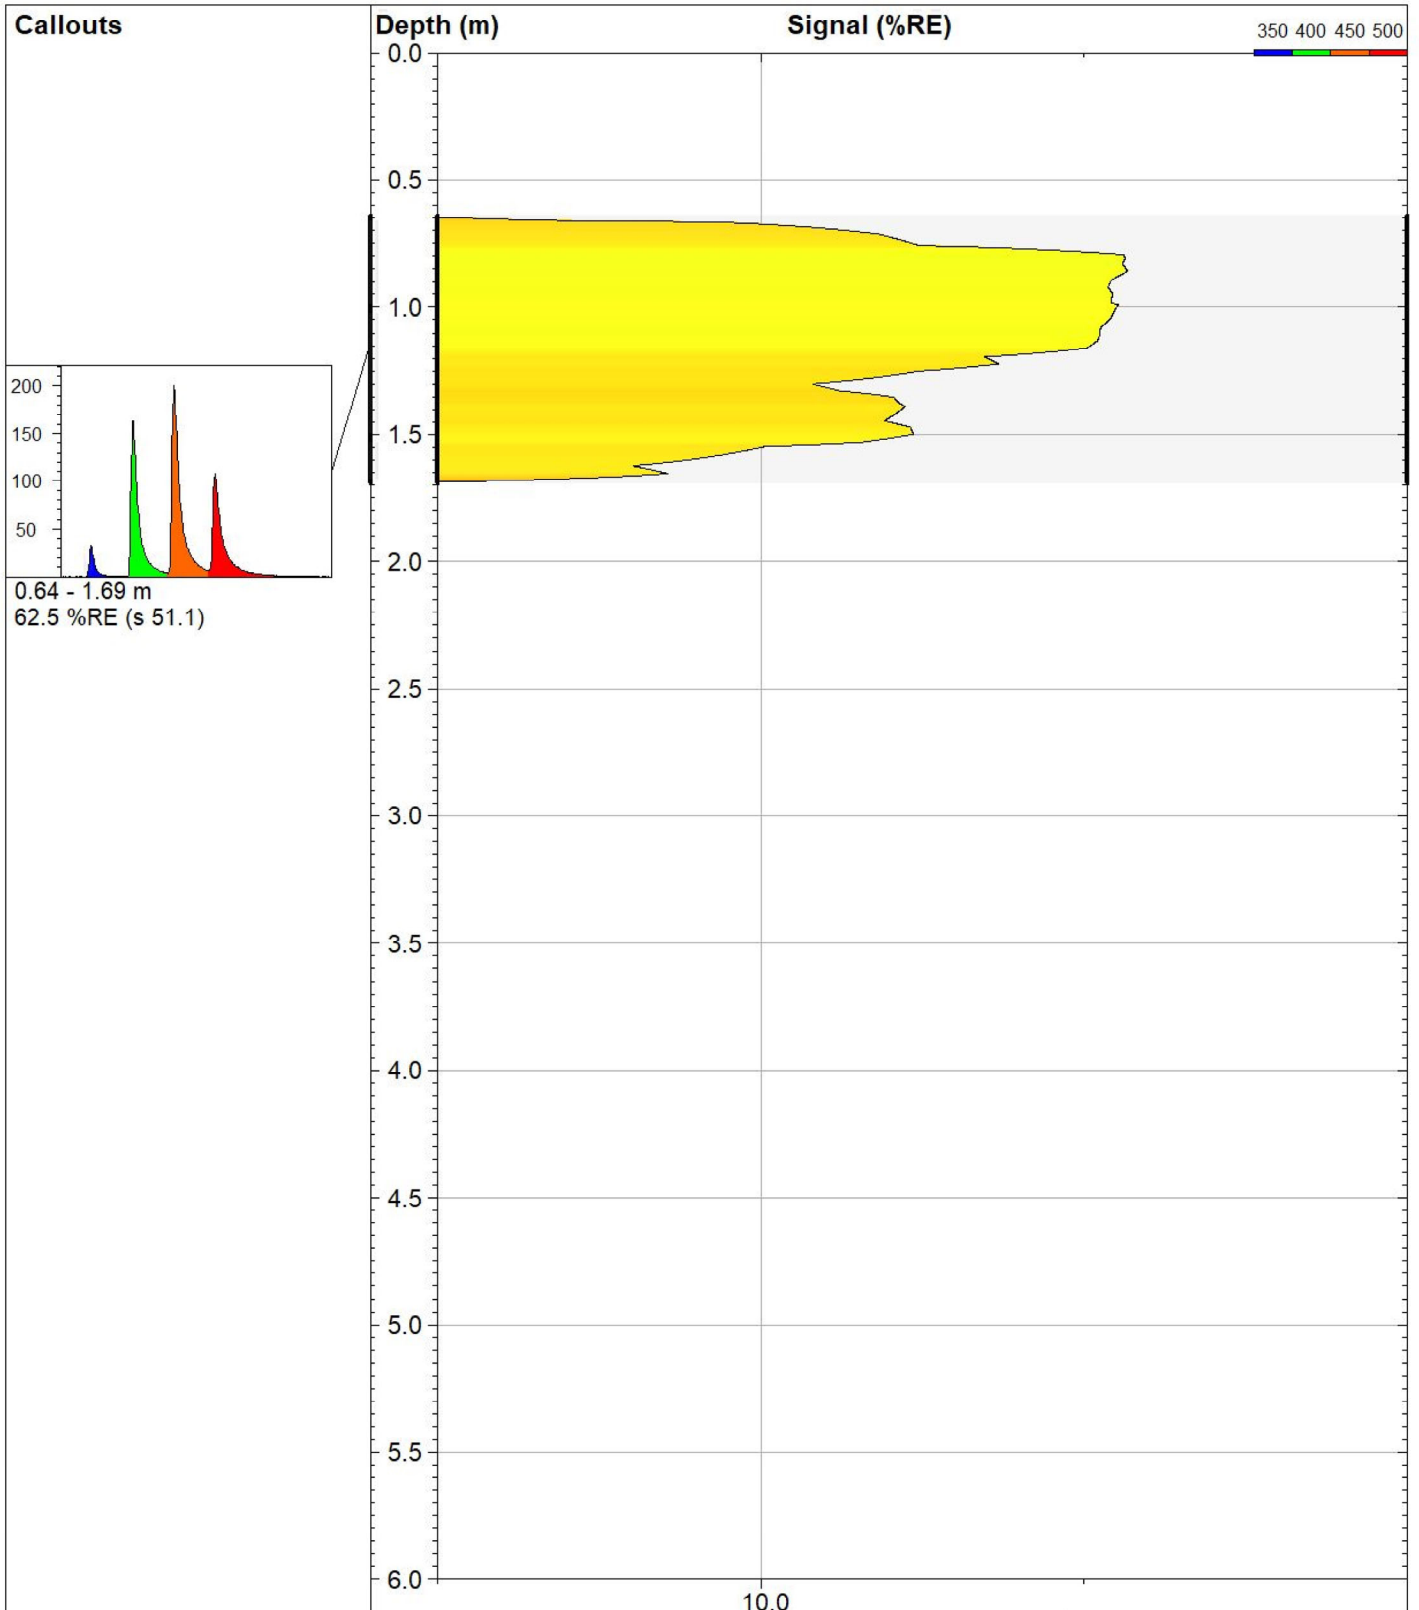
**LIF20070**

Final depth:  
**3.09 m**

Max signal:  
**137.1 %RE @ 0.86 m**

0.57 - 1.67 m  
76.5 %RE (s 51.3)

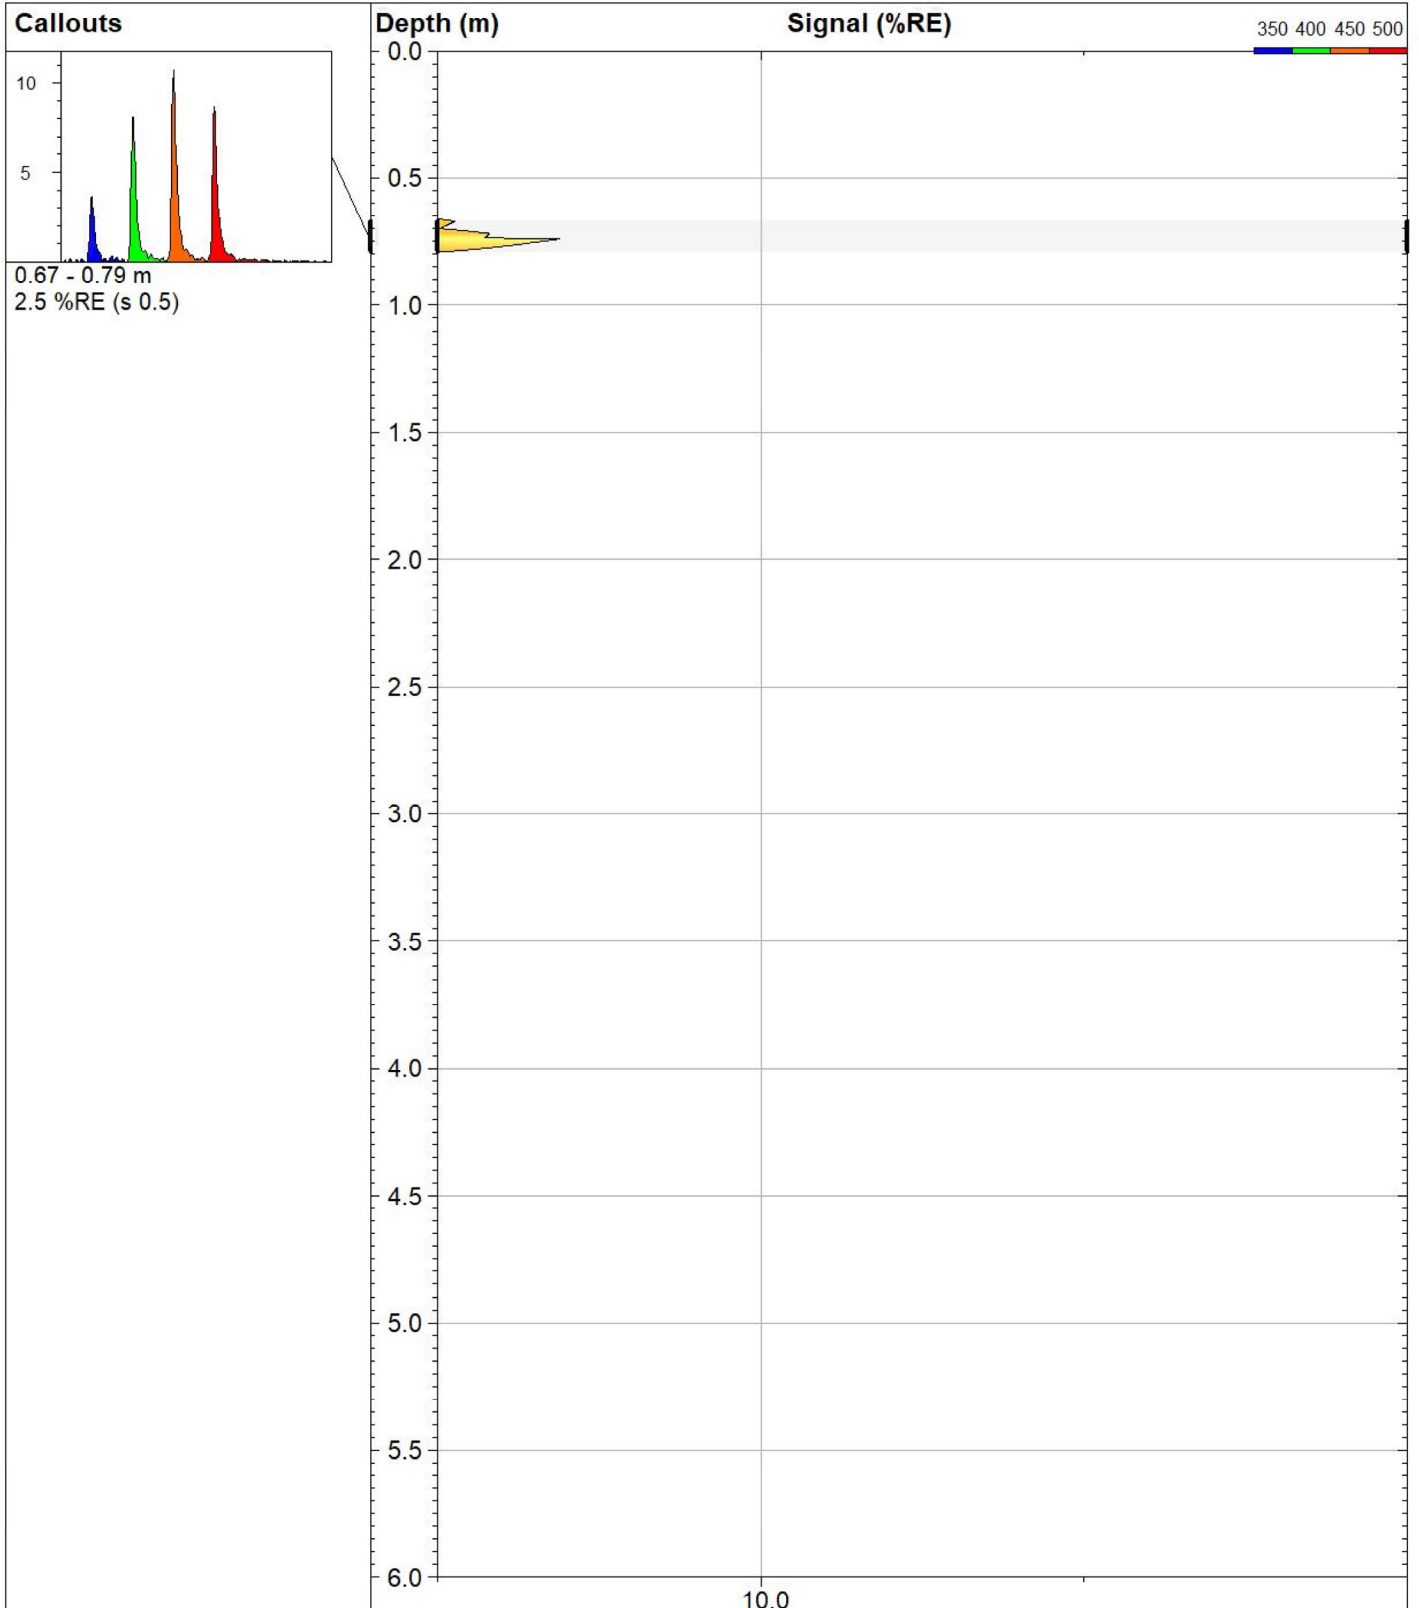
**LIF20072**

*Final depth:*  
**3.07 m**

*Max signal:*  
**3.4 %RE @ 0.74 m**

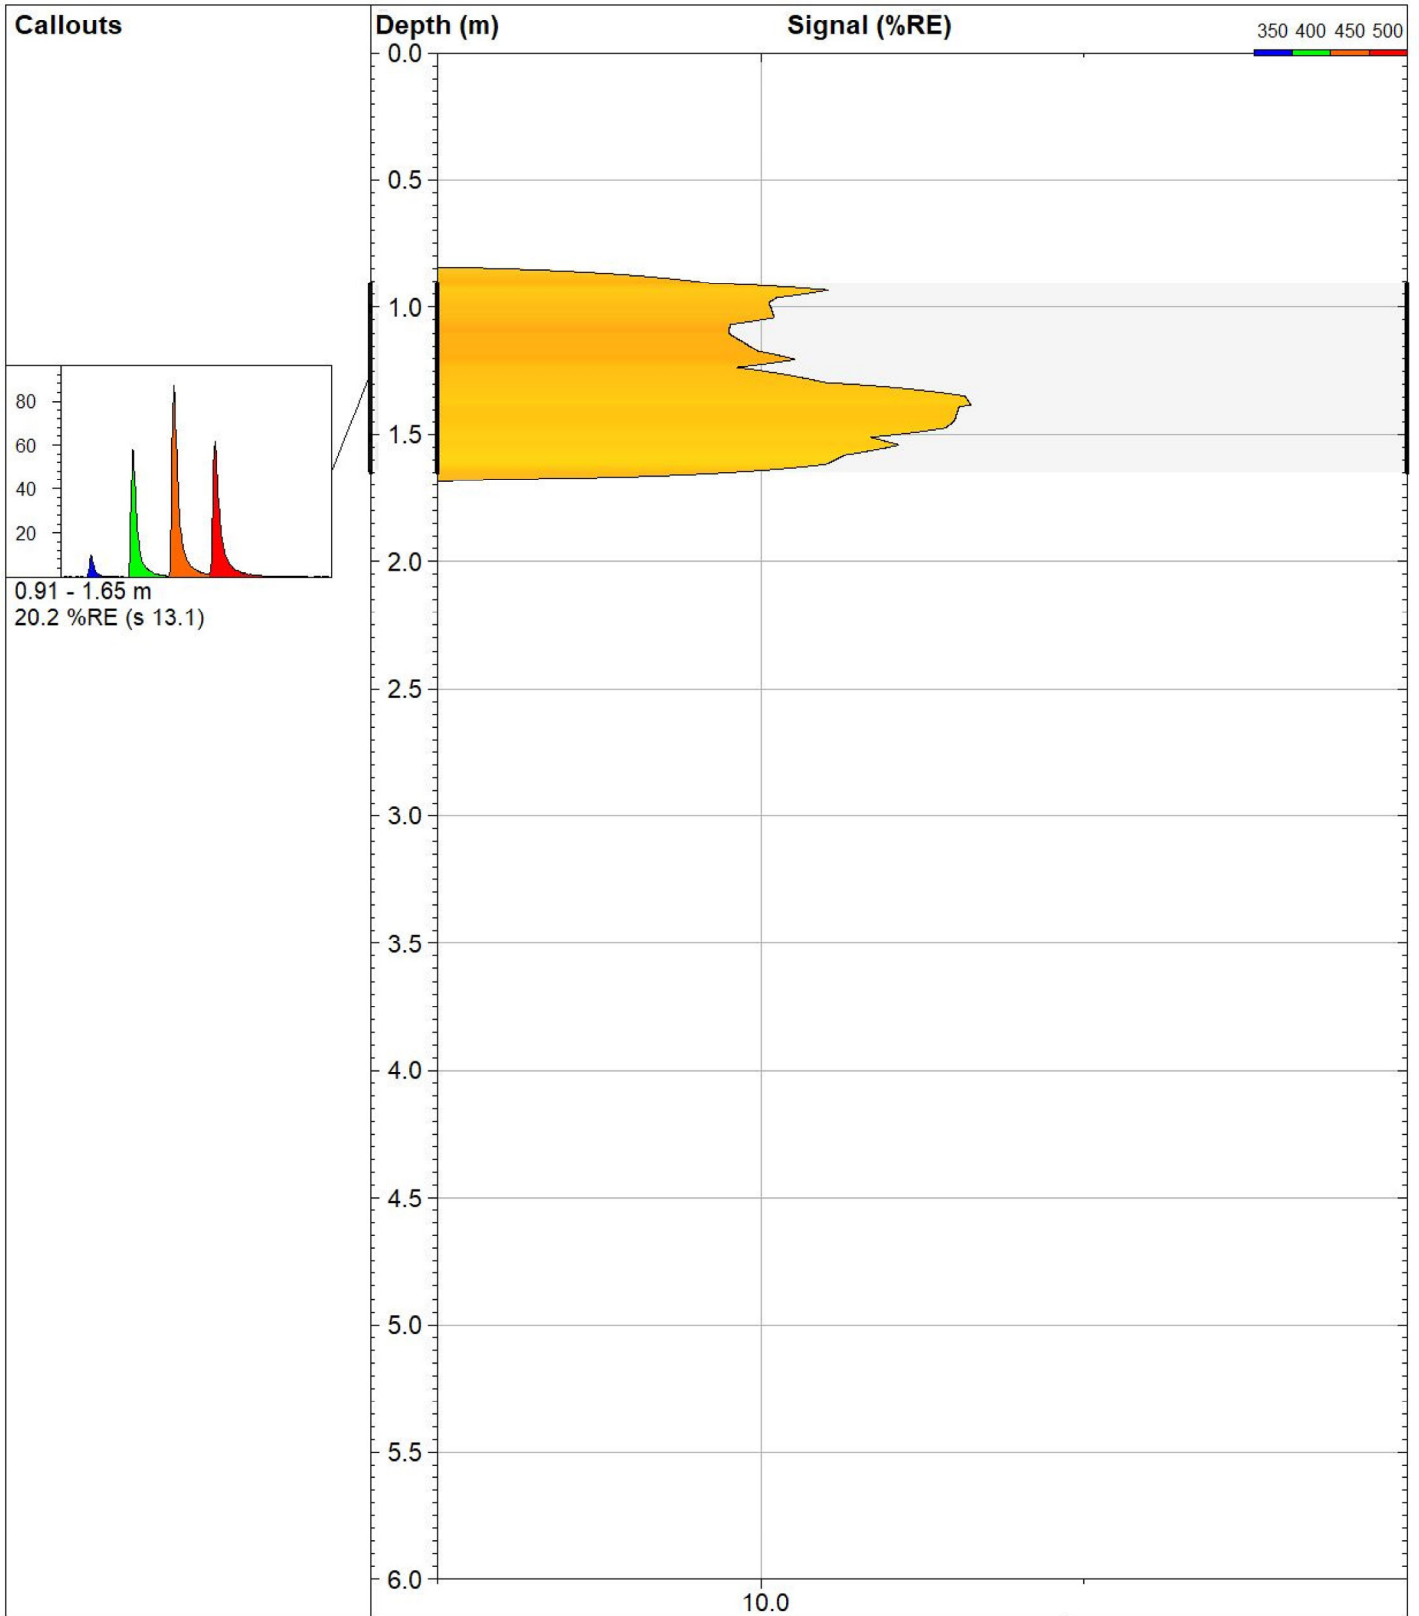
**LIF20073**

**Final depth:**  
3.07 m

**Max signal:**  
45.6 %RE @ 1.38 m

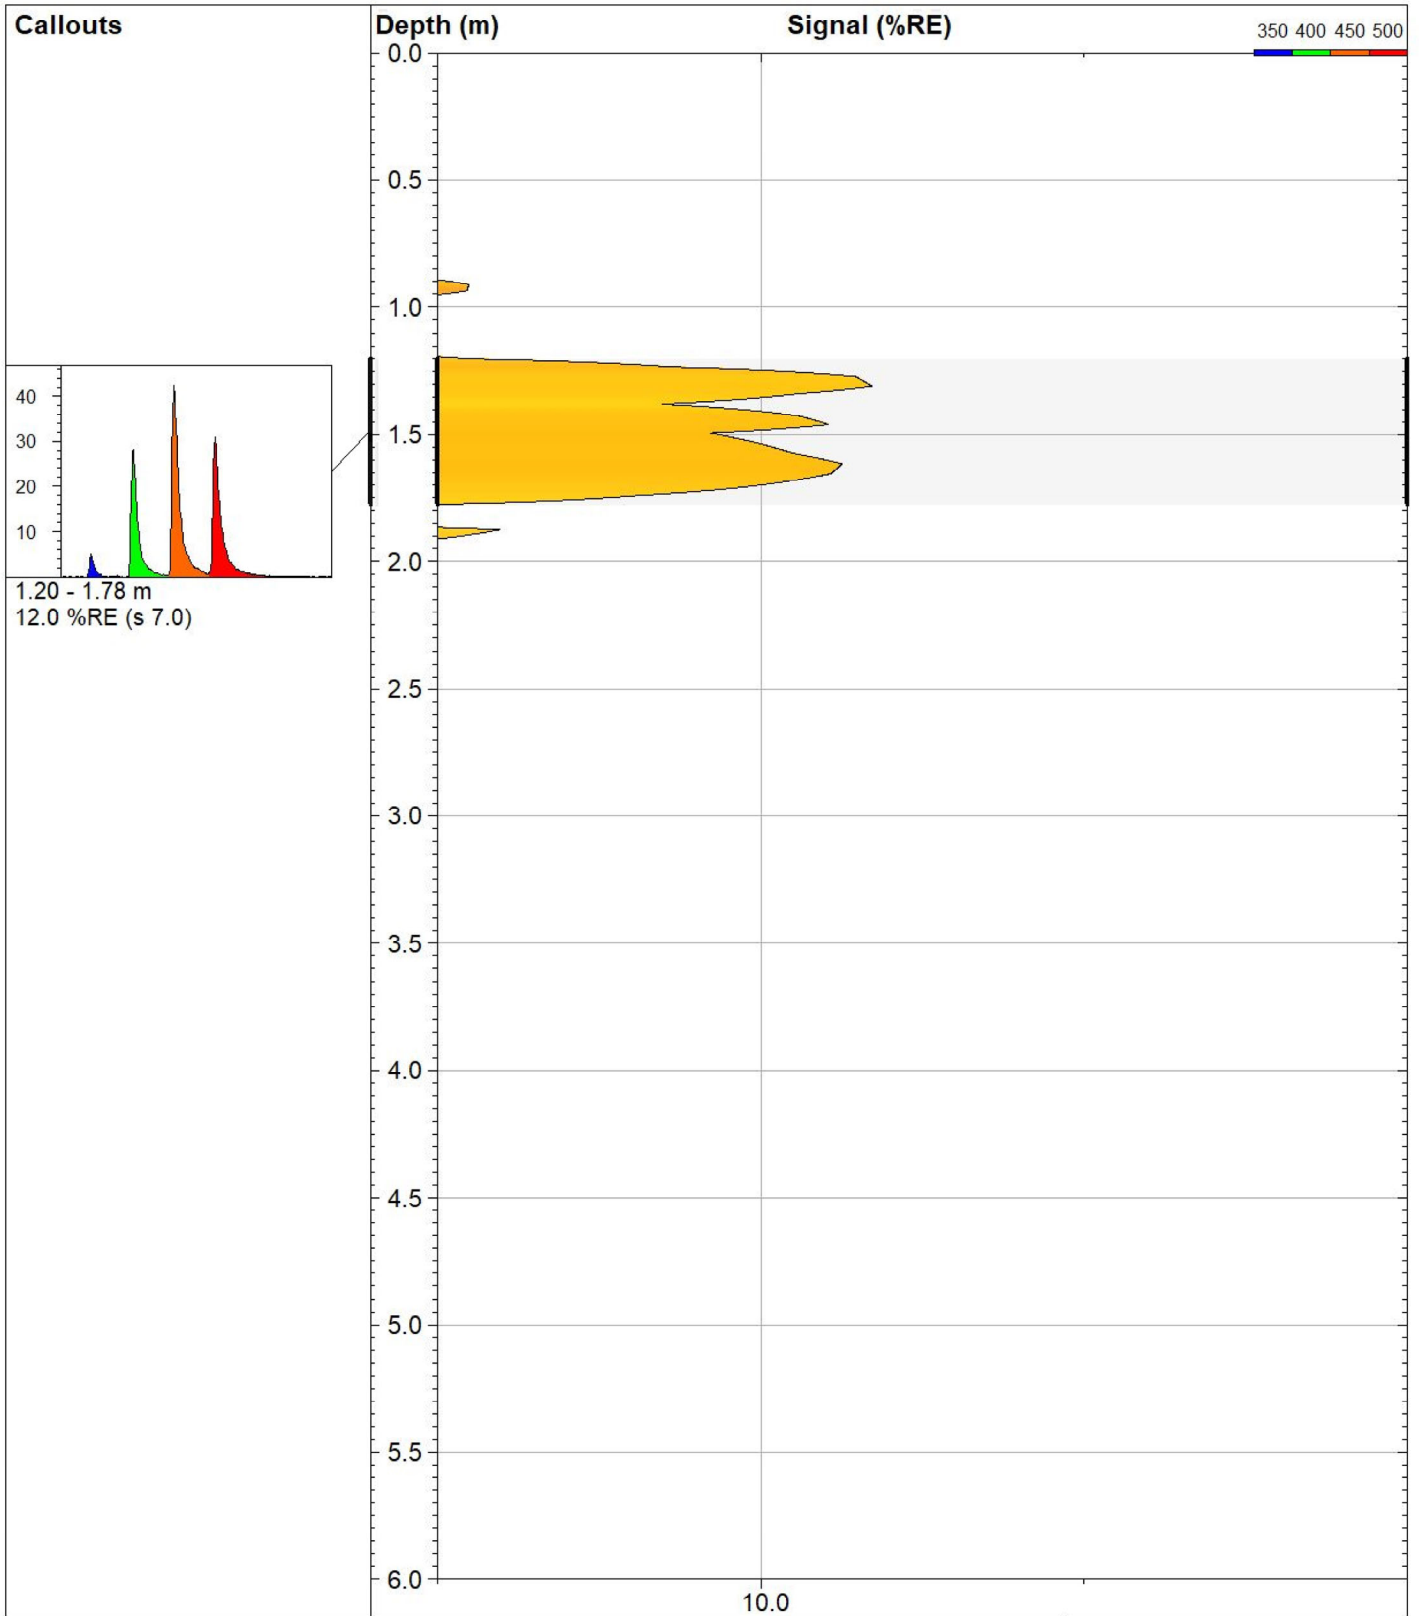
**LIF20074**

**Final depth:**  
3.08 m

**Max signal:**  
23.1 %RE @ 1.31 m

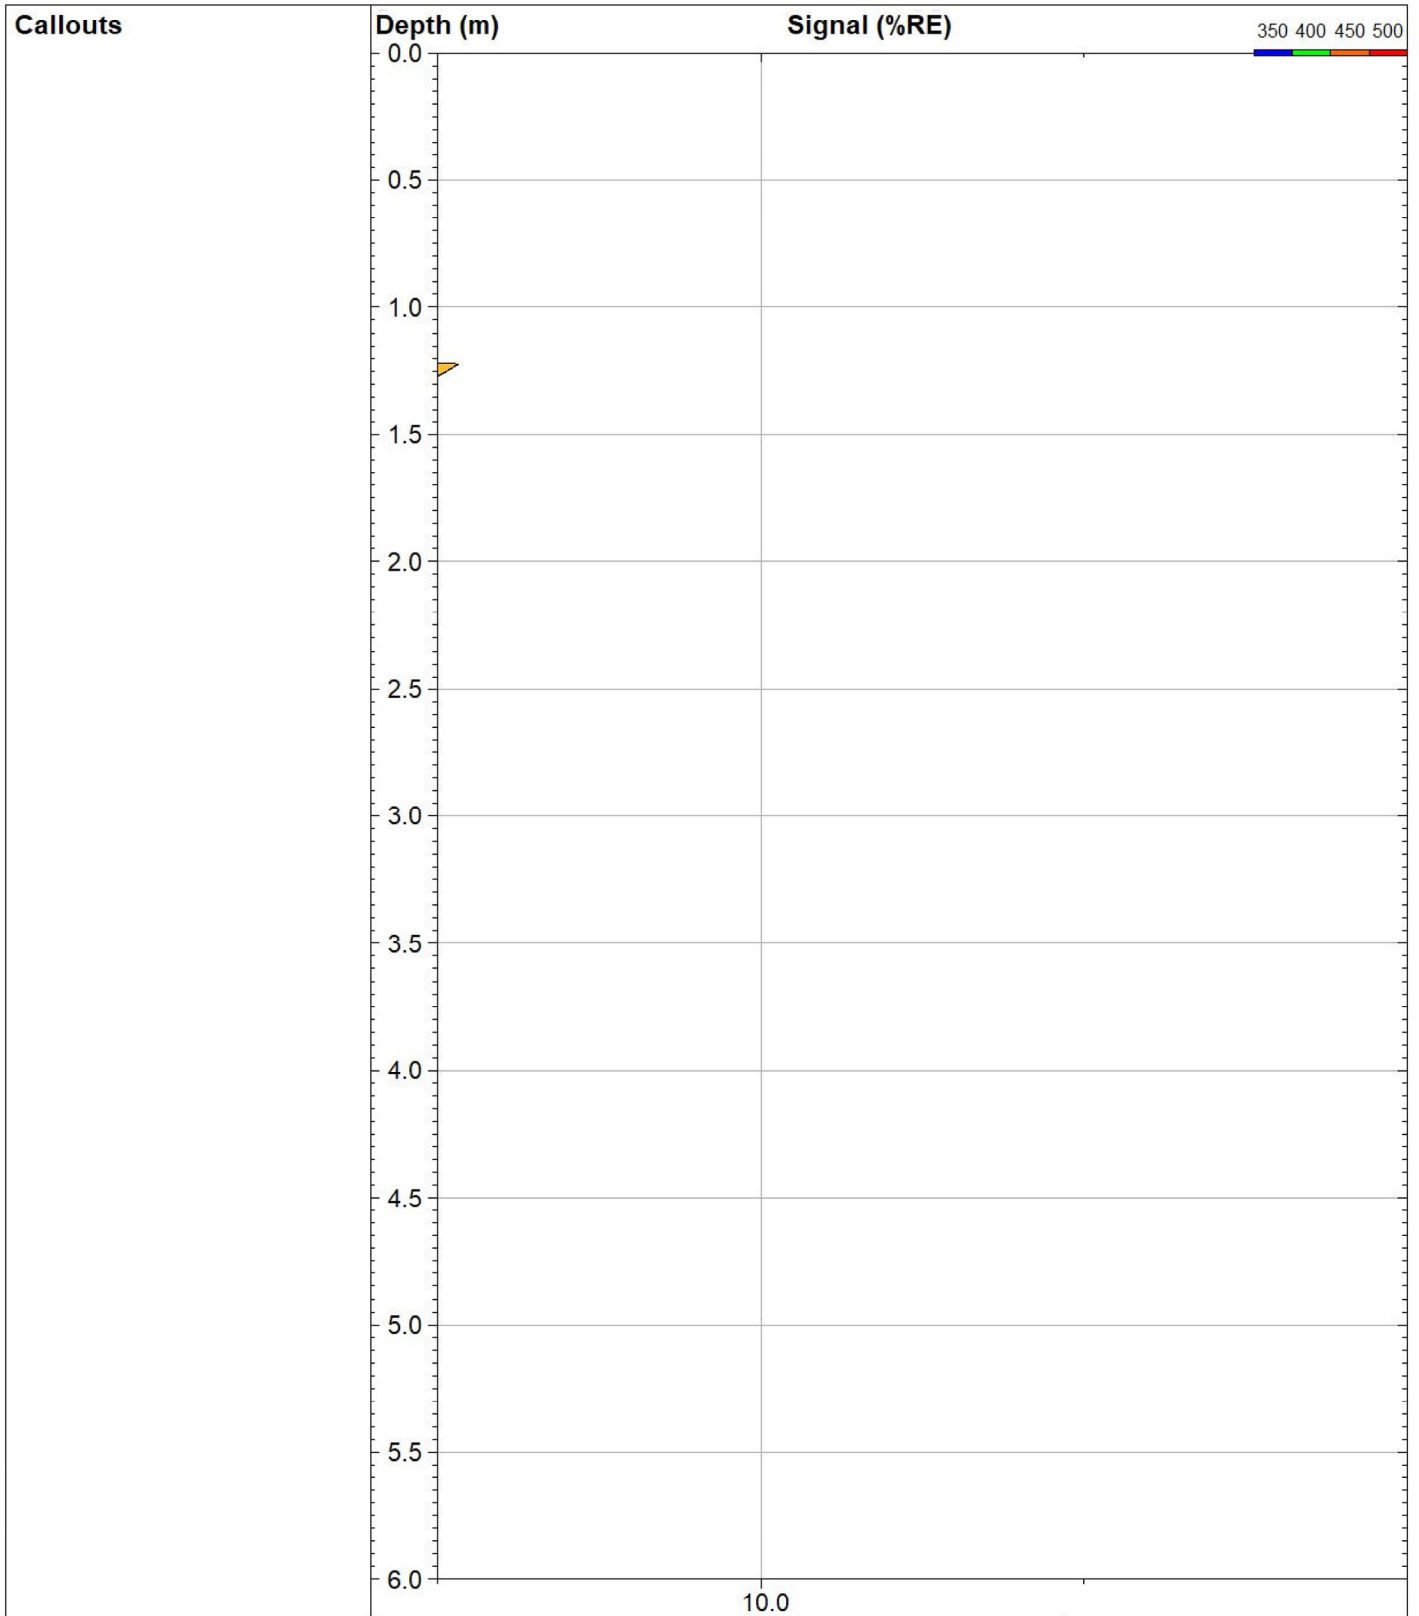
**LIF20075**

*Final depth:*  
**3.06 m**

*Max signal:*  
**2.2 %RE @ 1.22 m**
