**LIF20065**

*Site:*  
**Canatara Park**

*Client / Job:*  
**RWDI / VE848**

**UVOST® By Dakota**  
www.DakotaTechnologies.com

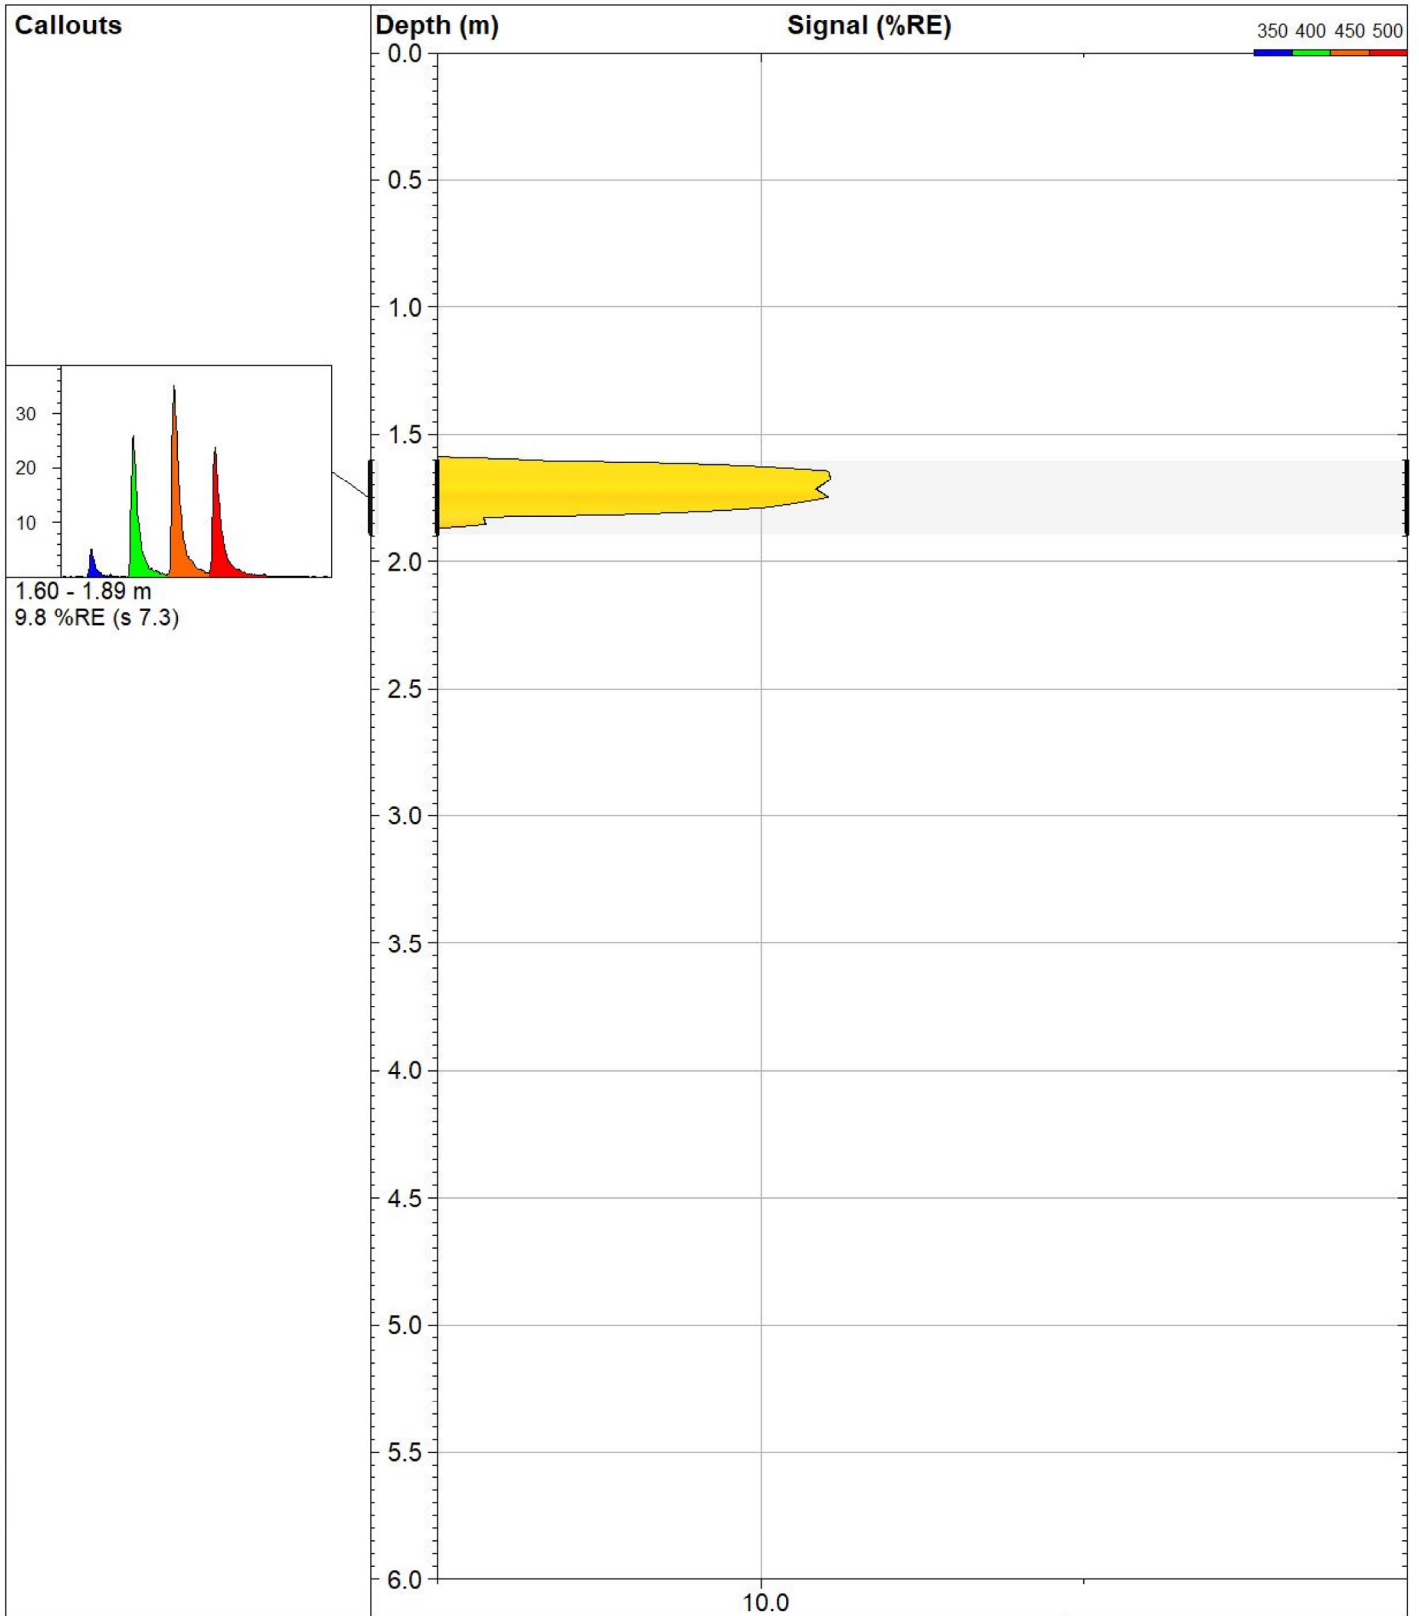
**LIF20076**

*Final depth:*  
**3.07 m**

*Max signal:*  
**17.5 %RE @ 1.68 m**

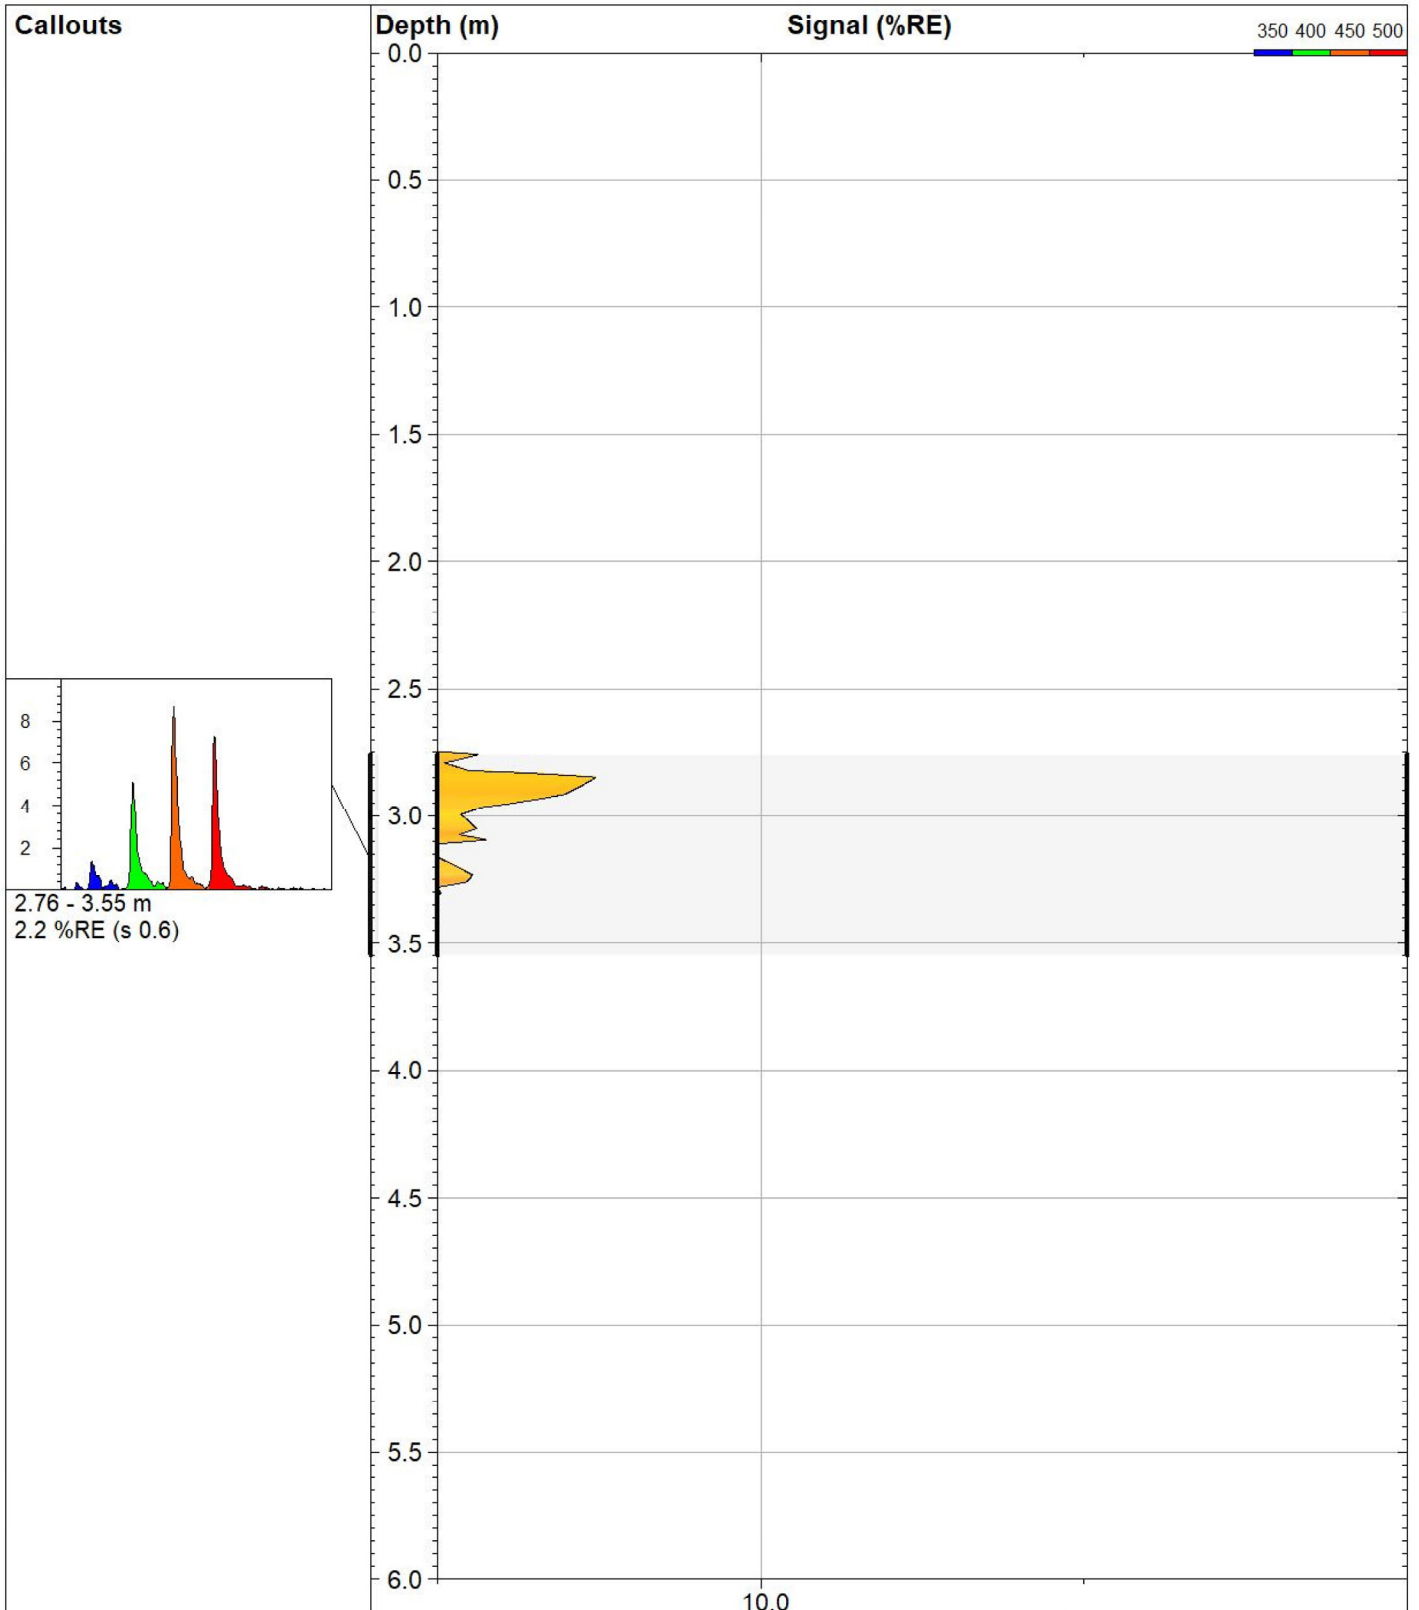
**LIF20079**

Final depth:  
**3.72 m**

Max signal:  
**4.1 %RE @ 2.85 m**

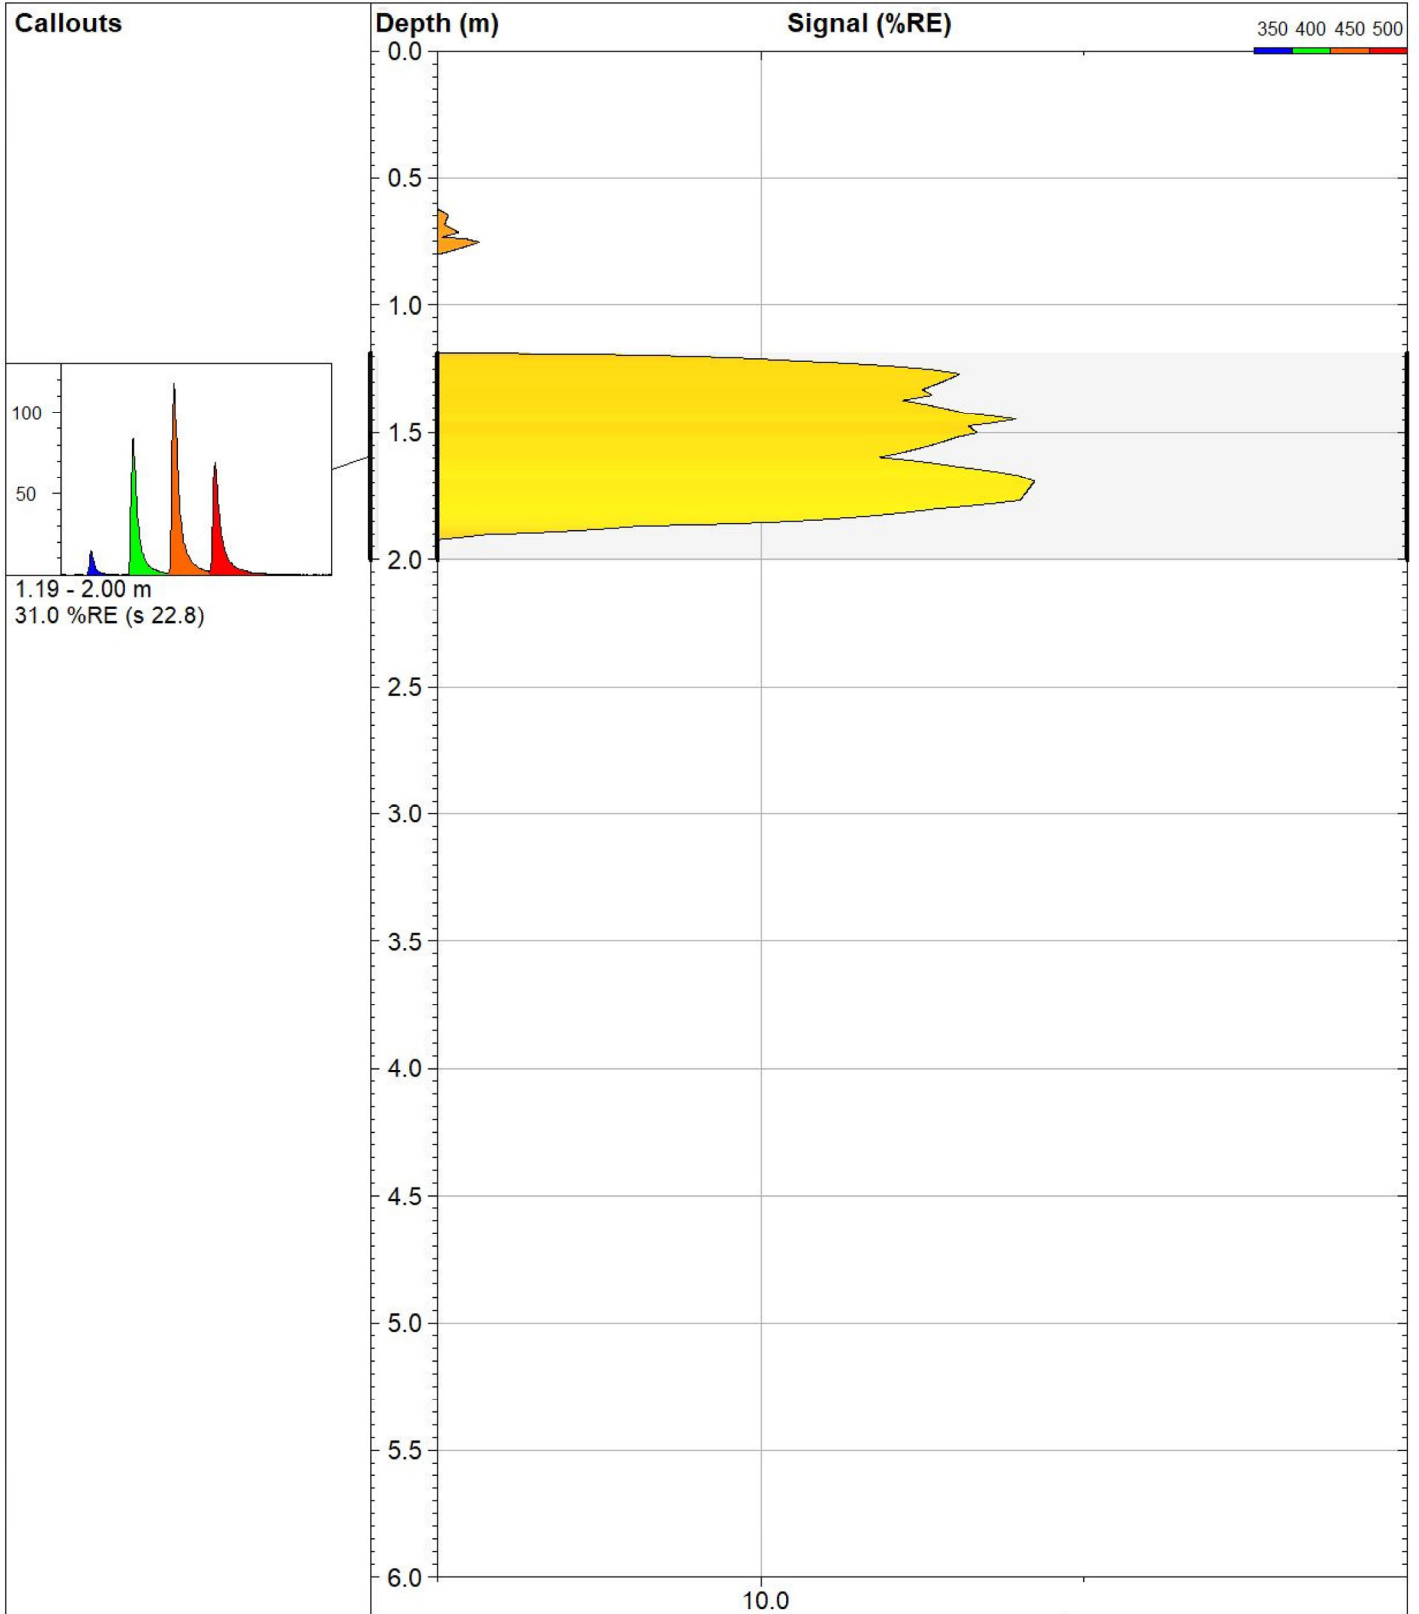
**LIF20080**

*Final depth:*  
**3.06 m**

*Max signal:*  
**71.2 %RE @ 1.69 m**

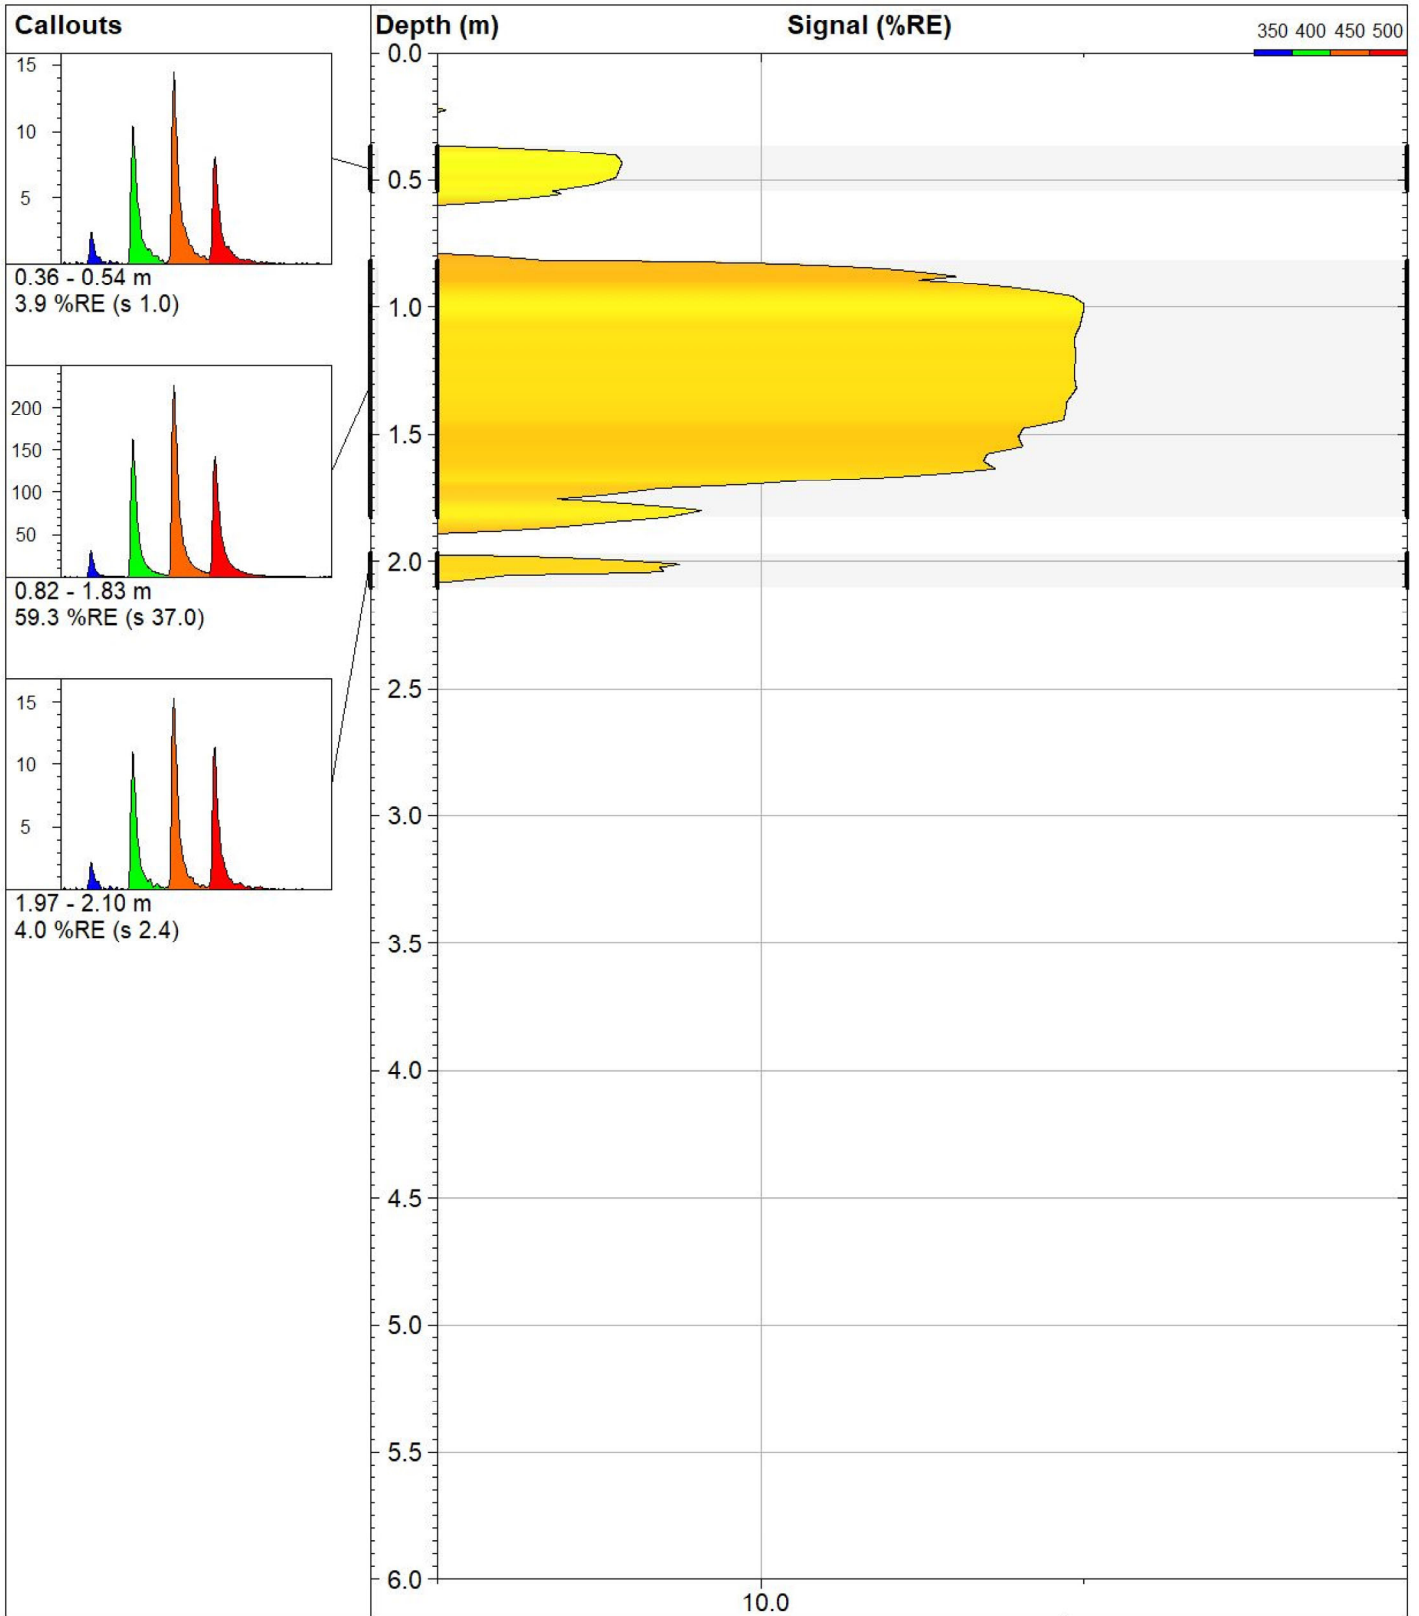
**LIF20081**

Final depth:  
**3.07 m**

Max signal:  
**100.7 %RE @ 1.01 m**

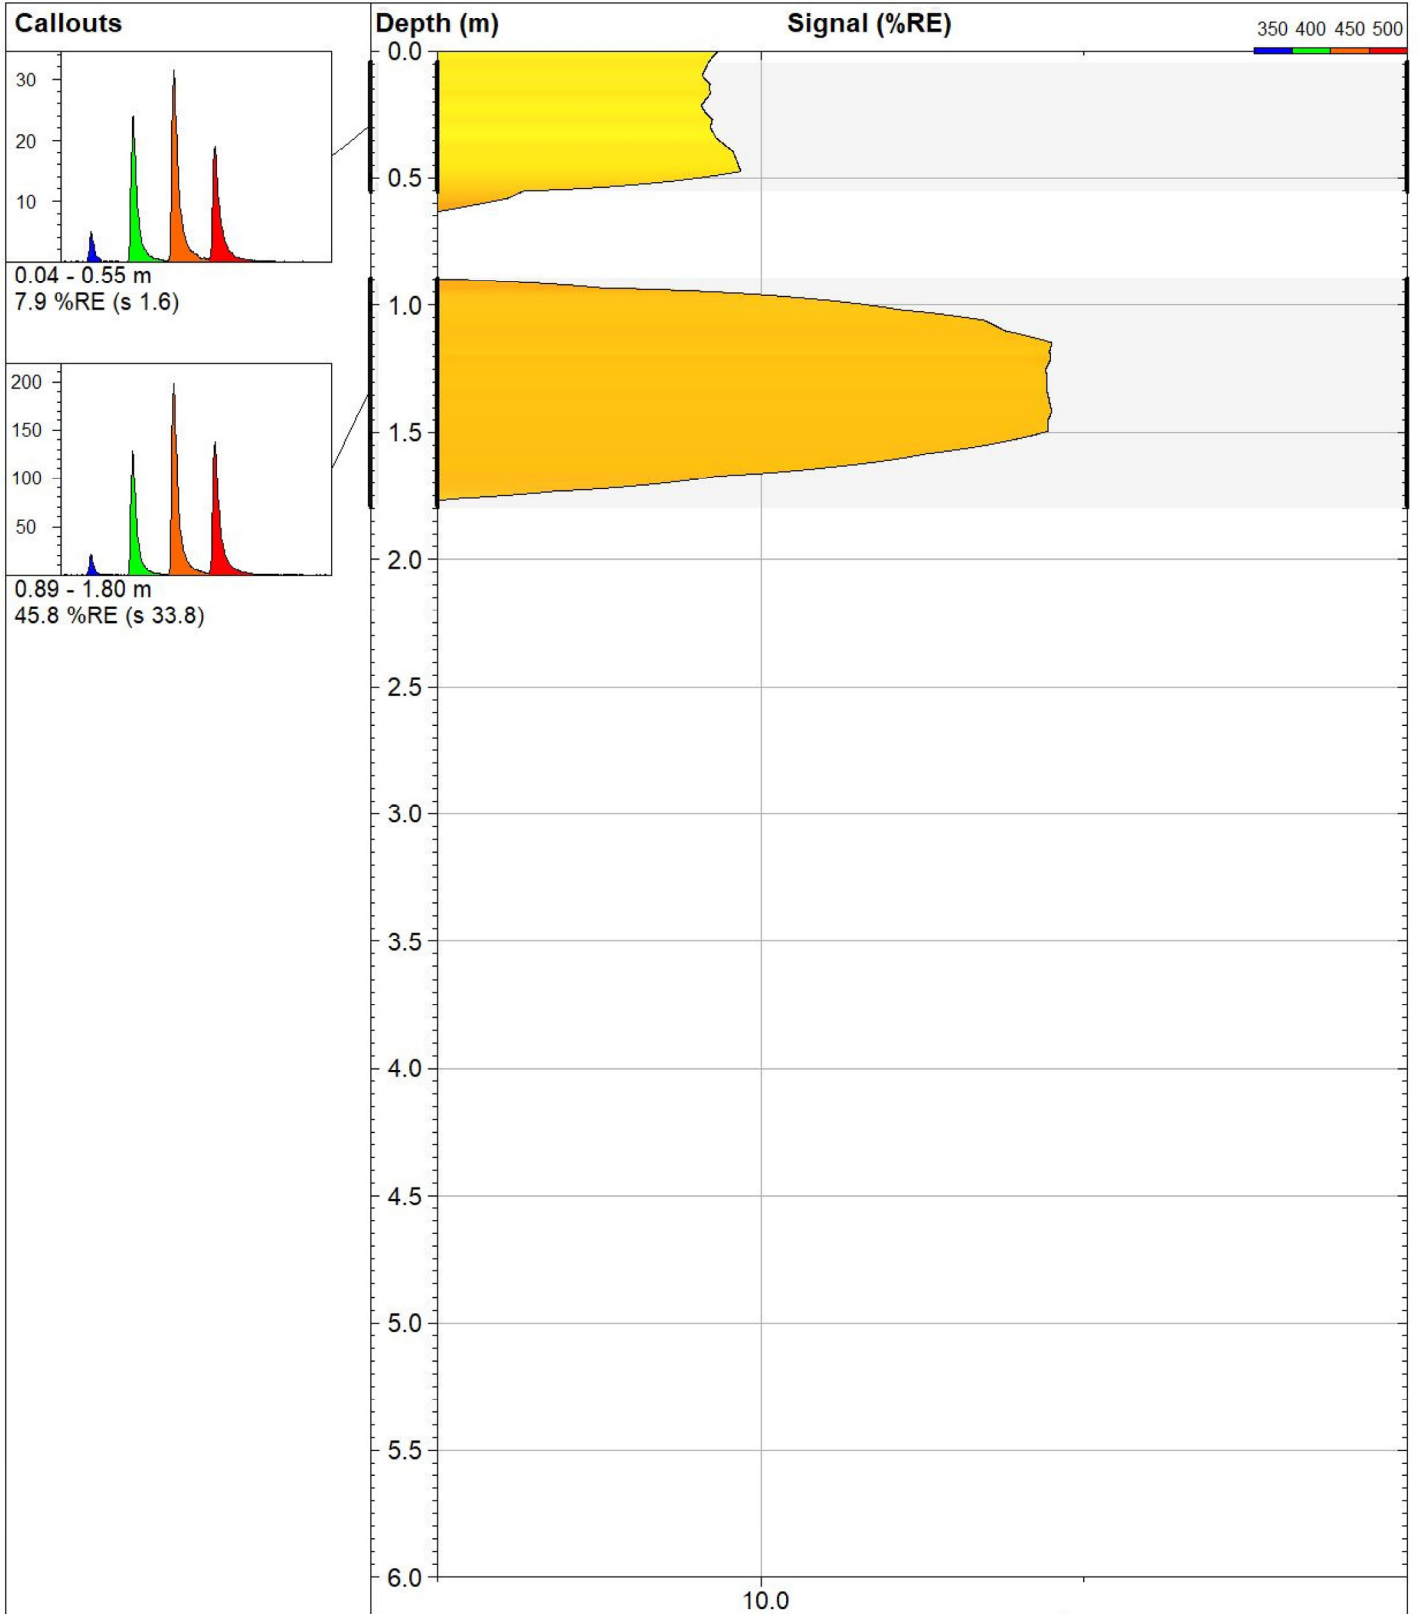
**LIF20082**

**Final depth:**  
3.06 m

**Max signal:**  
80.5 %RE @ 1.15 m

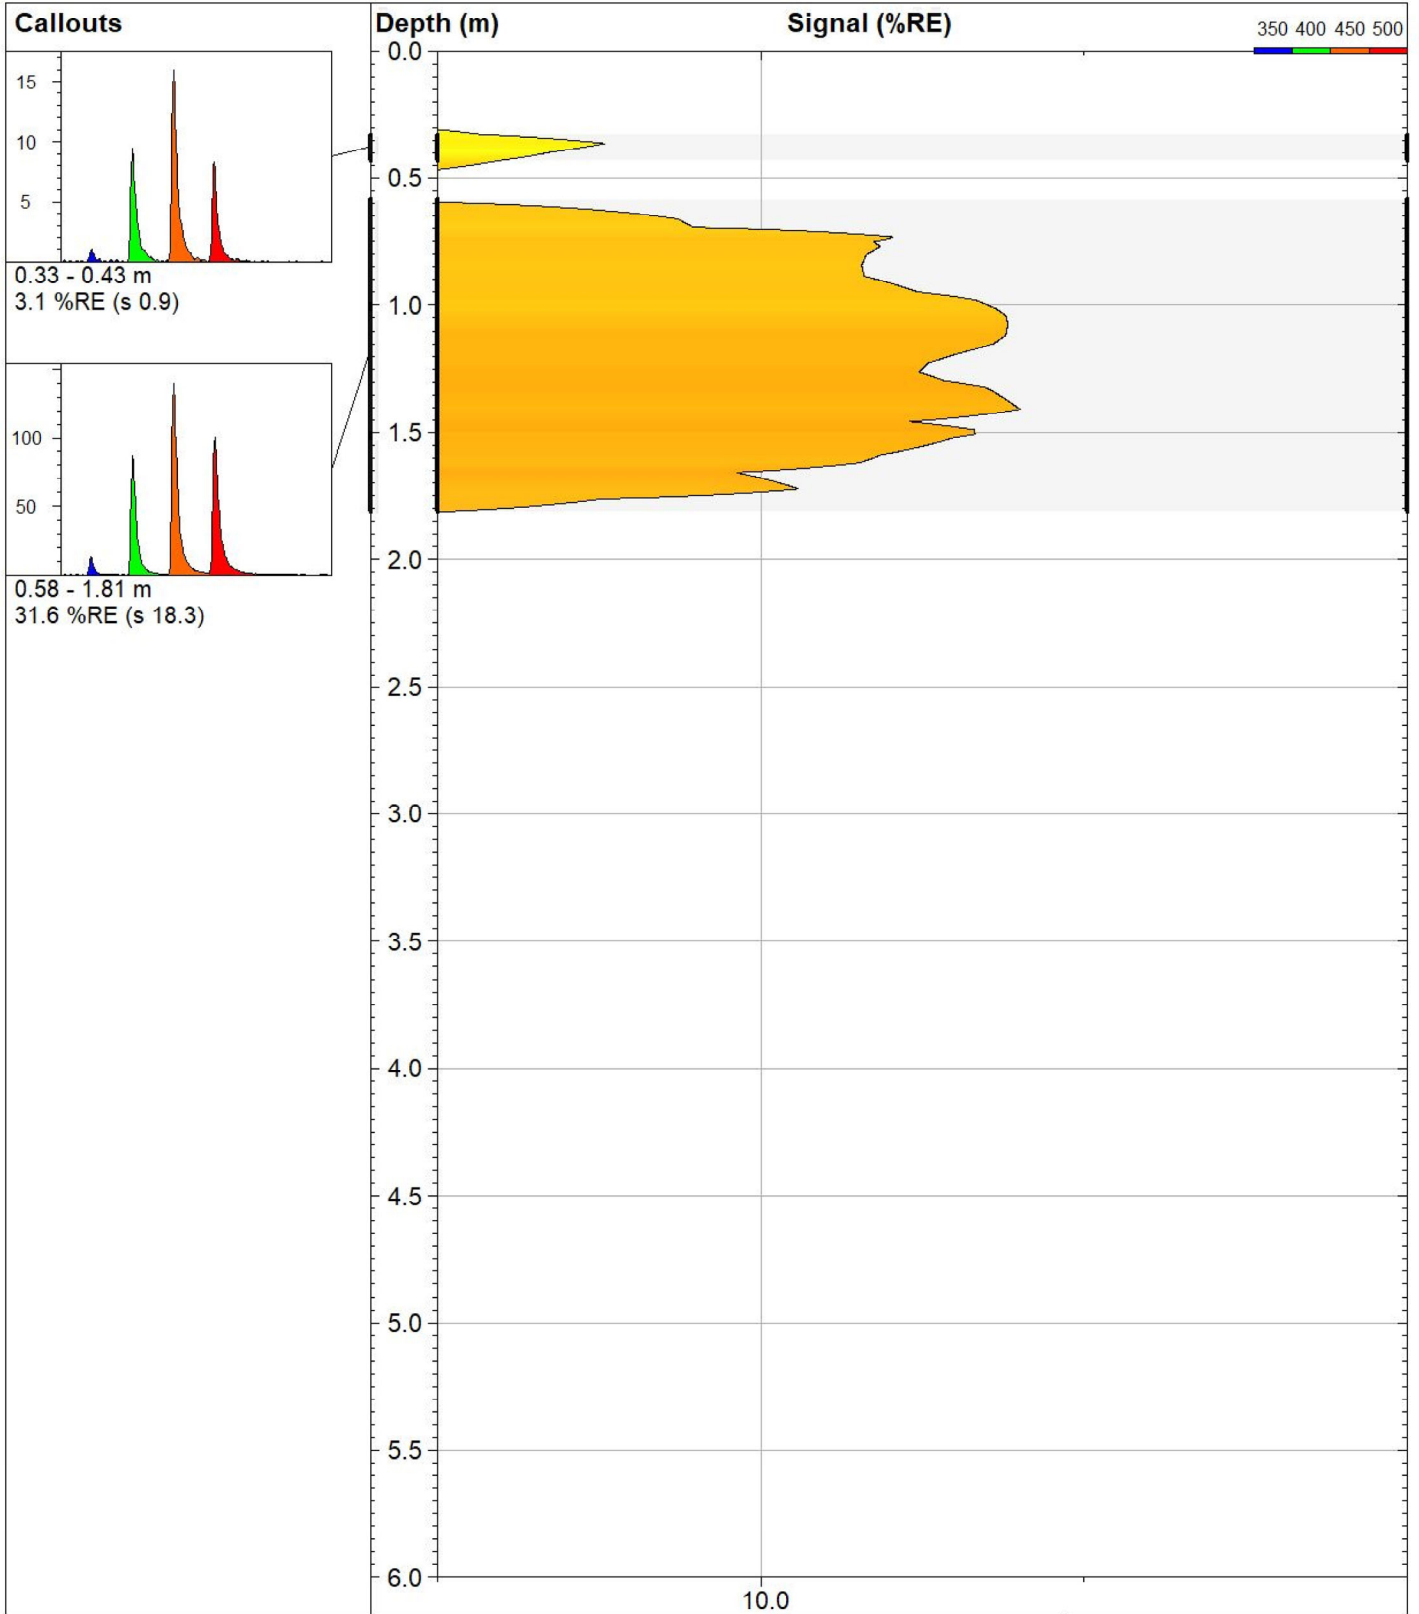
**LIF20083**

Final depth:  
**3.07 m**

Max signal:  
**64.4 %RE @ 1.41 m**

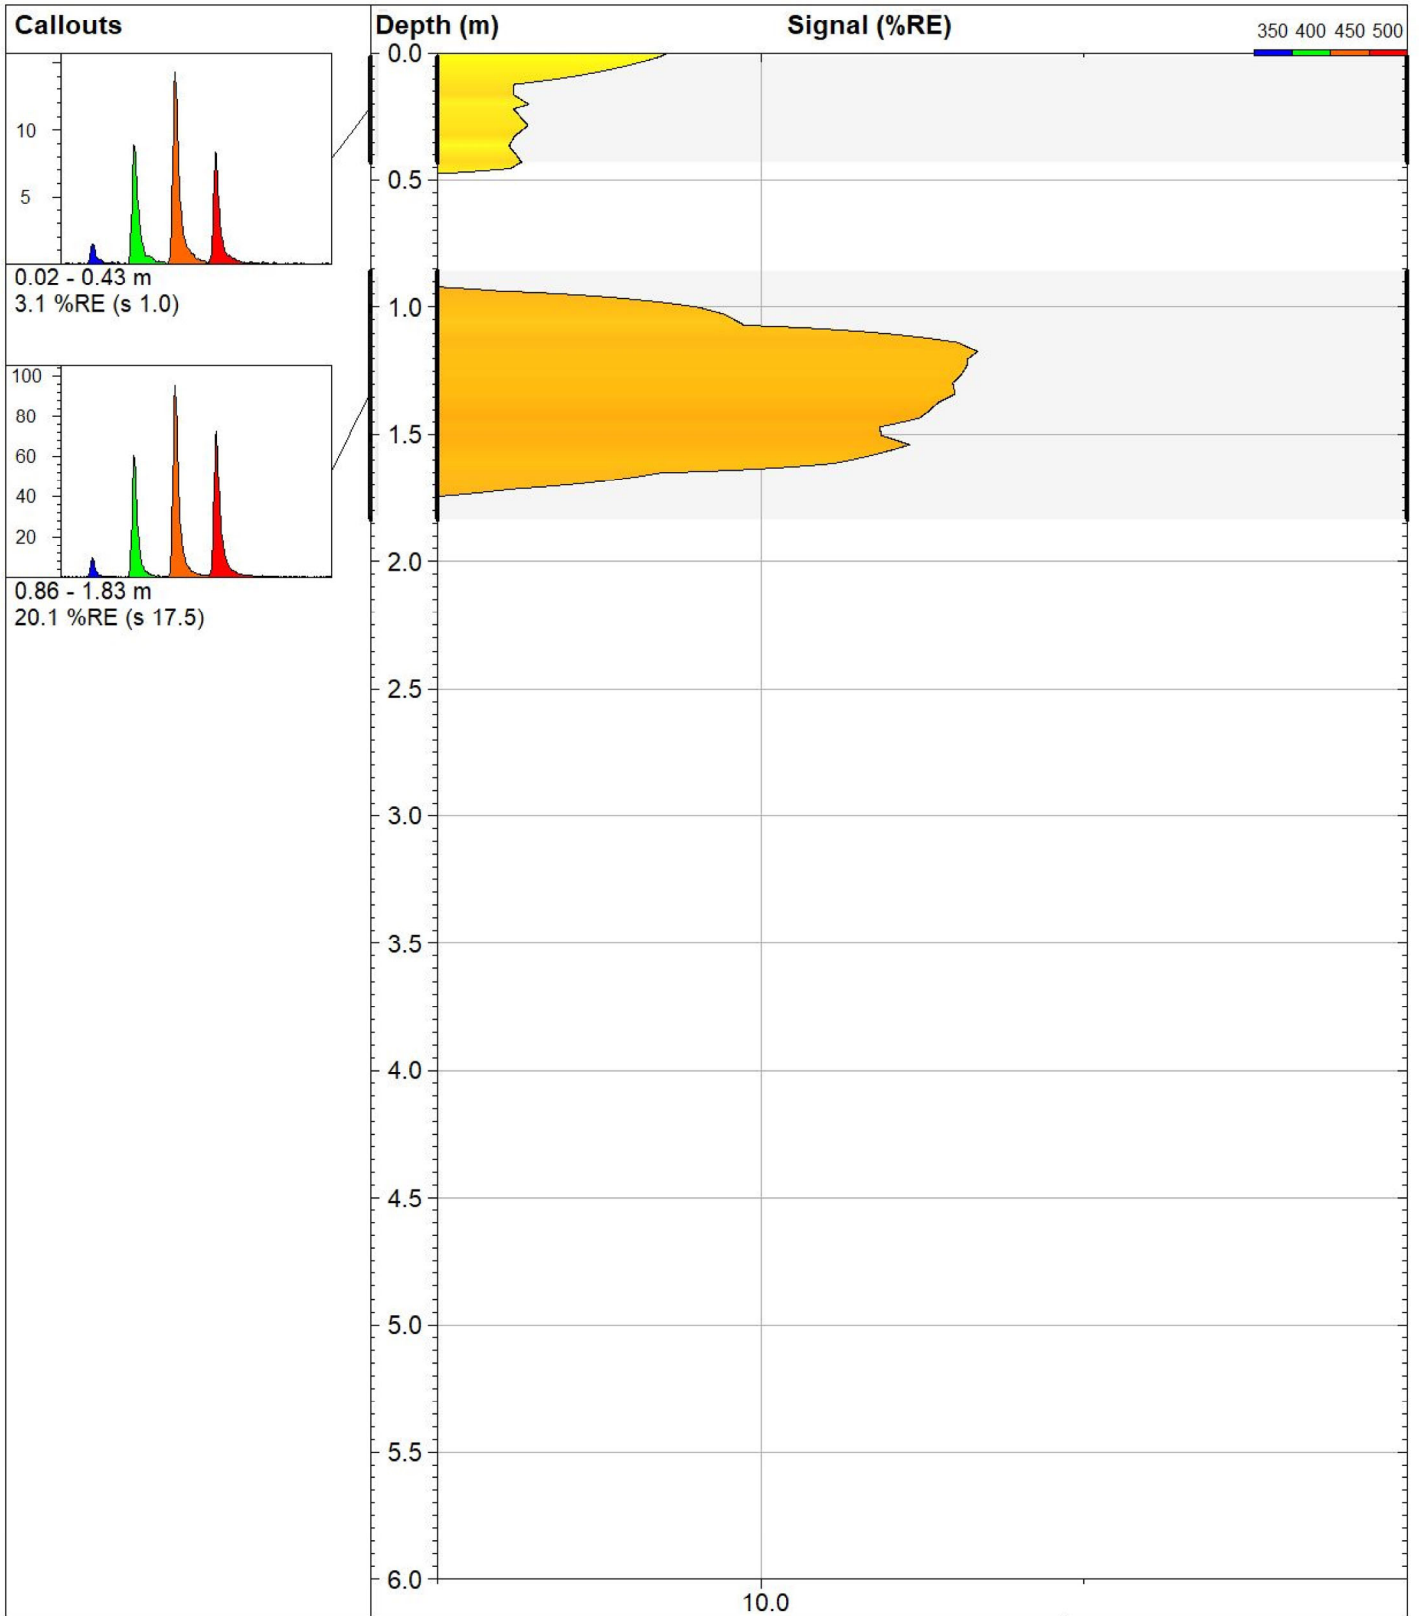
**LIF20086**

Final depth:  
**3.17 m**

Max signal:  
**47.8 %RE @ 1.17 m**

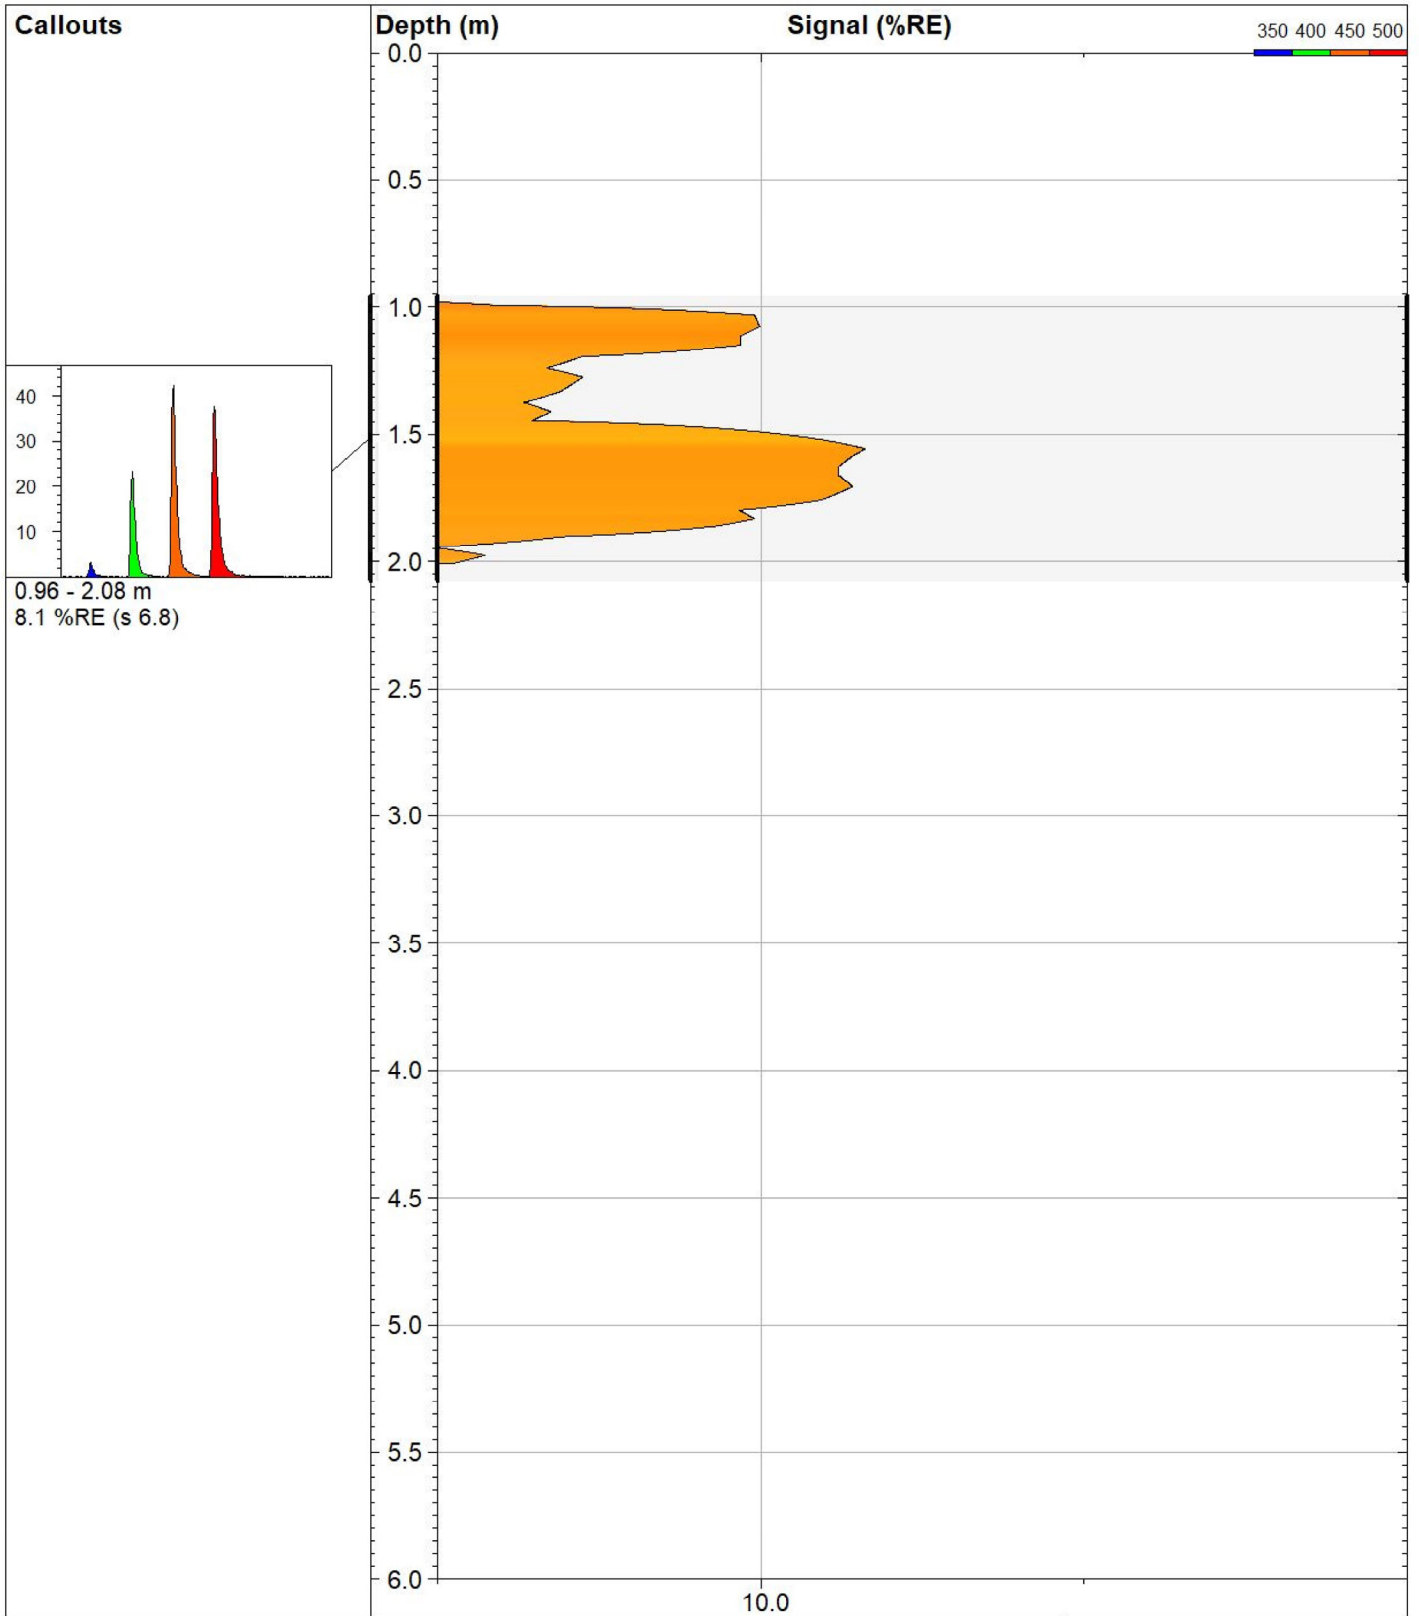
**LIF20087**

*Final depth:*  
**3.06 m**

*Max signal:*  
**22.0 %RE @ 1.56 m**

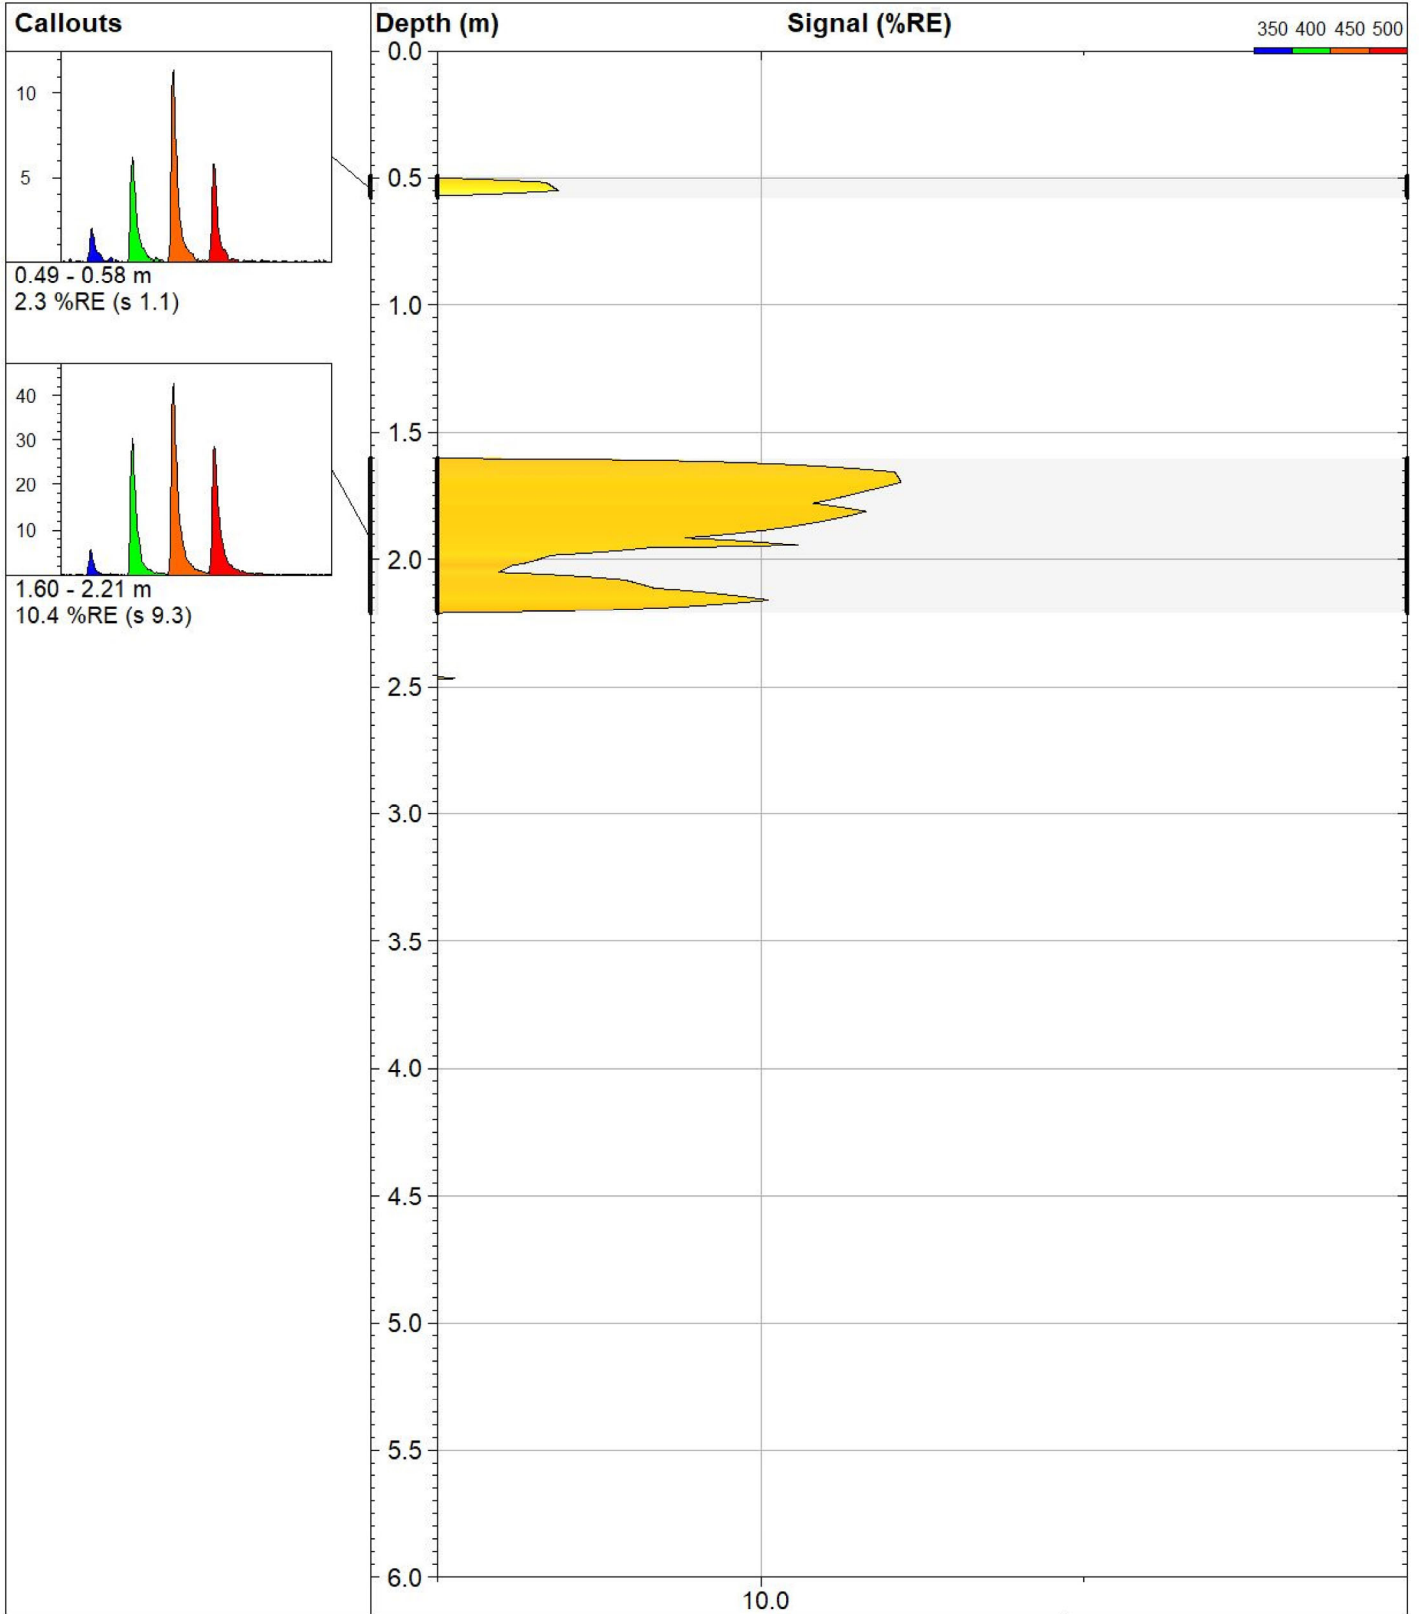
**LIF20089**

Final depth:  
**3.06 m**

Max signal:  
**28.1 %RE @ 1.70 m**

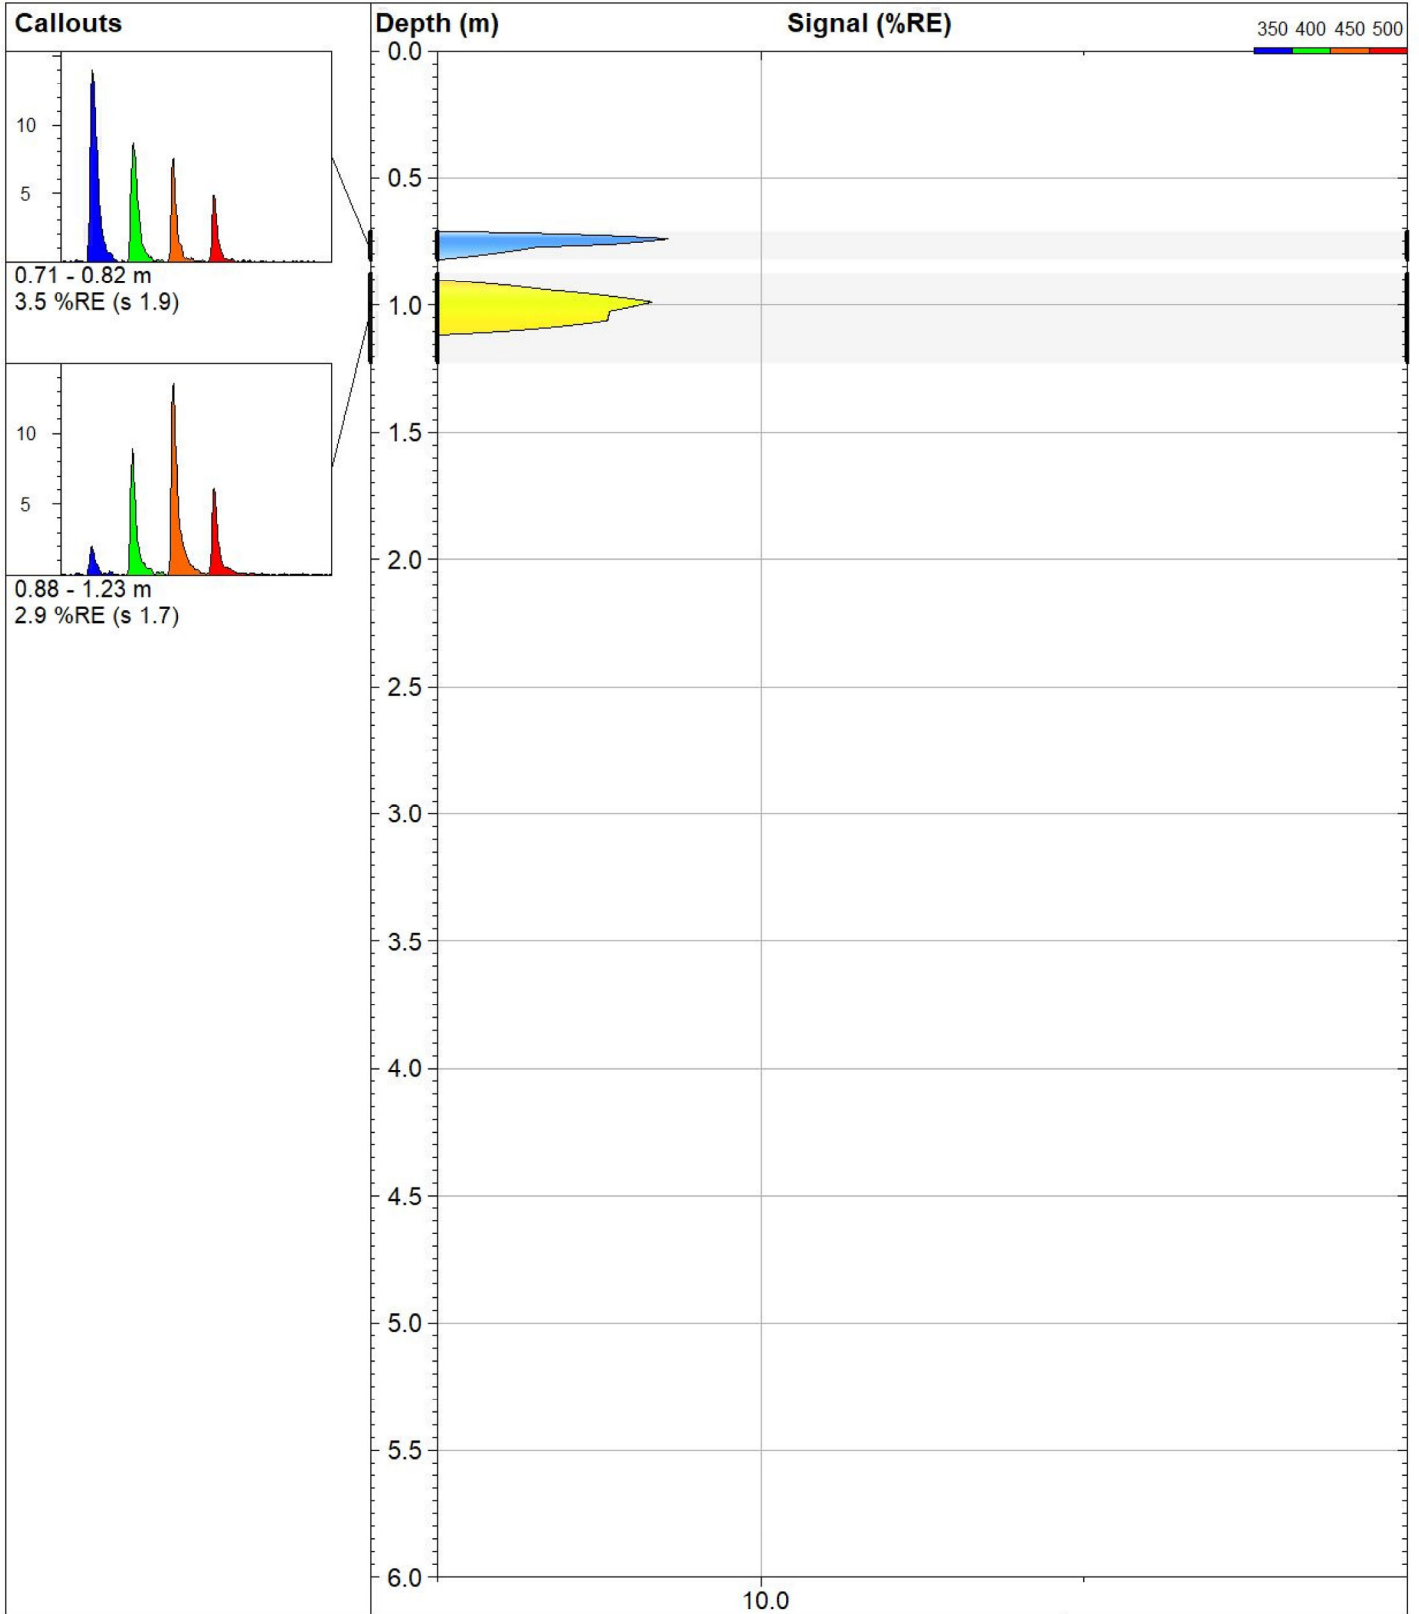
**LIF20090**

Final depth:  
**3.05 m**

Max signal:  
**6.2 %RE @ 0.74 m**
