**LIF20065**

*Site:*  
**Canatara Park**

*Client / Job:*  
**RWDI / VE848**

**UVOST® By Dakota**  
www.DakotaTechnologies.com

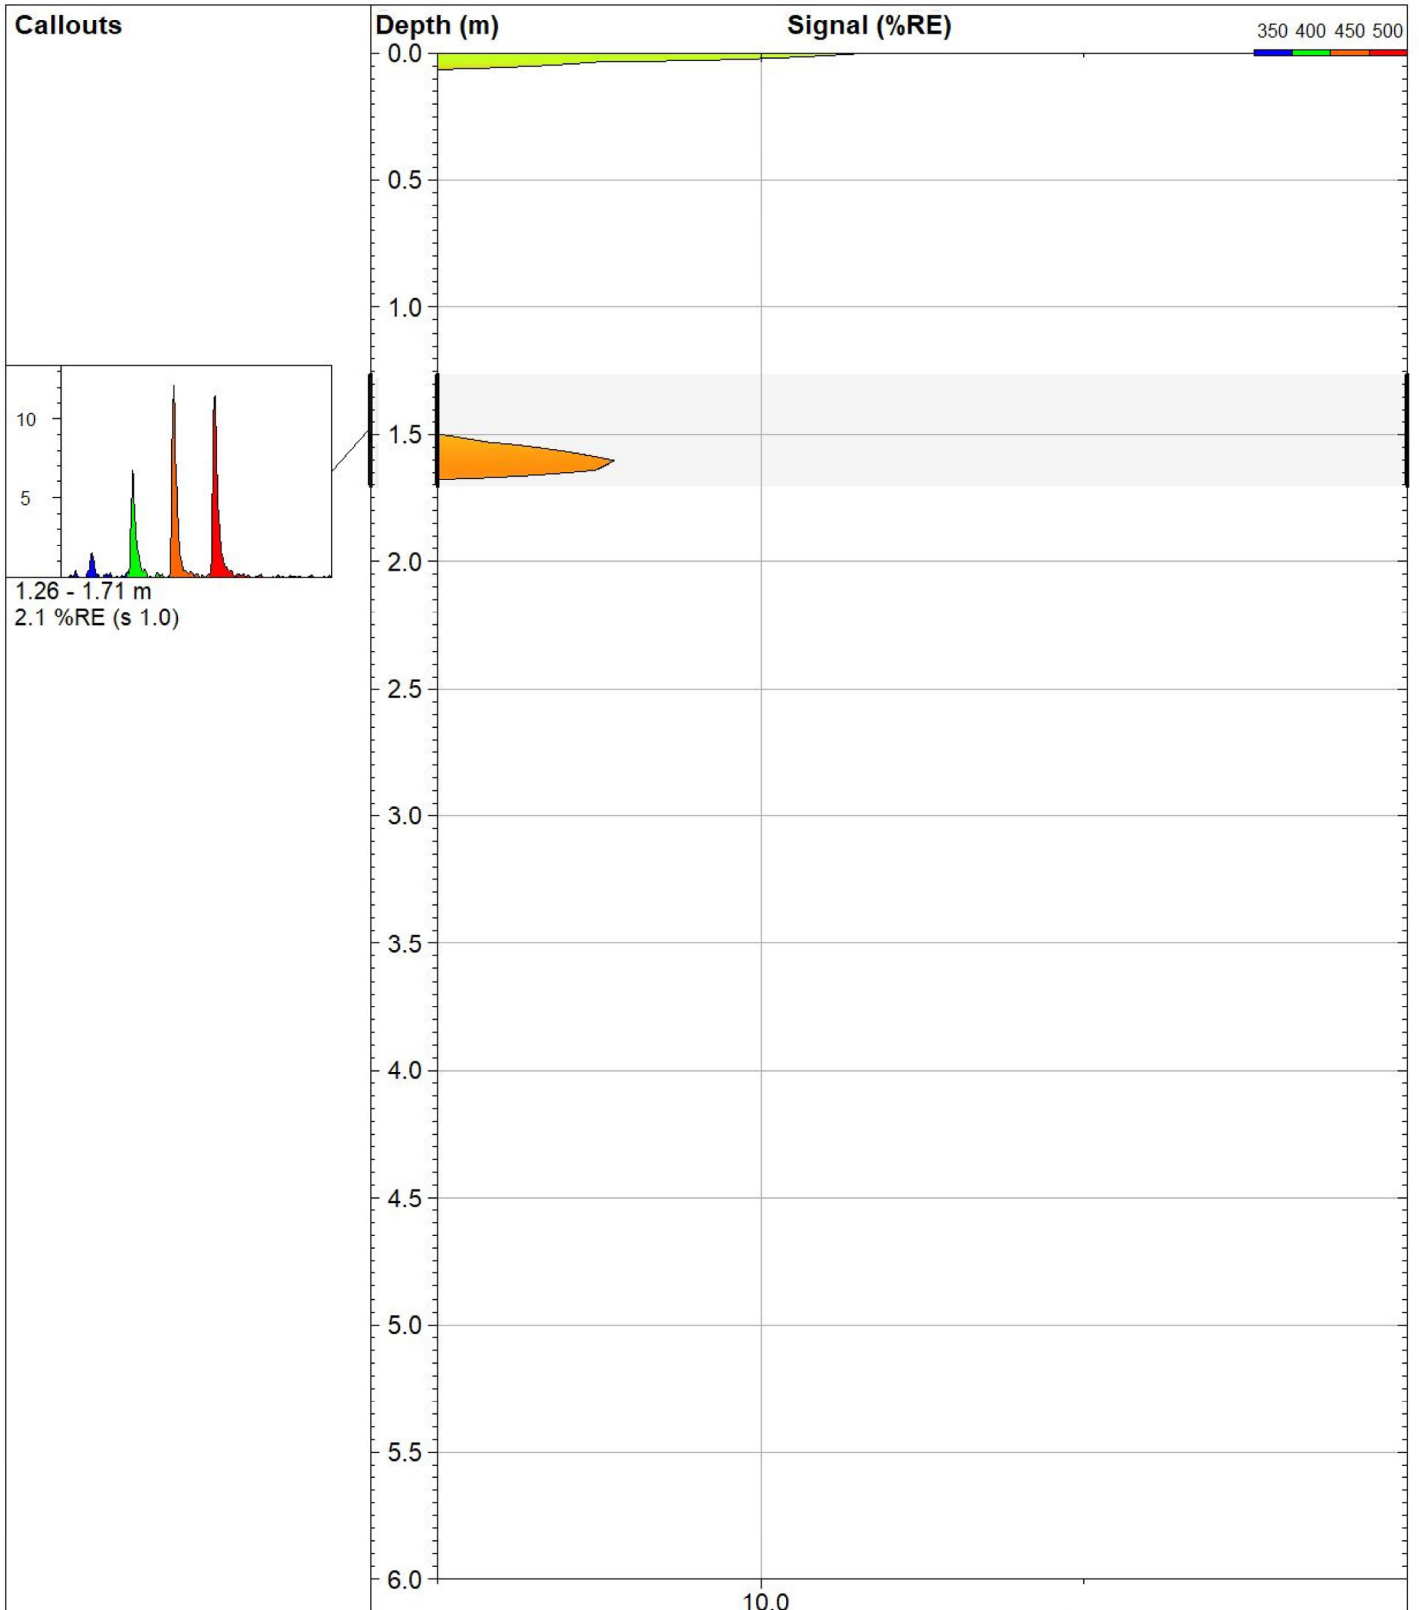
**LIF20091**

*Final depth:*  
**3.06 m**

*Max signal:*  
**22.6 %RE @ 0.00 m**
