**VERTEX**  
Environmental Inc.

**LIF20129**

Site:  
**Canatara Park**

Client / Job:  
**RWDI / VE848**

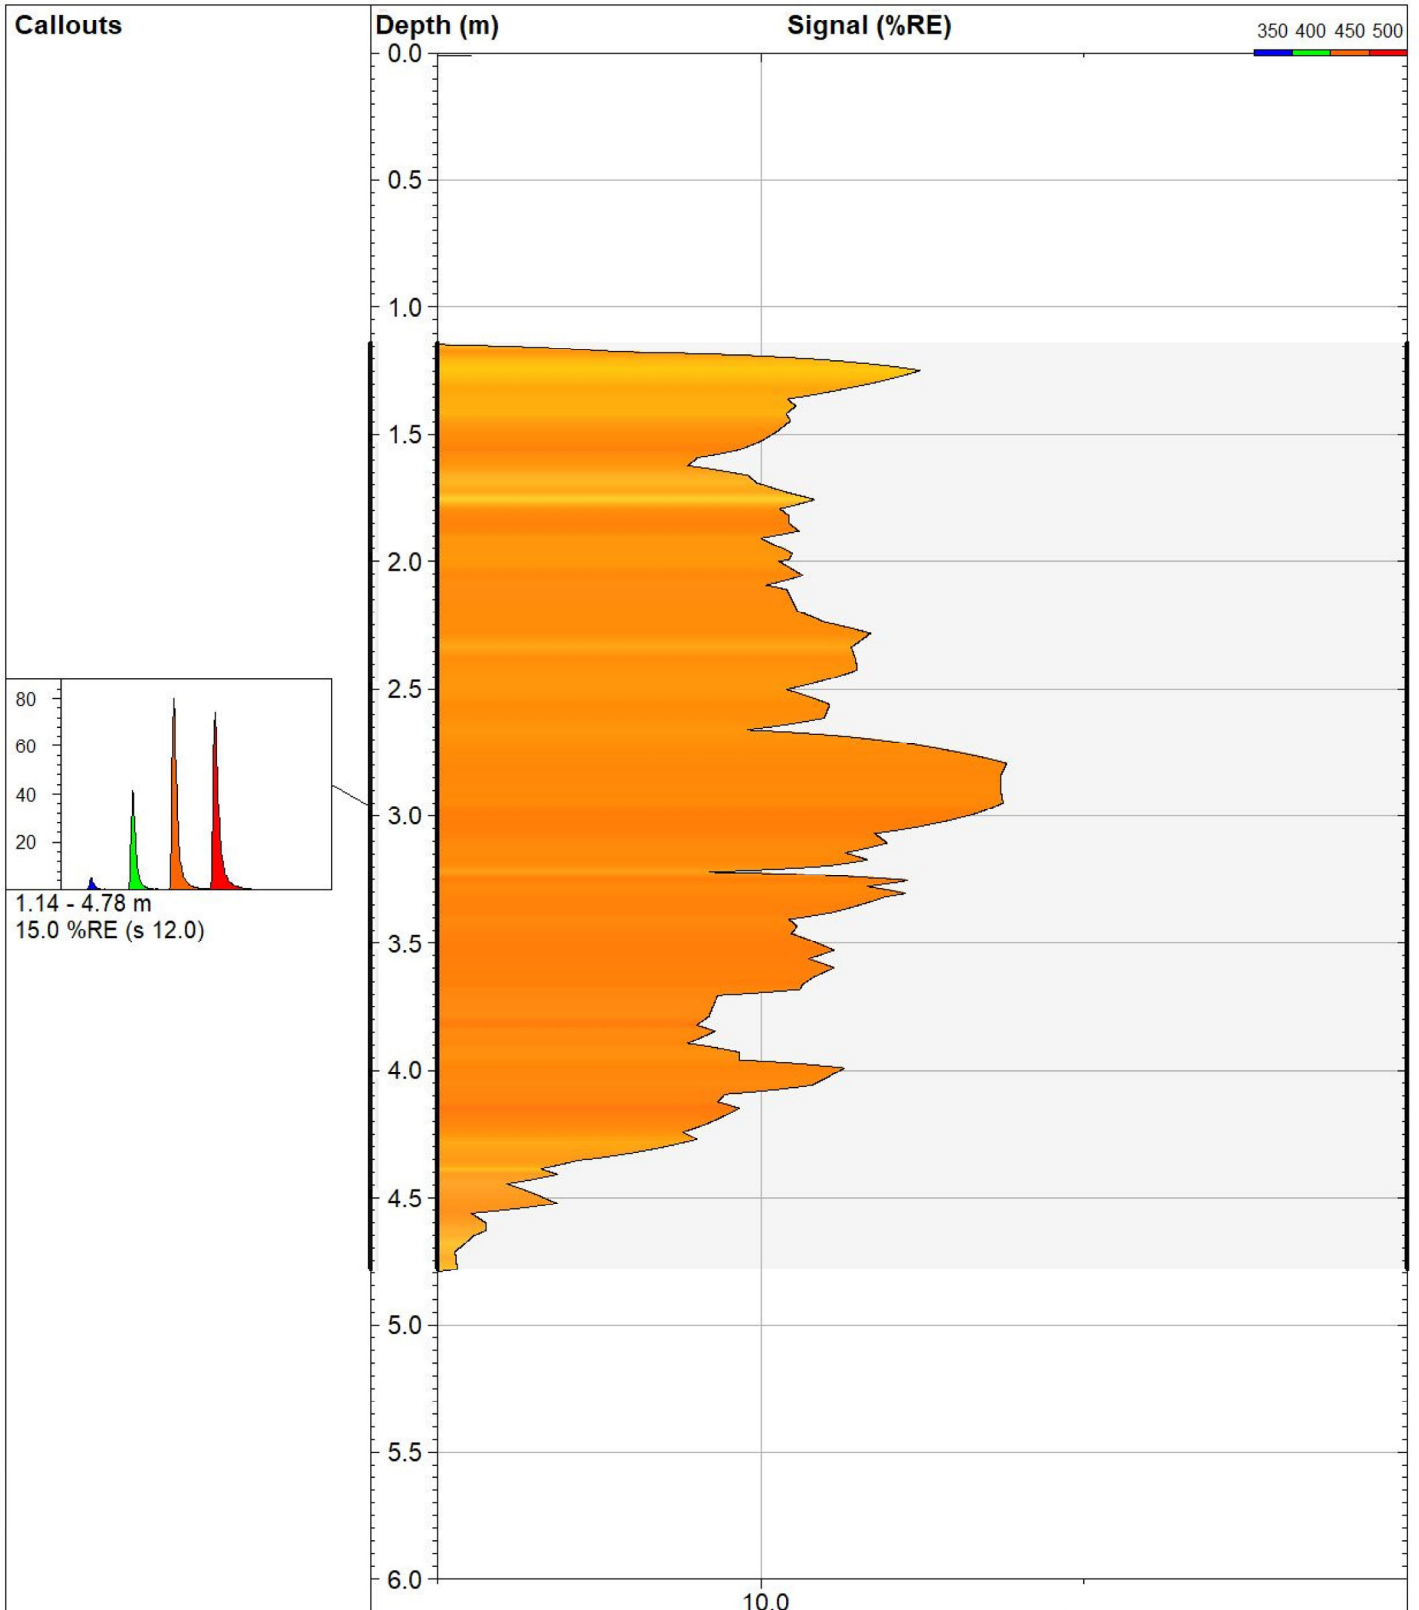
Final depth:  
**5.52 m**

Max signal:  
**58.6 %RE @ 2.79 m**

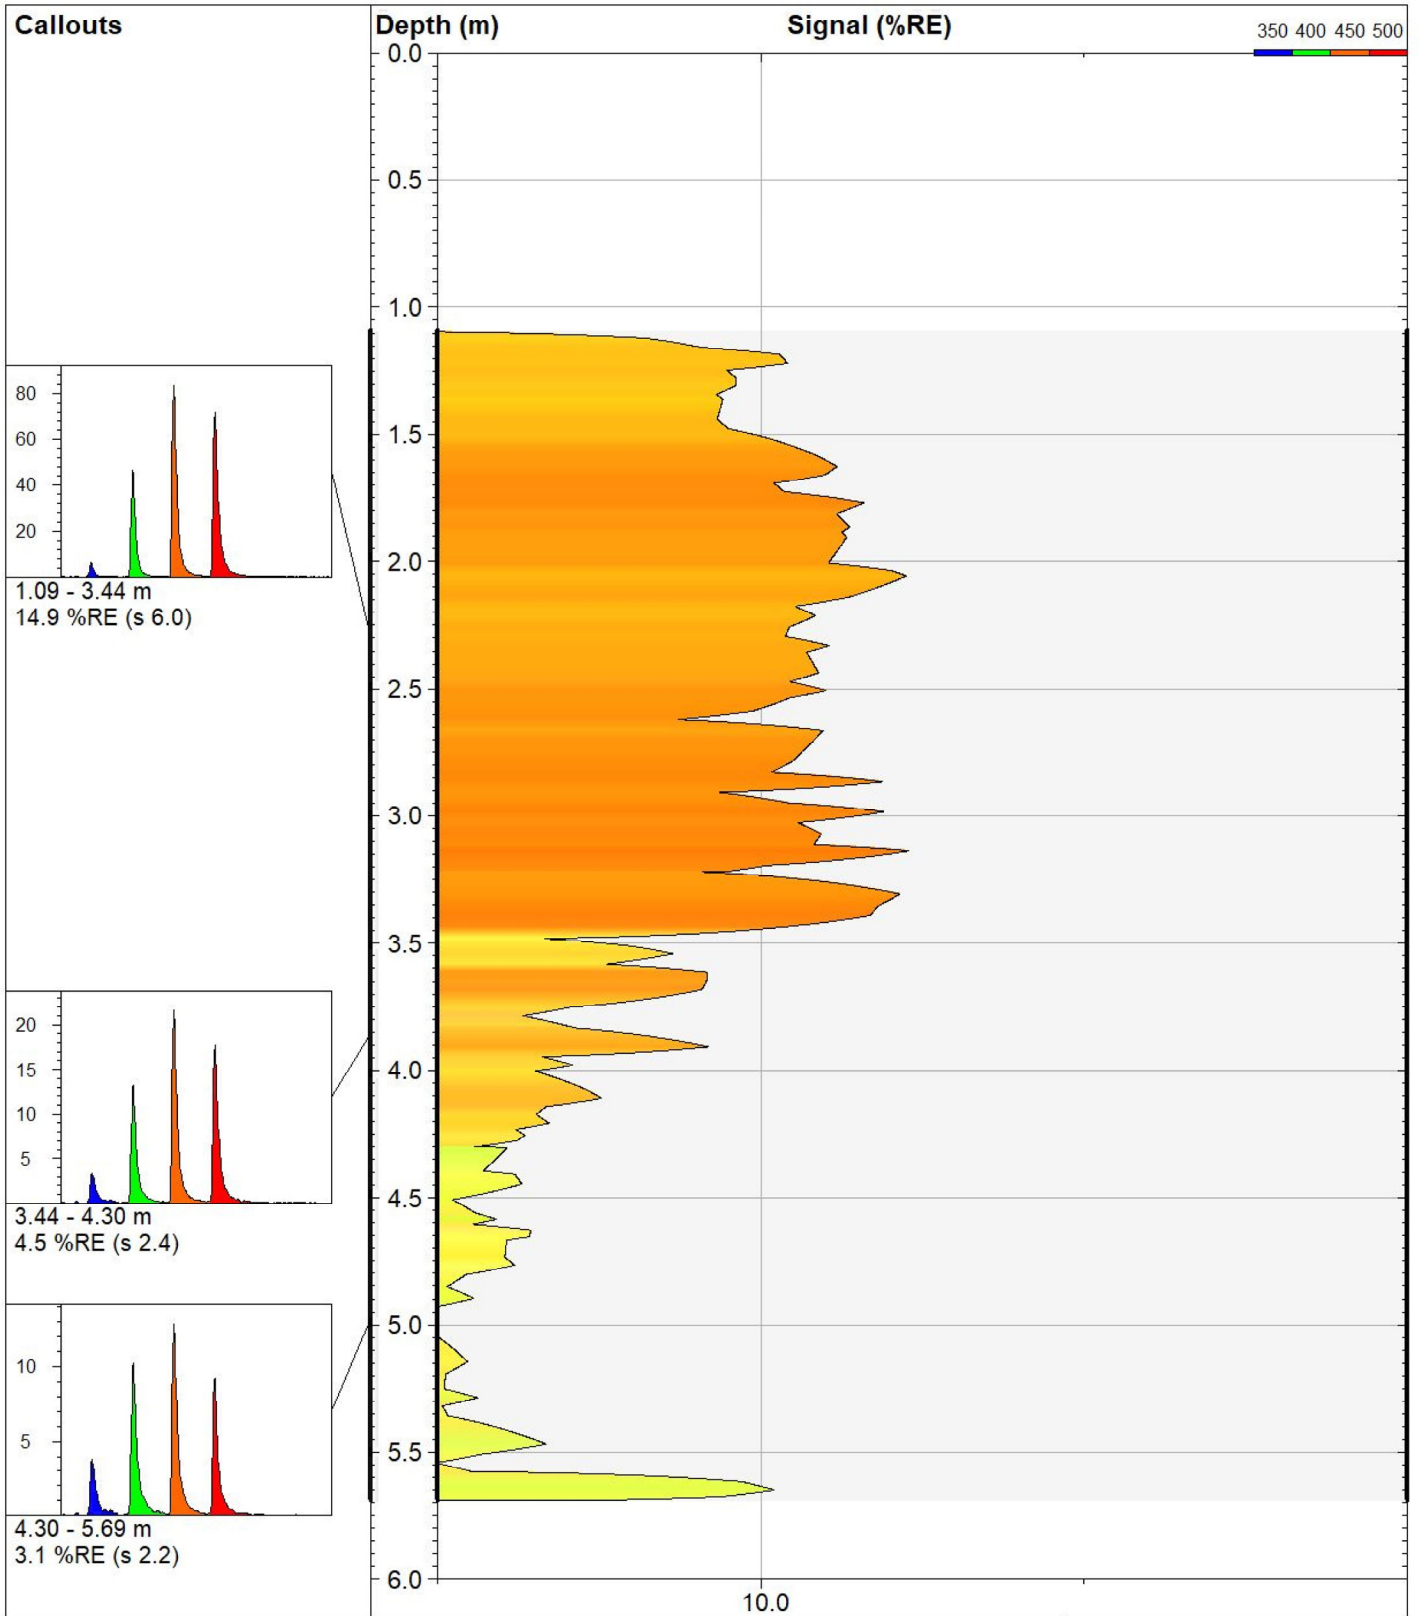
**LIF20130**

**Final depth:**  
5.69 m

**Max signal:**  
29.8 %RE @ 3.14 m

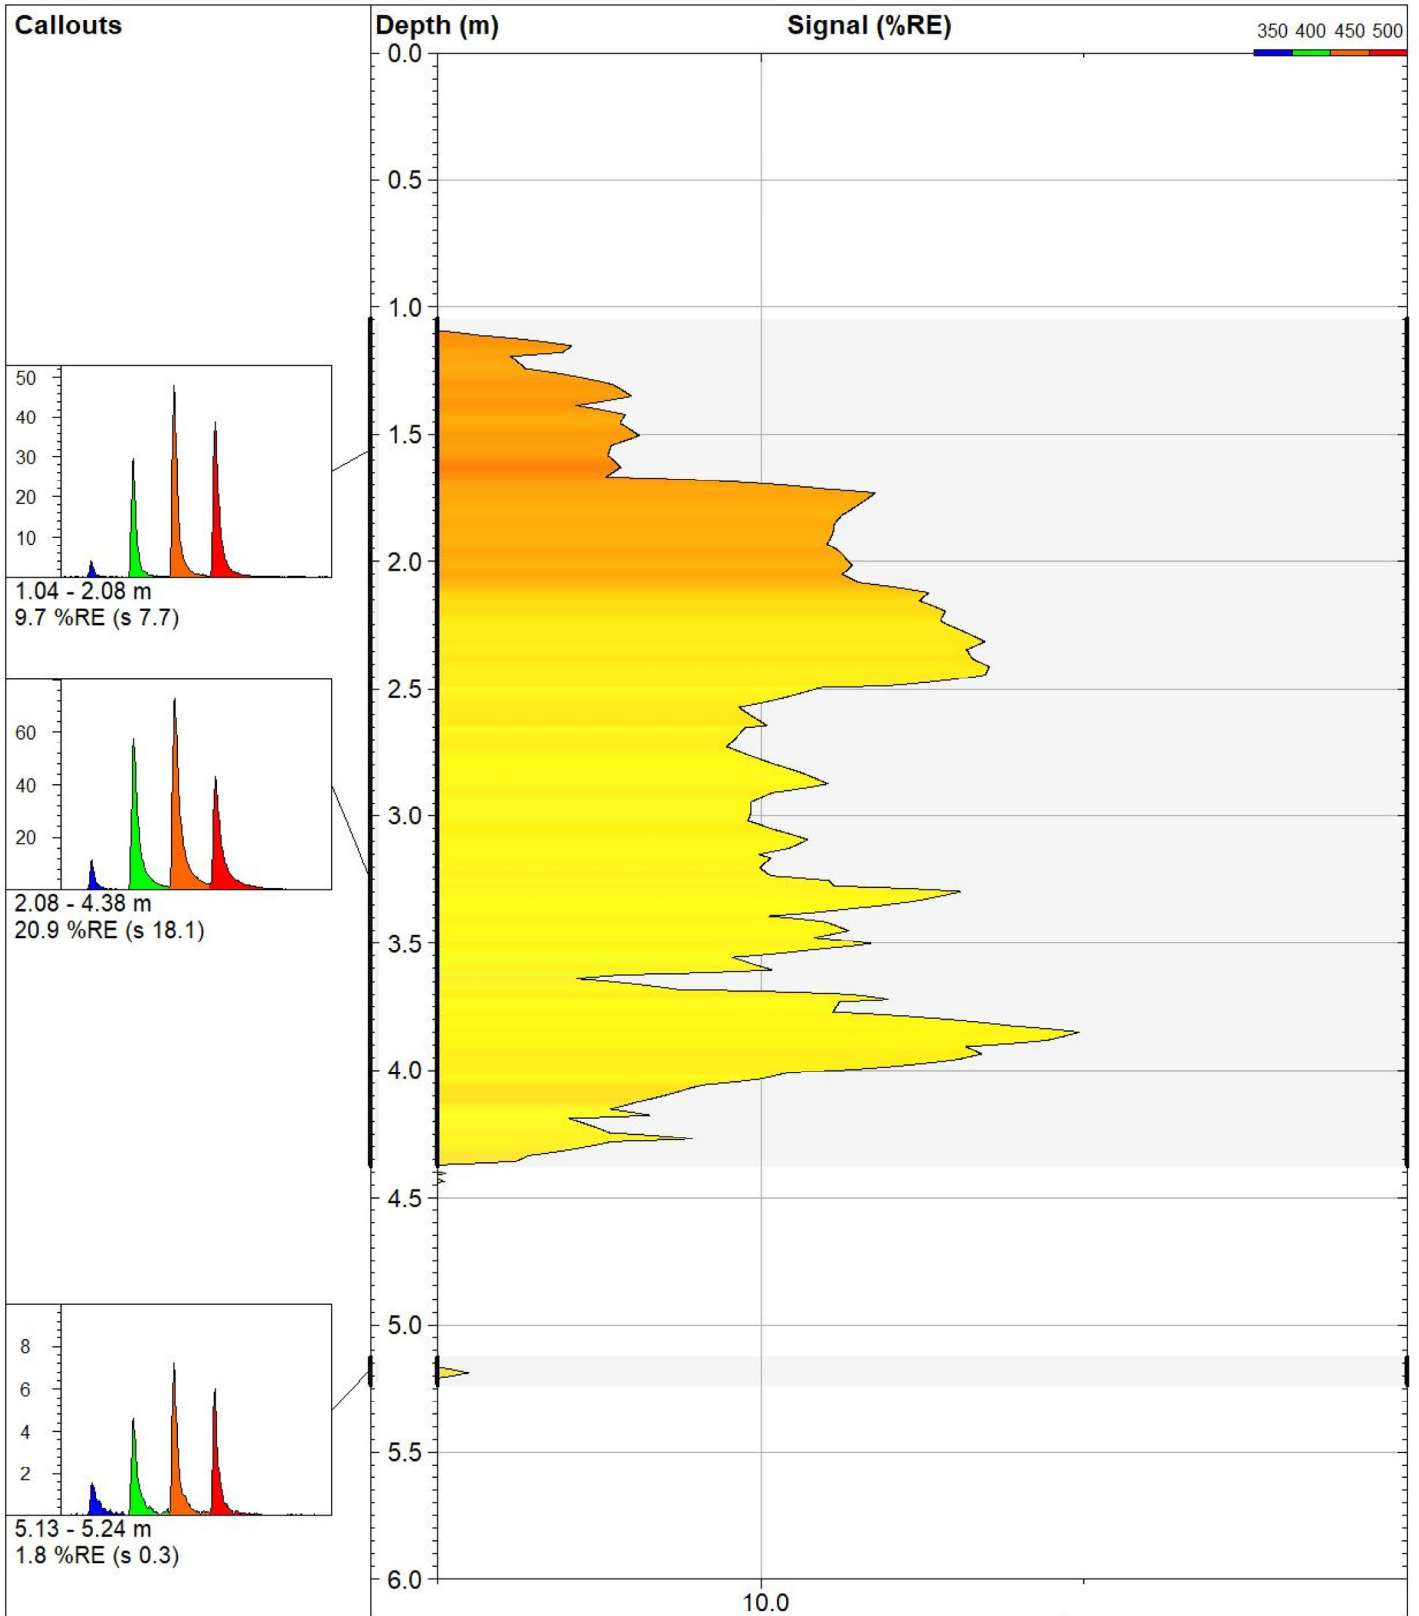
**LIF20131**

Final depth:  
**5.58 m**

Max signal:  
**97.4 %RE @ 3.85 m**

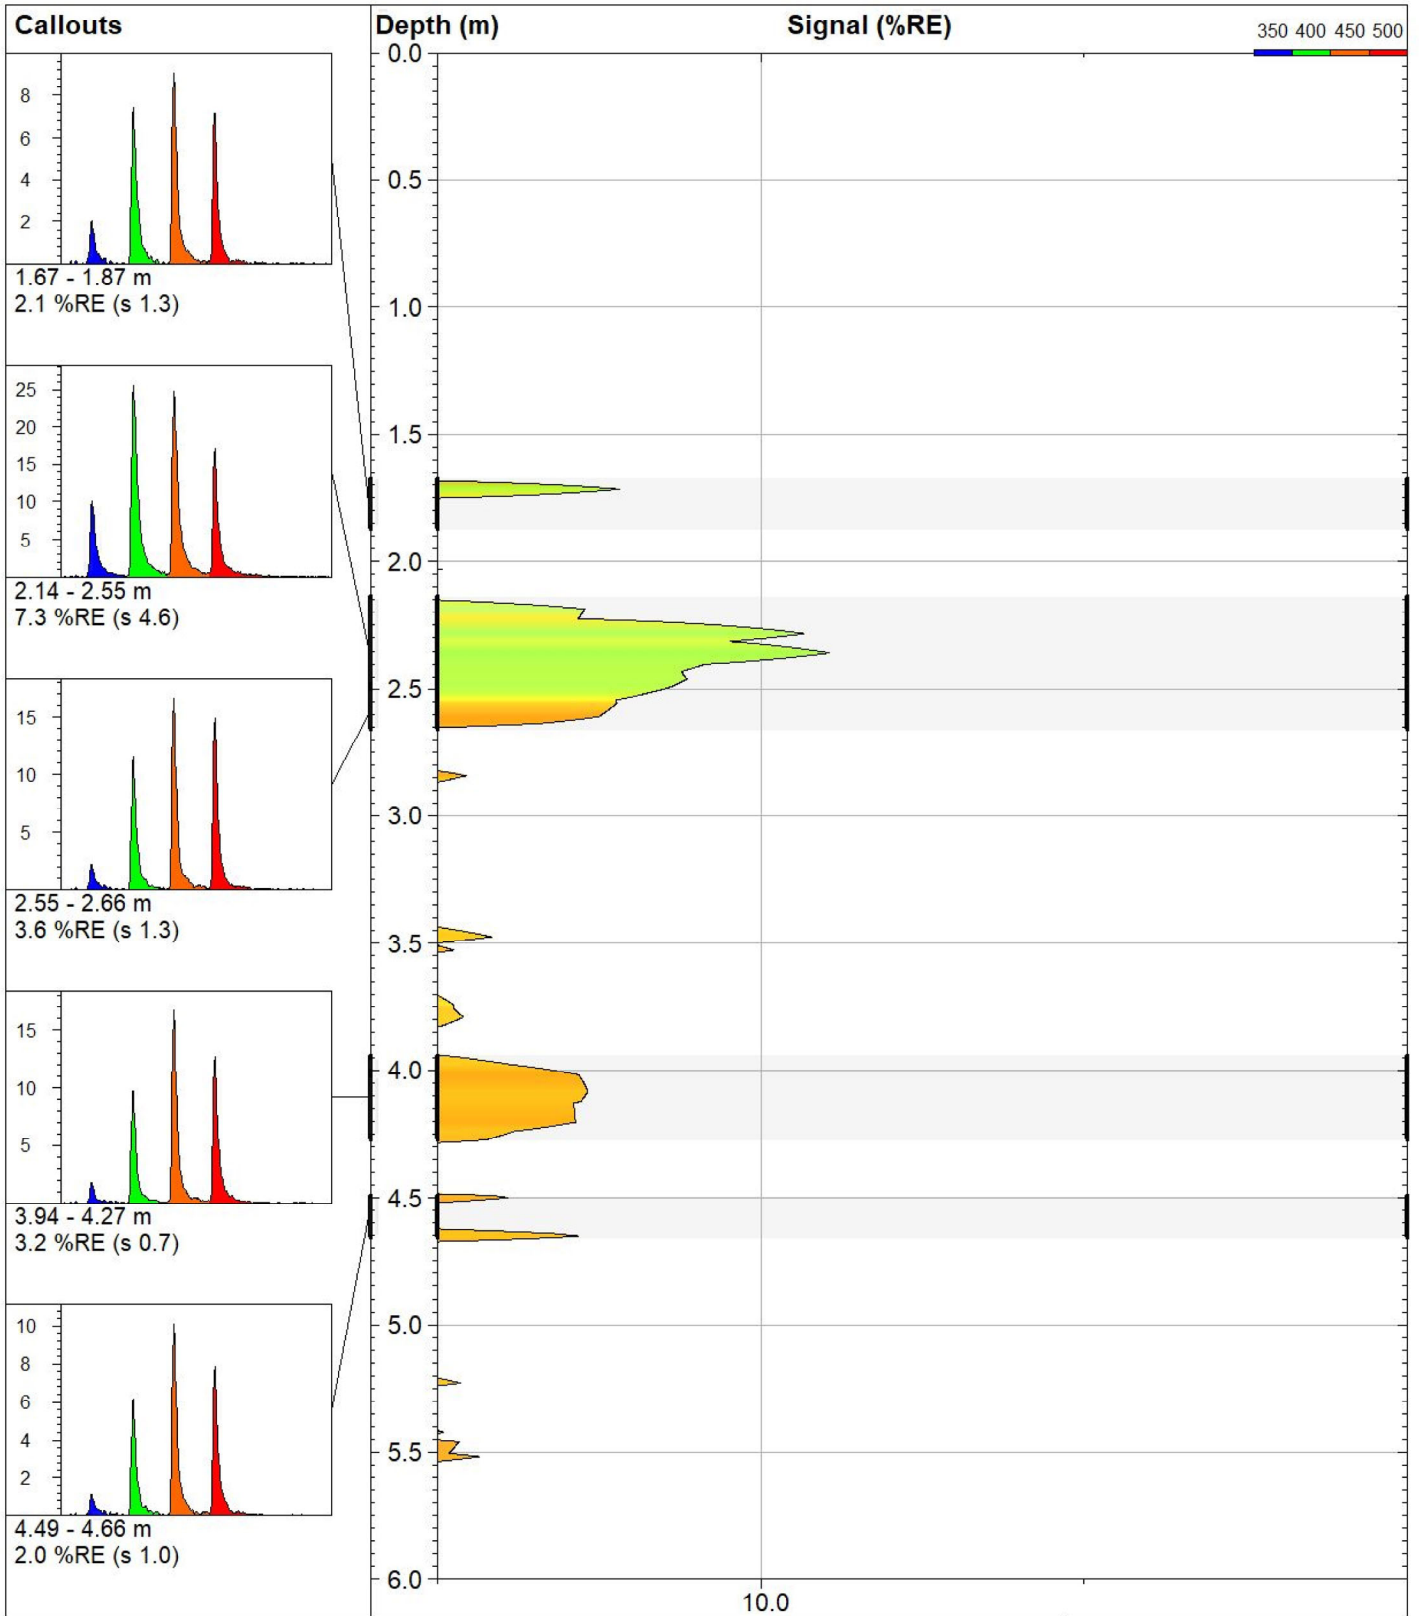
**LIF20132**

Final depth:  
**5.68 m**

Max signal:  
**17.3 %RE @ 2.36 m**

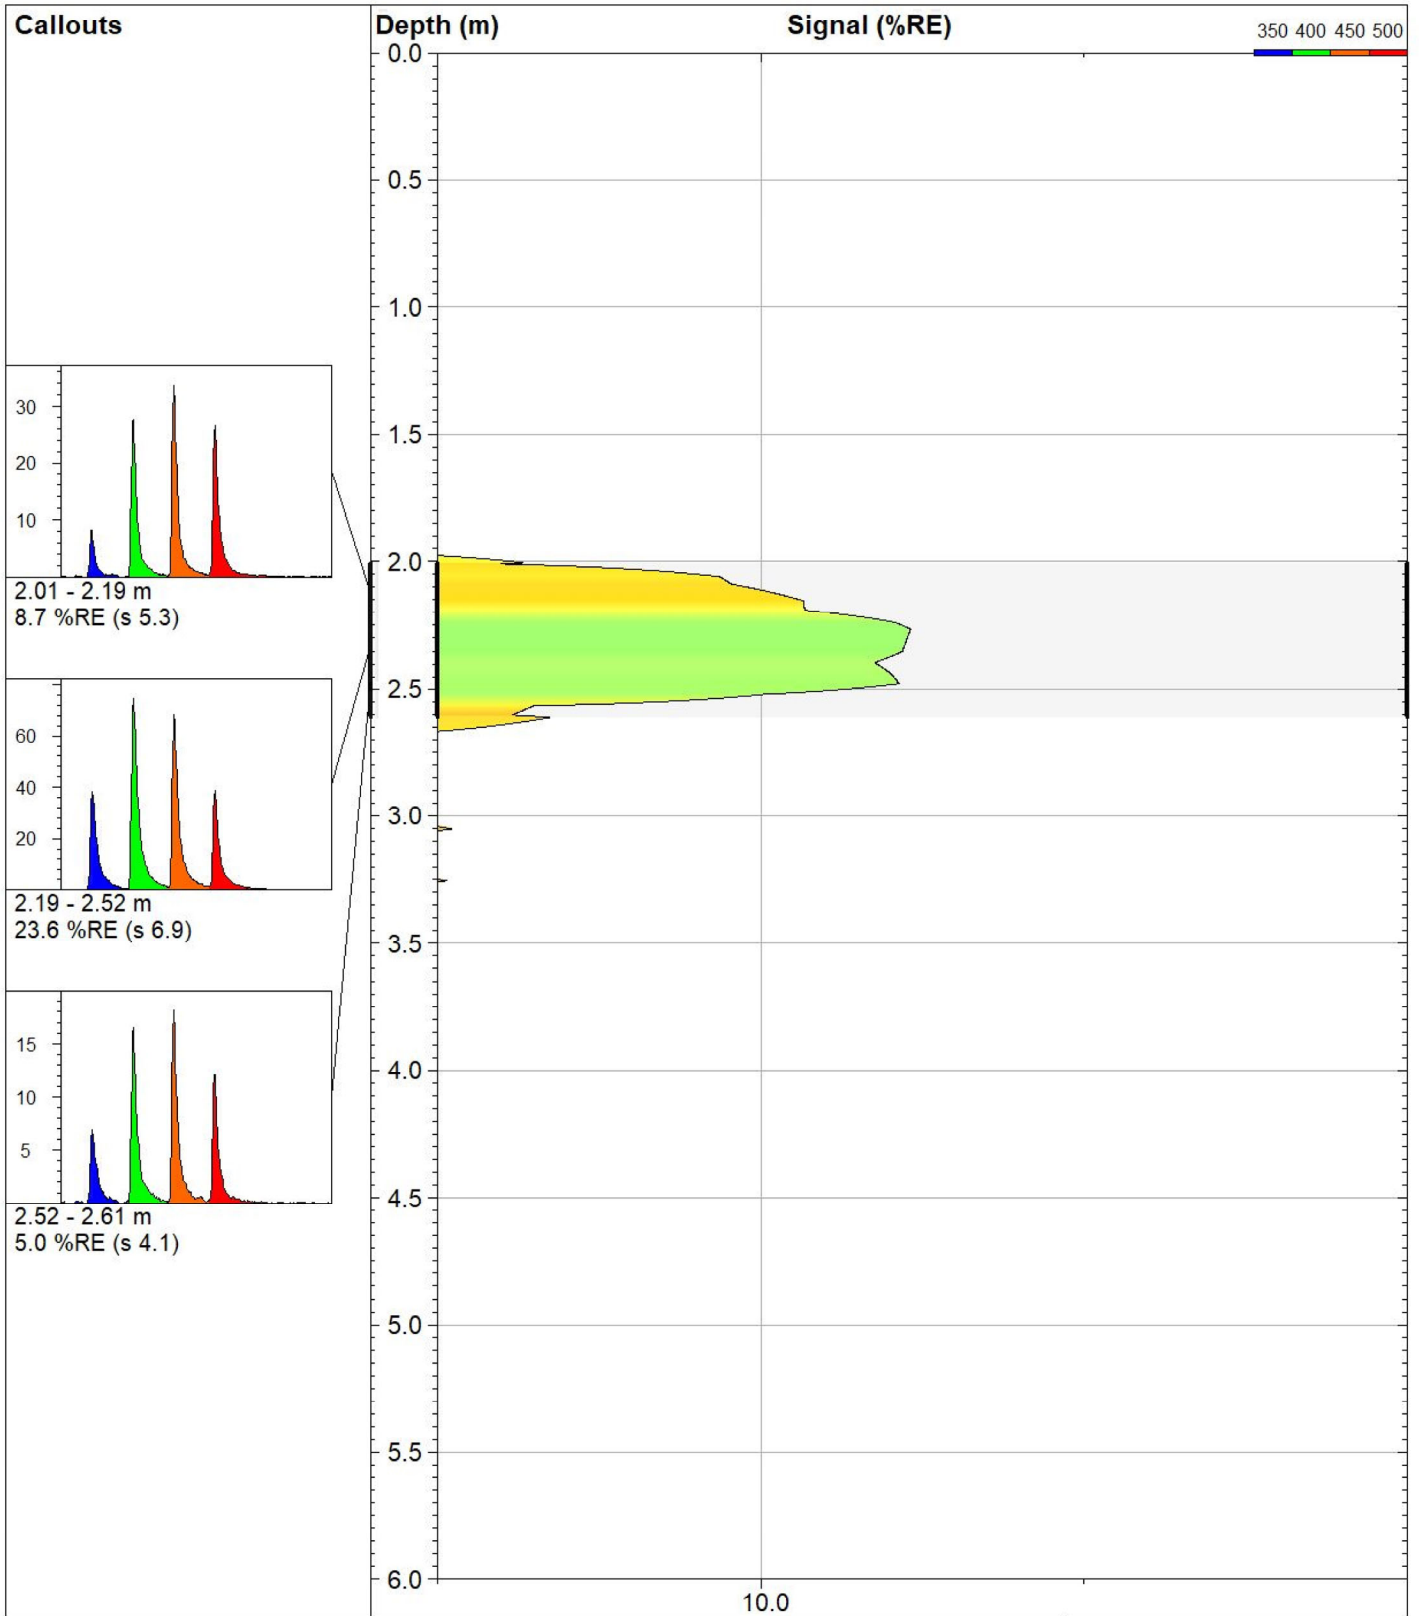
**LIF20133**

**Final depth:**  
4.30 m

**Max signal:**  
30.0 %RE @ 2.26 m

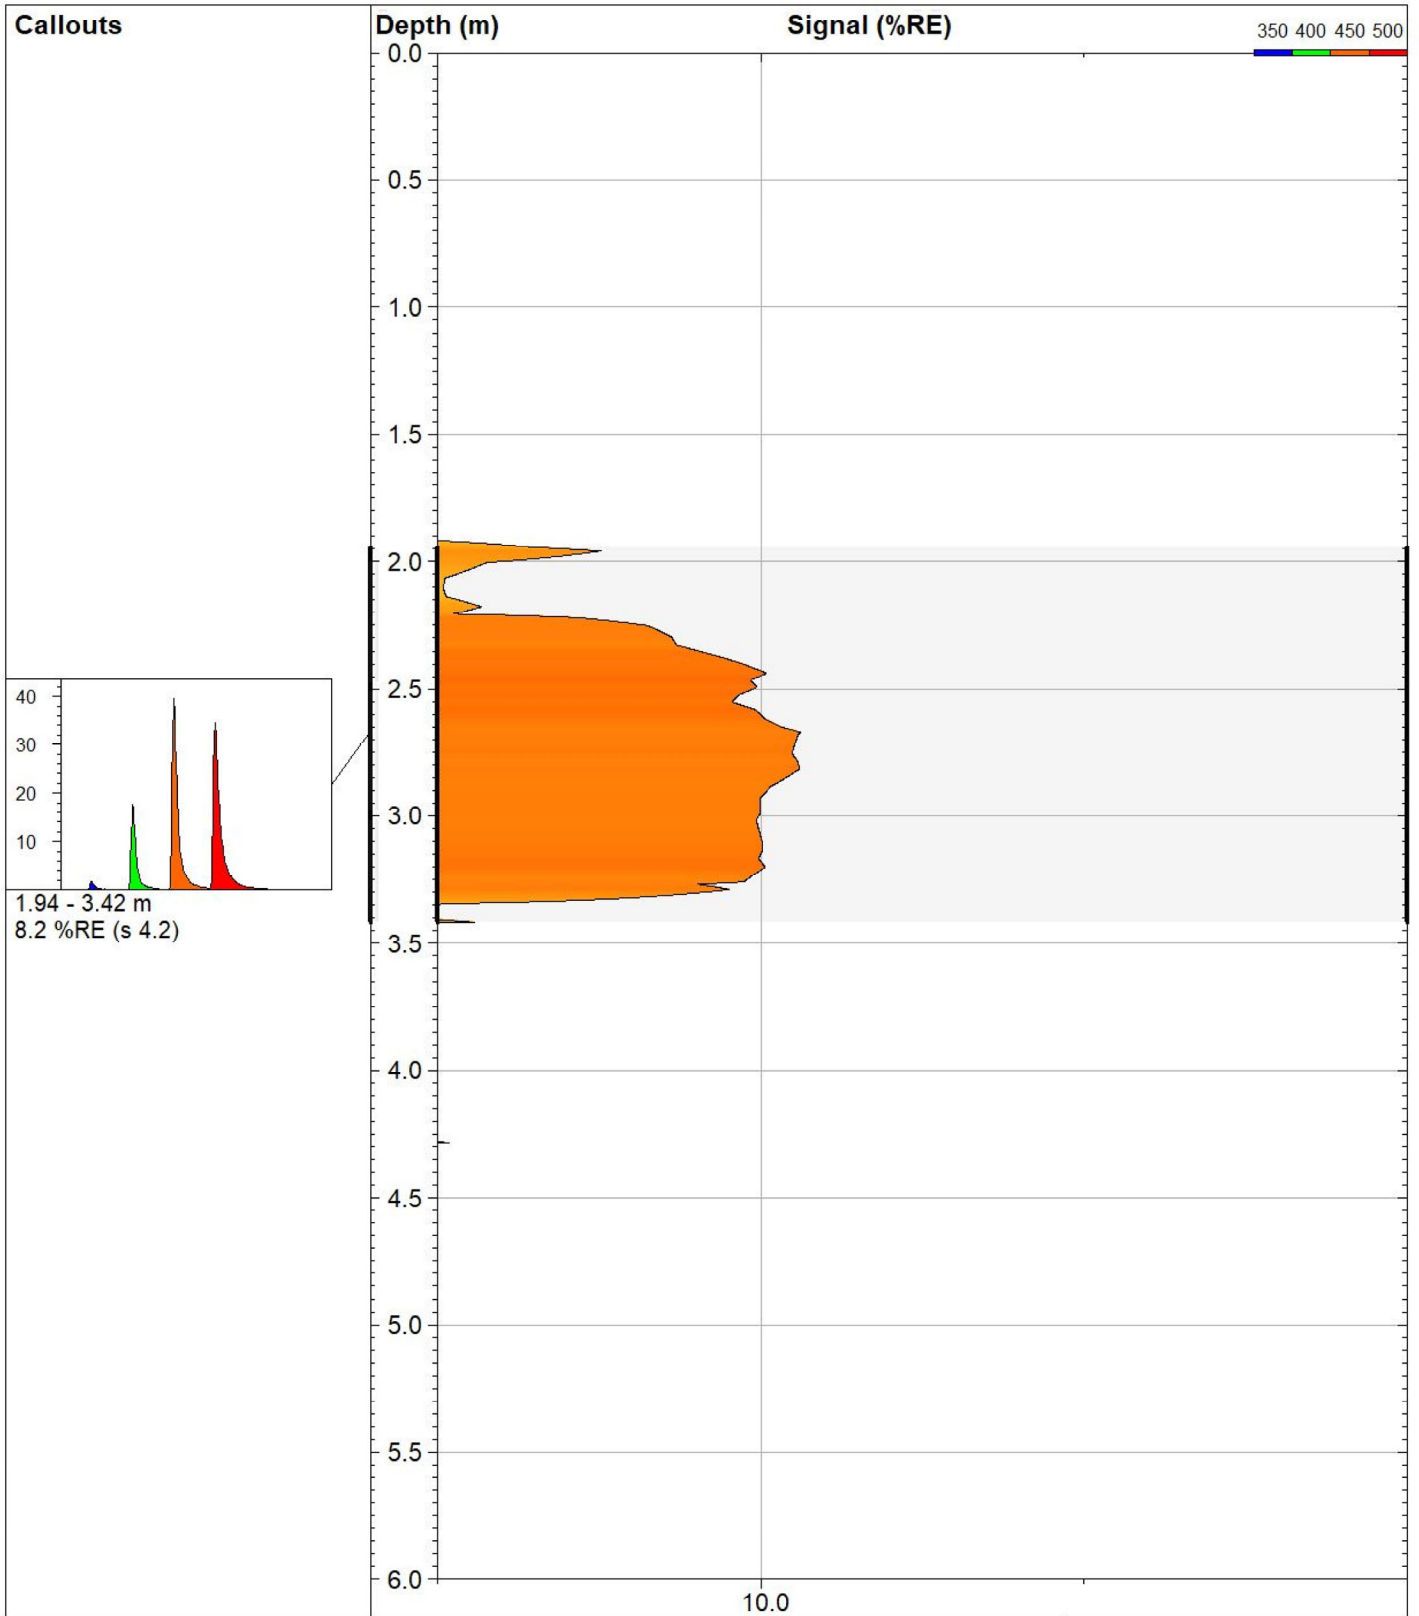
**LIF20134**

Final depth:  
**4.29 m**

Max signal:  
**14.2 %RE @ 2.67 m**

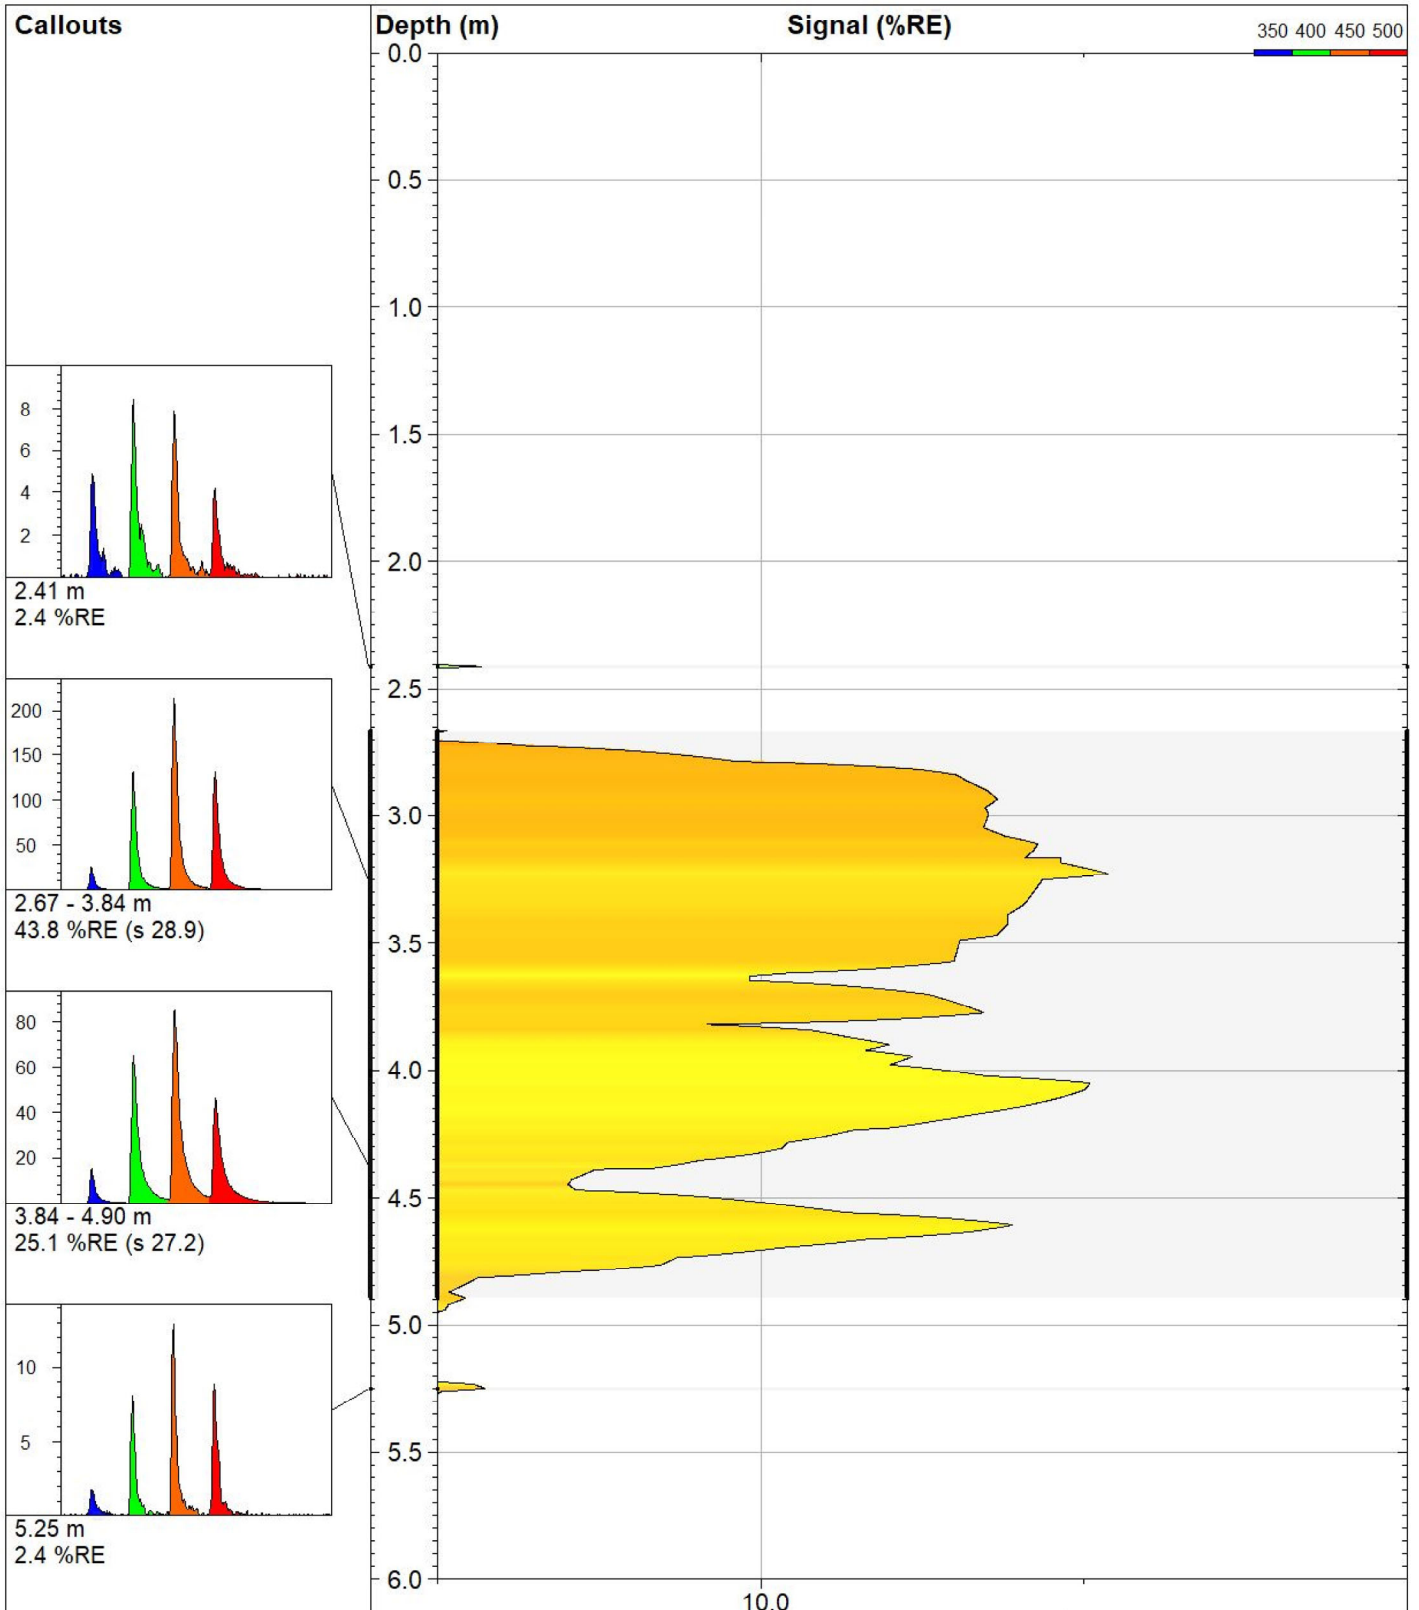
**LIF20135**

Final depth:  
**5.49 m**

Max signal:  
**120.2 %RE @ 3.23 m**

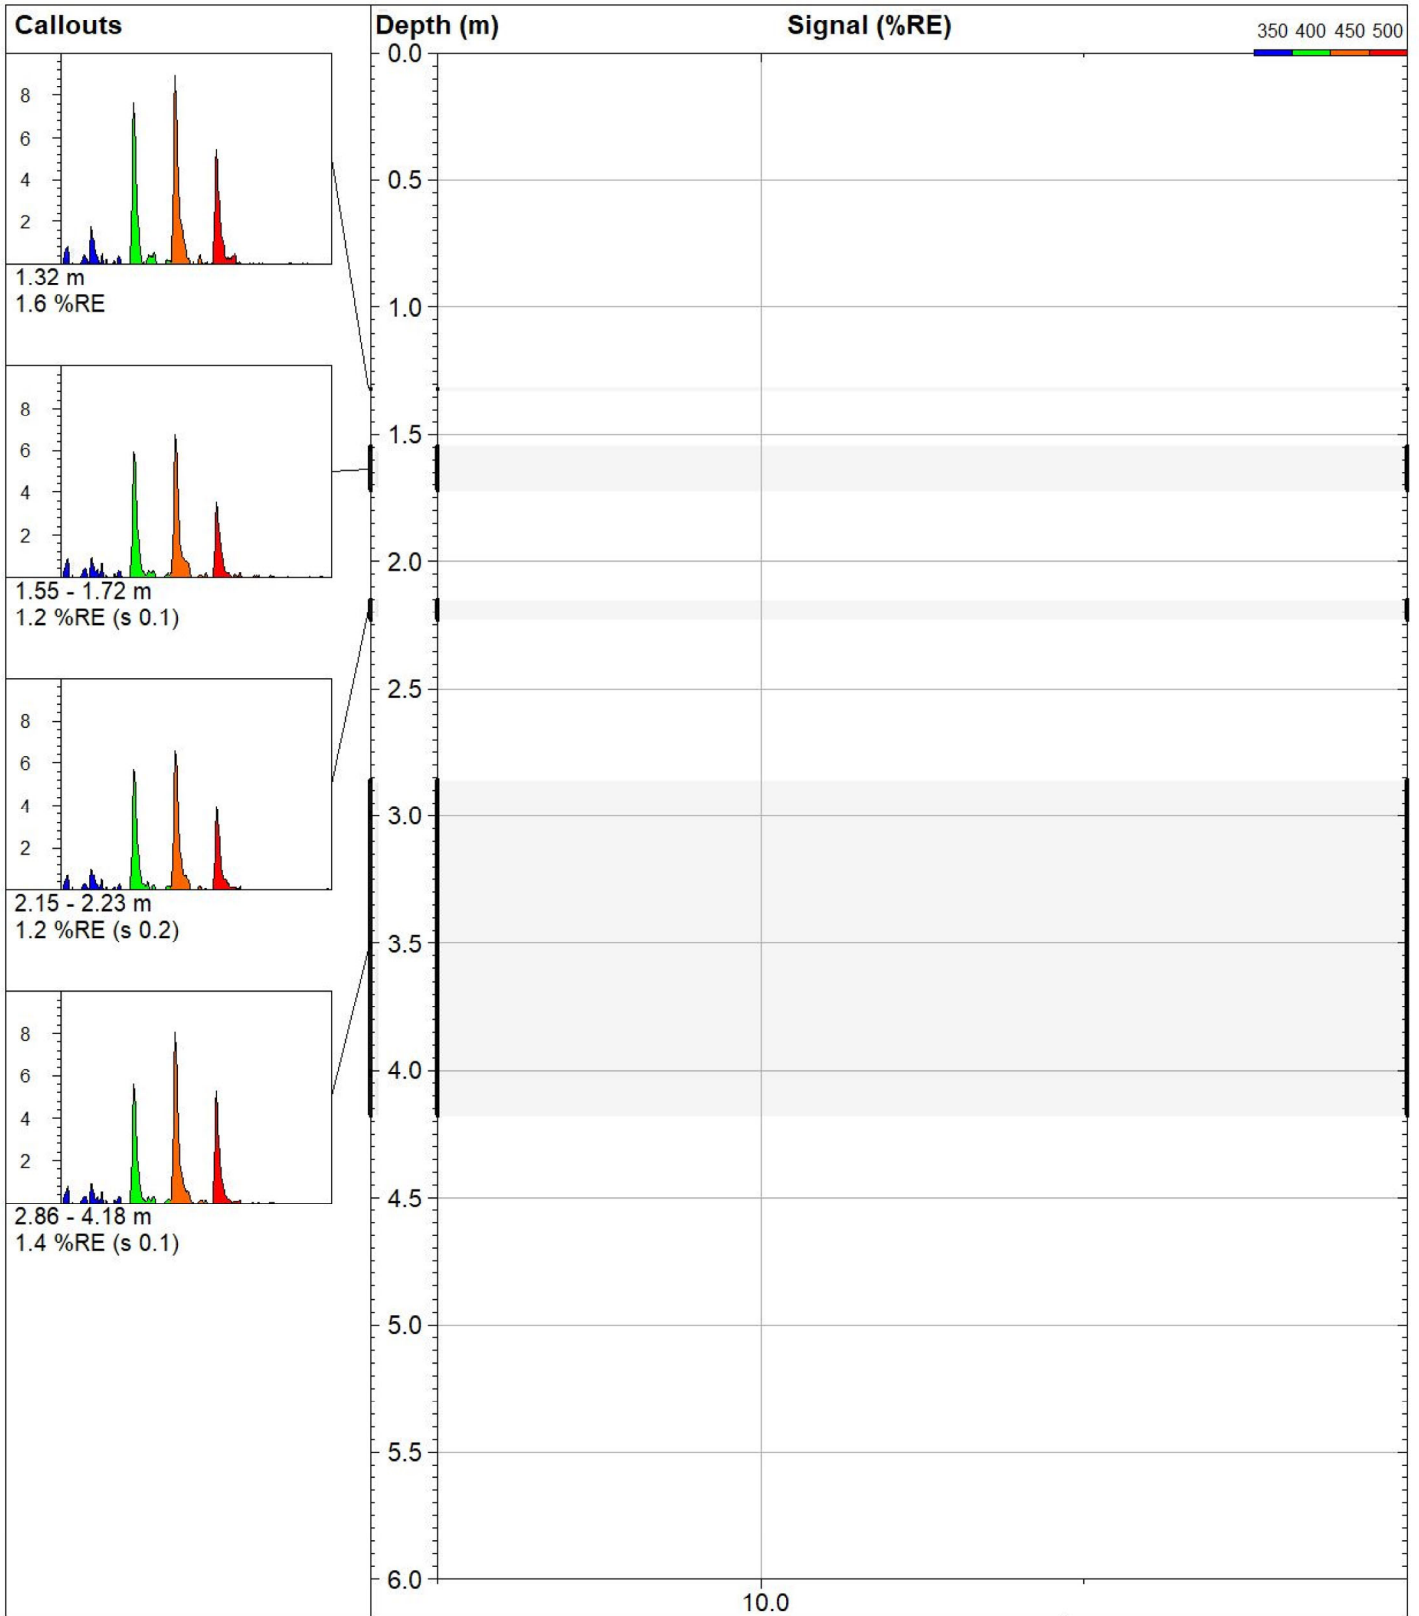
**LIF20138b**

Final depth:  
**4.28 m**

Max signal:  
**1.7 %RE @ 3.66 m**

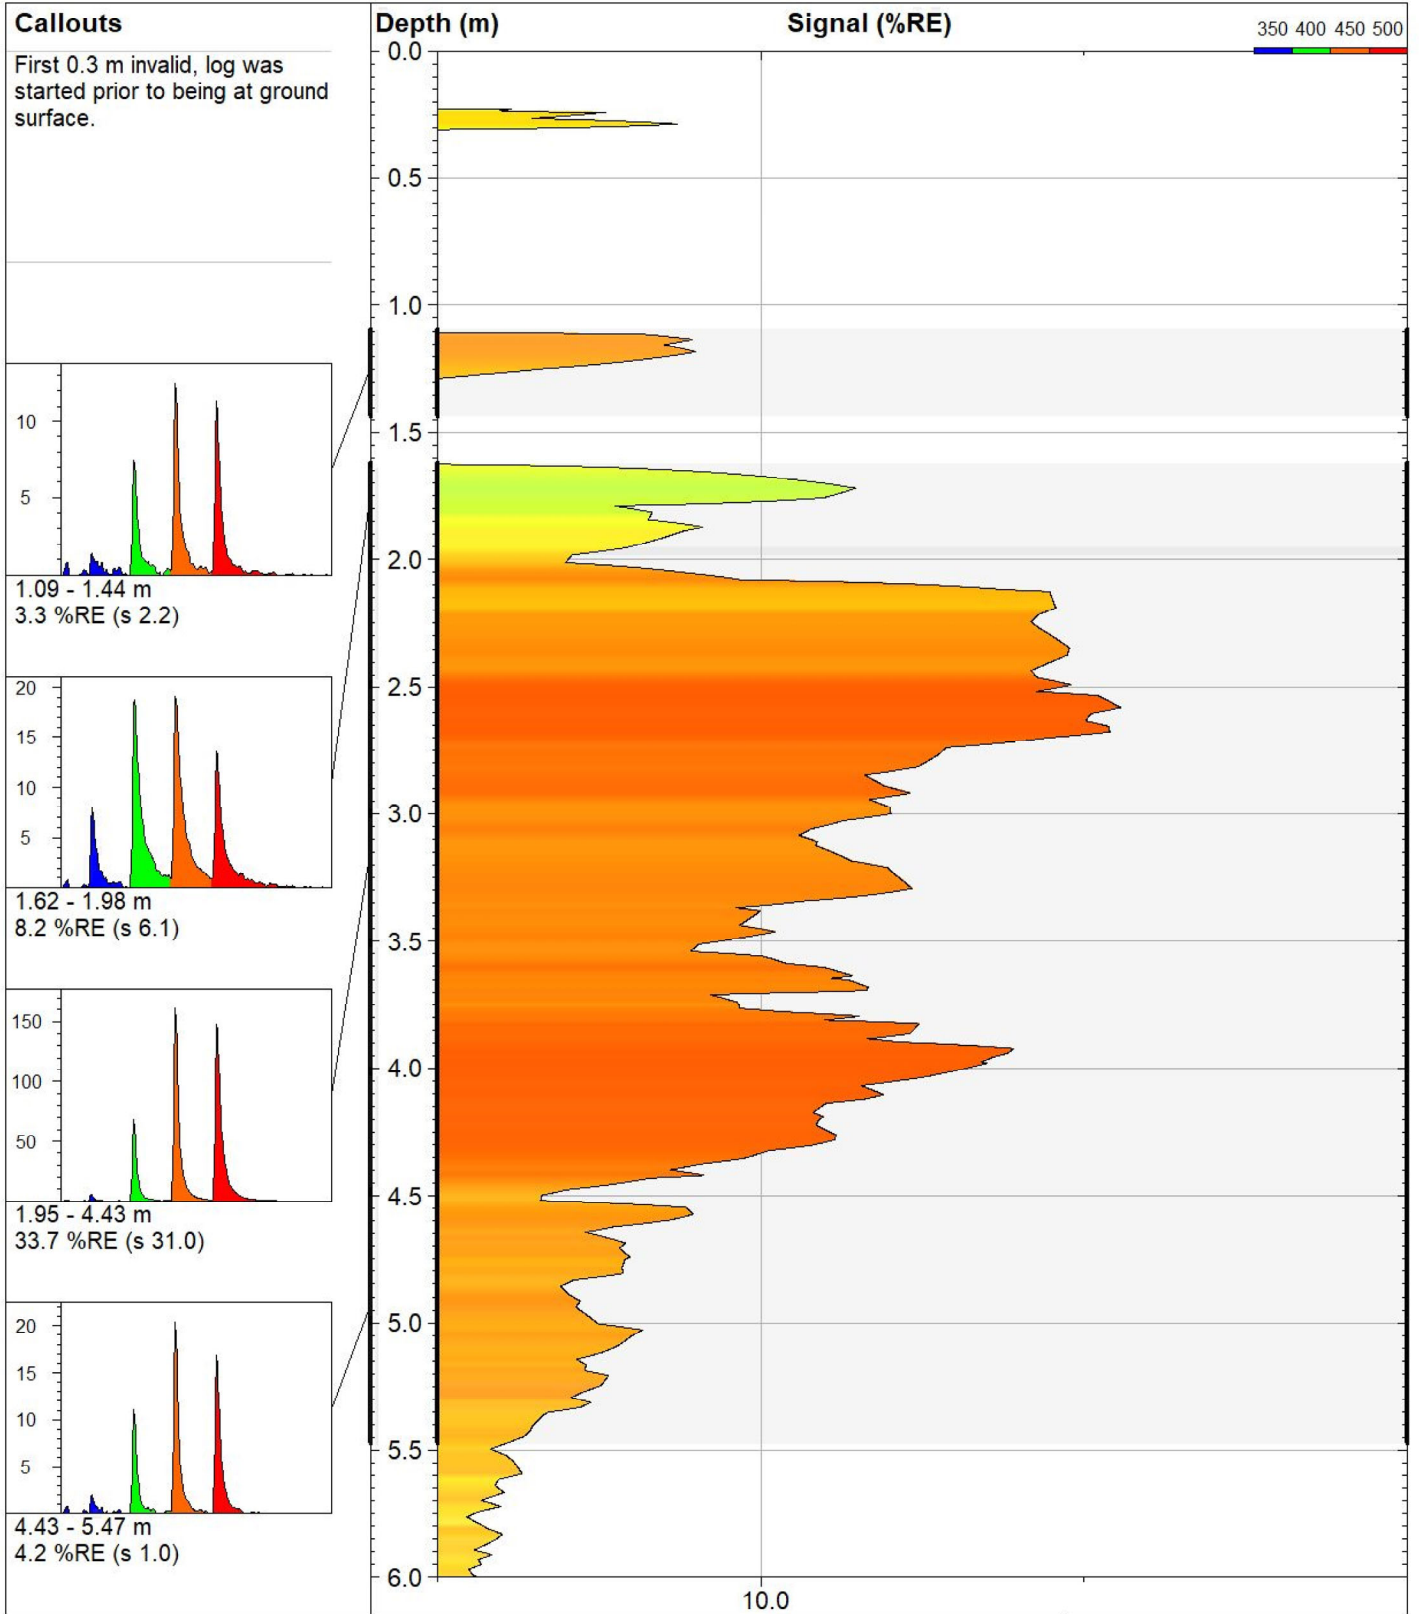
**LIF20139**

Final depth:  
**6.01 m**

Max signal:  
**130.5 %RE @ 2.58 m**

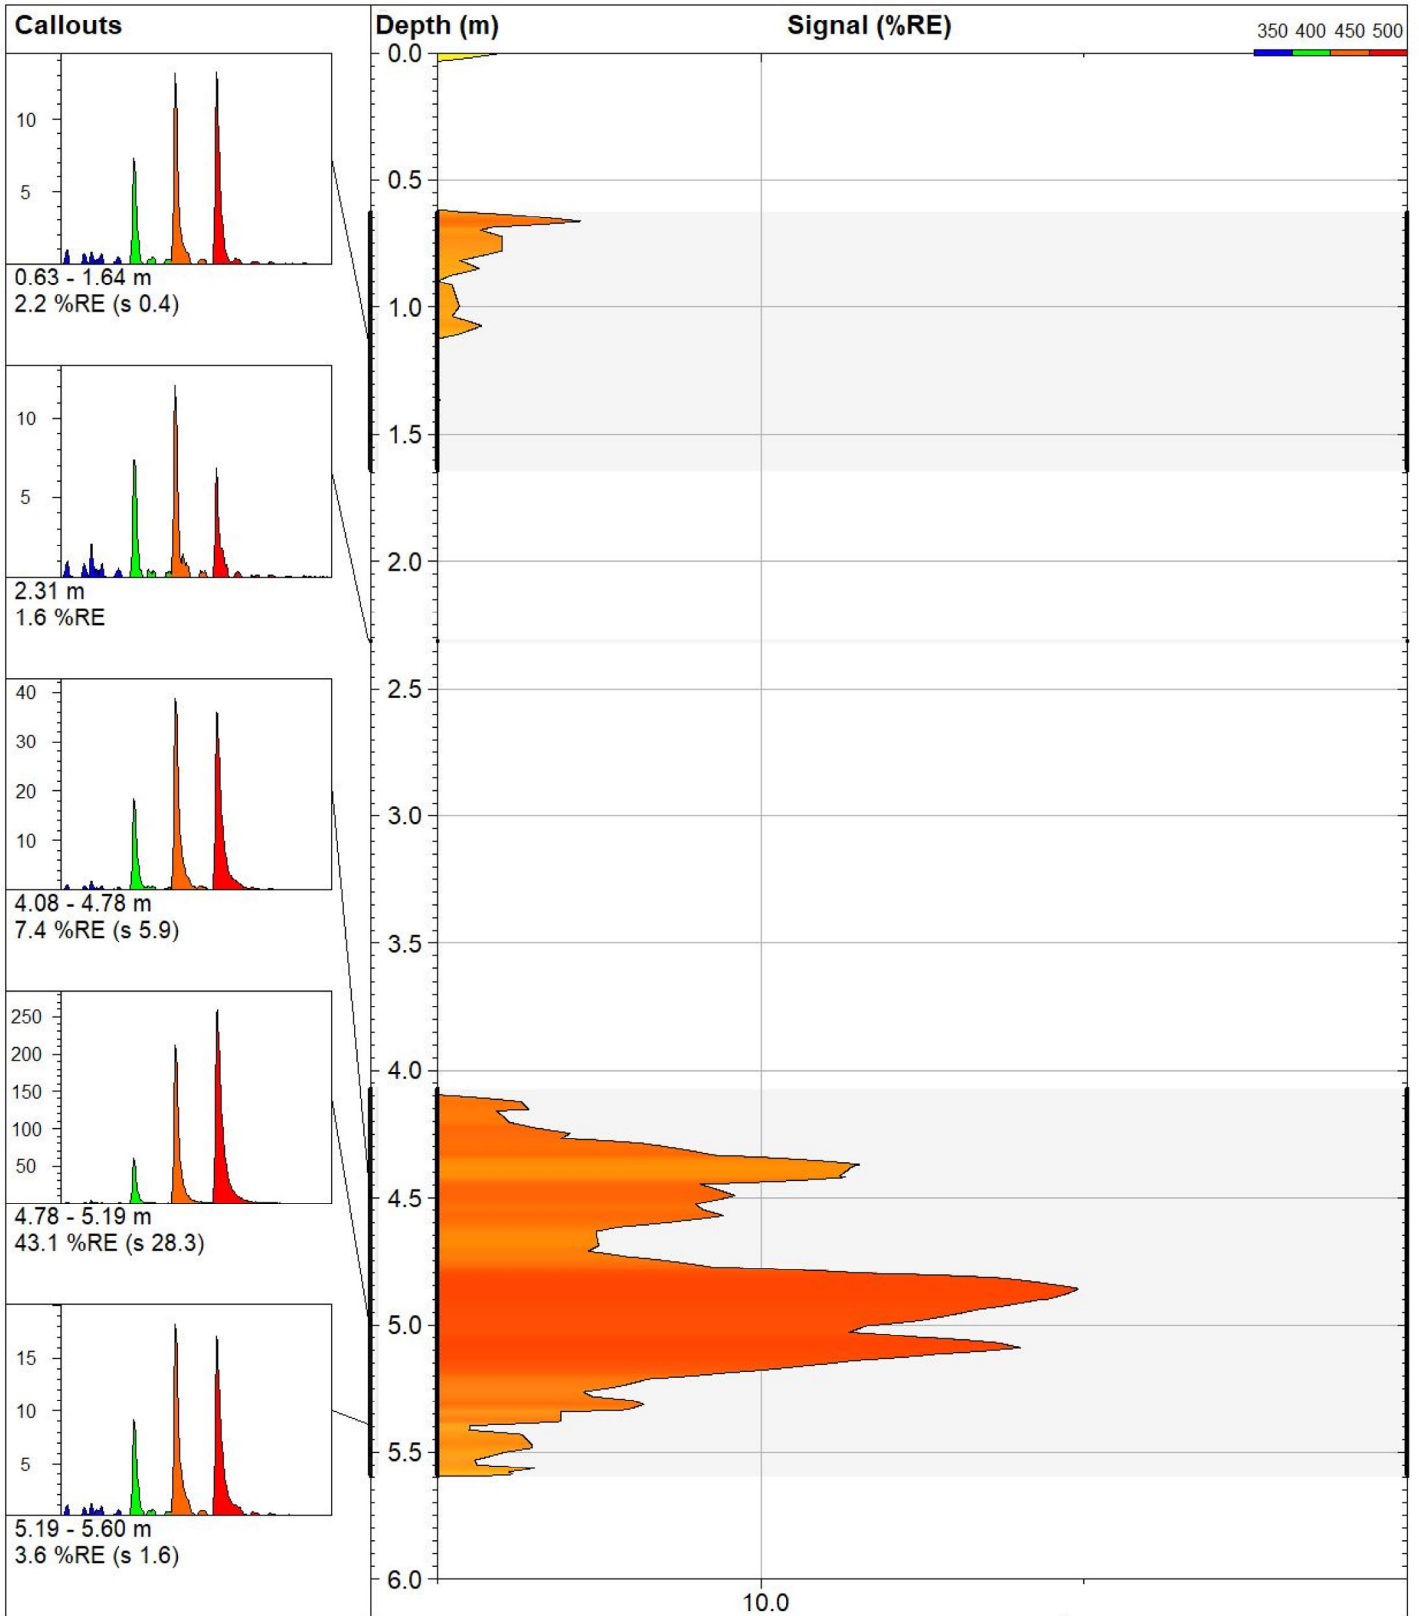
**LIF20141b**

Final depth:  
**5.60 m**

Max signal:  
**97.3 %RE @ 4.86 m**
