**VERTEX**  
Environmental Inc.

**LIF20129**

Site:  
**Canatara Park**

Client / Job:  
**RWDI / VE848**

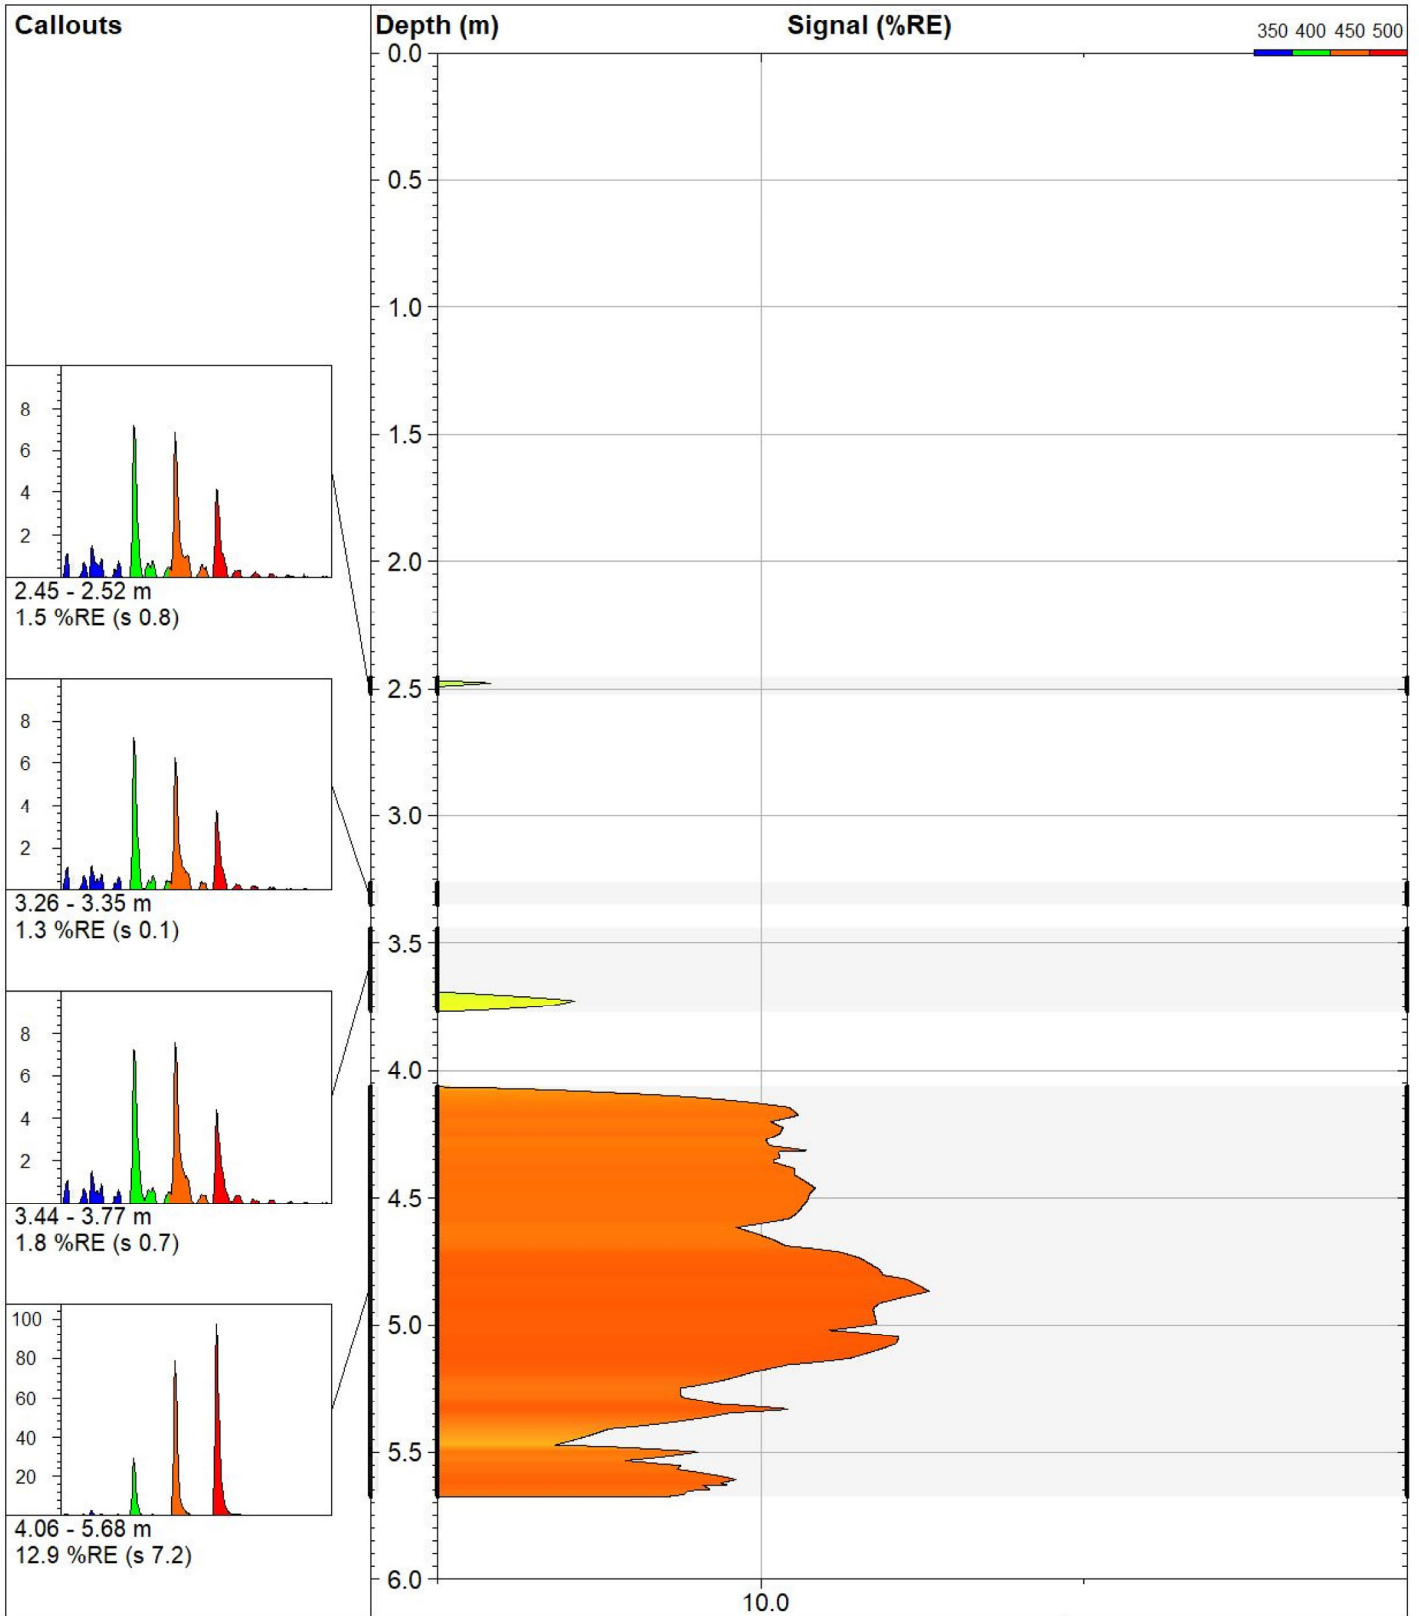
**LIF20142**

Final depth:  
**5.68 m**

Max signal:  
**34.1 %RE @ 4.87 m**

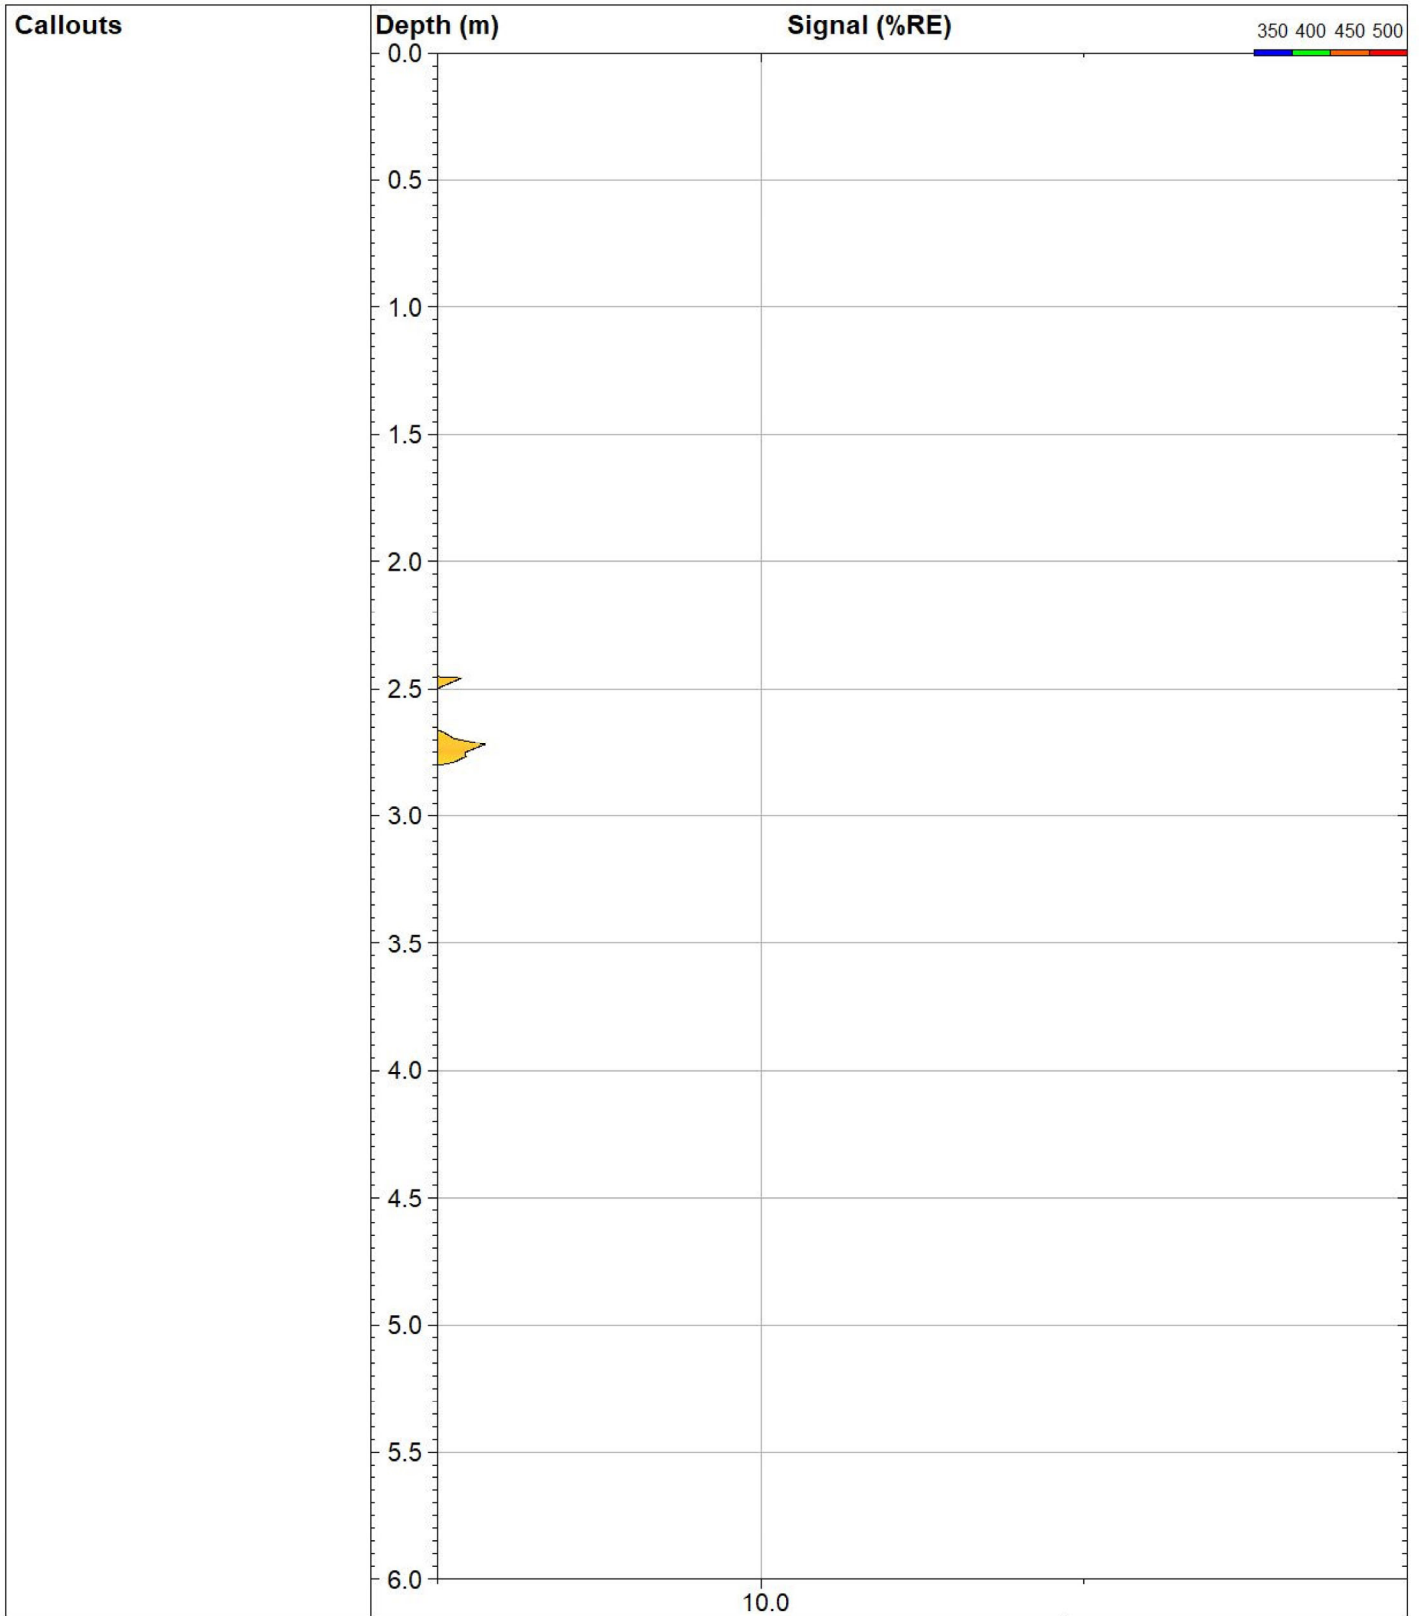
**LIF20143**

*Final depth:*  
**3.07 m**

*Max signal:*  
**2.4 %RE @ 2.72 m**

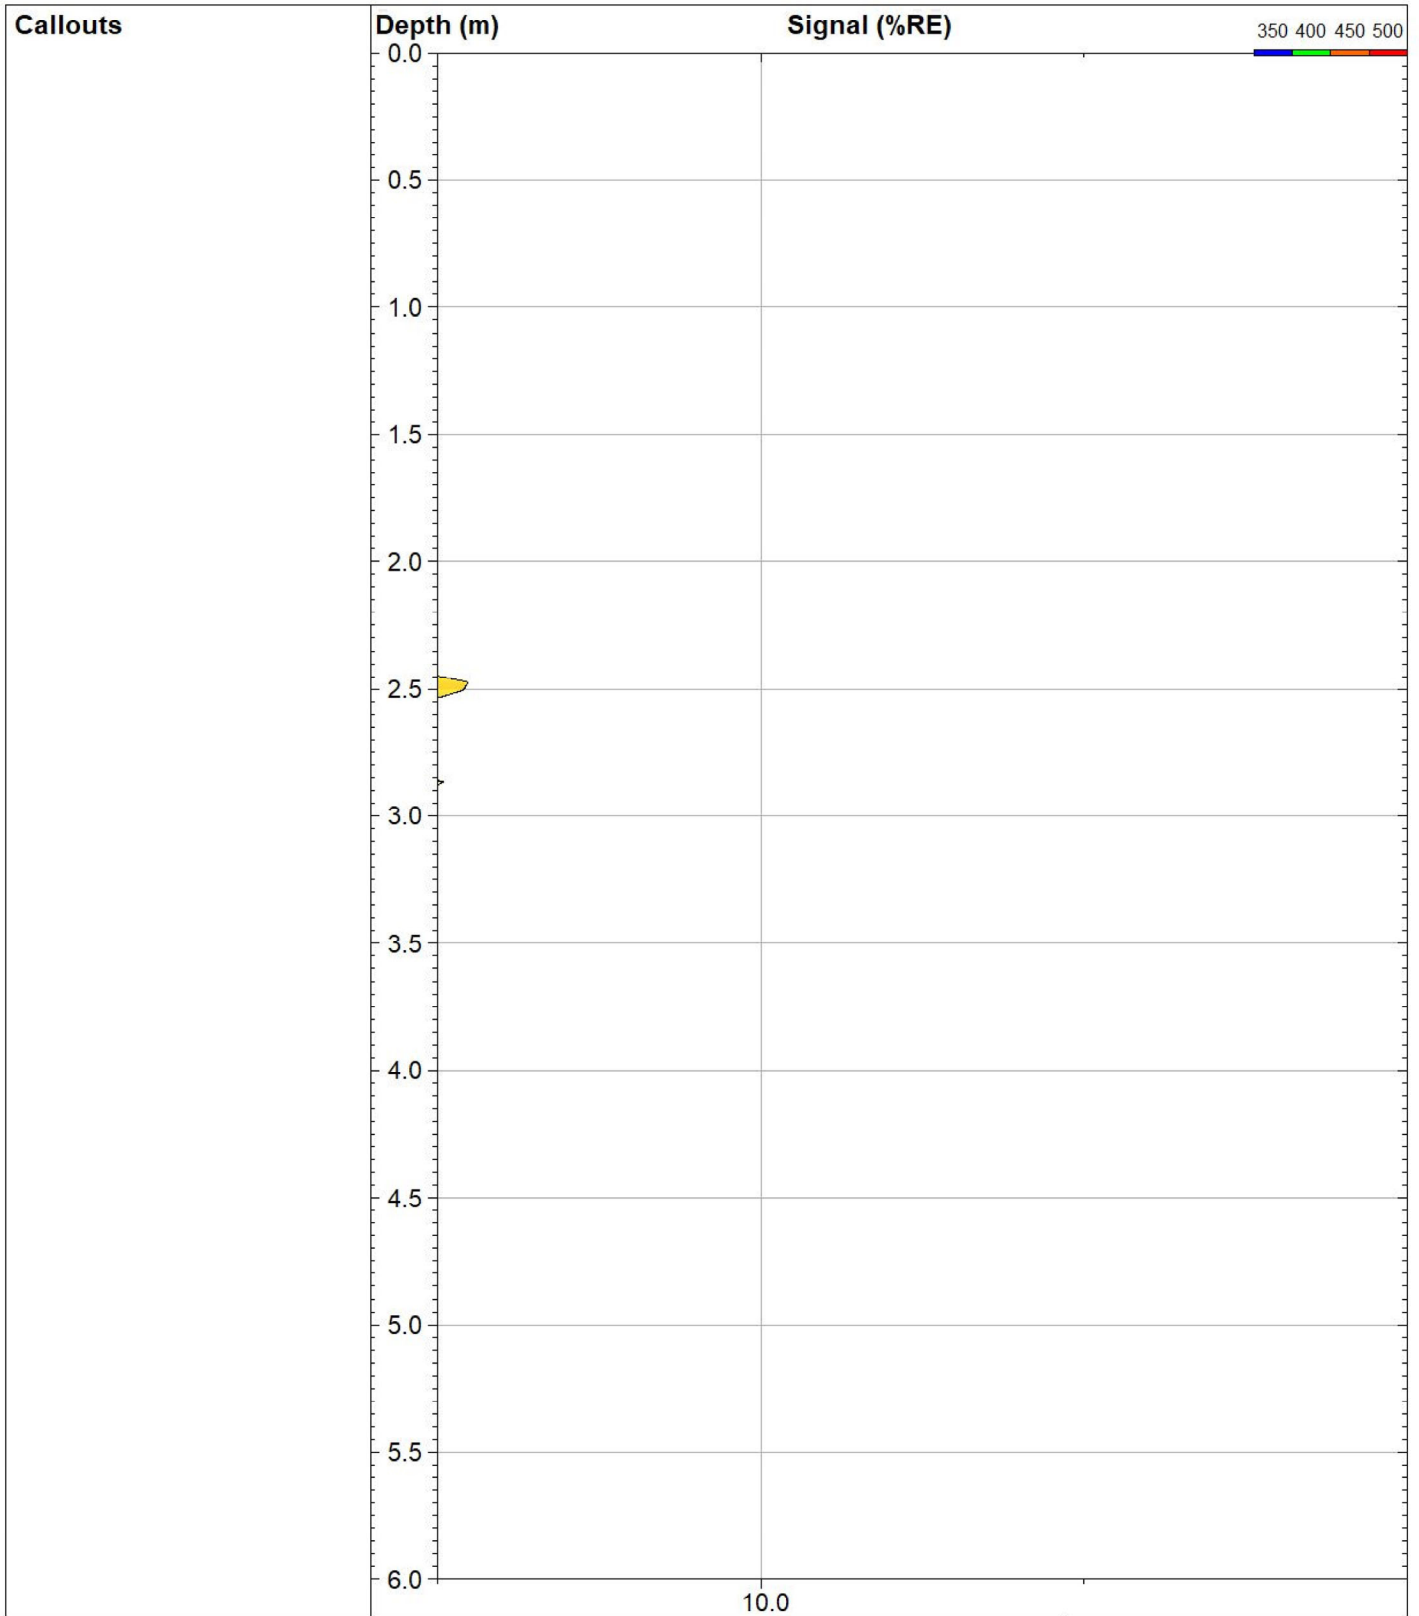
**LIF20145**

*Final depth:*  
**3.07 m**

*Max signal:*  
**2.2 %RE @ 2.47 m**

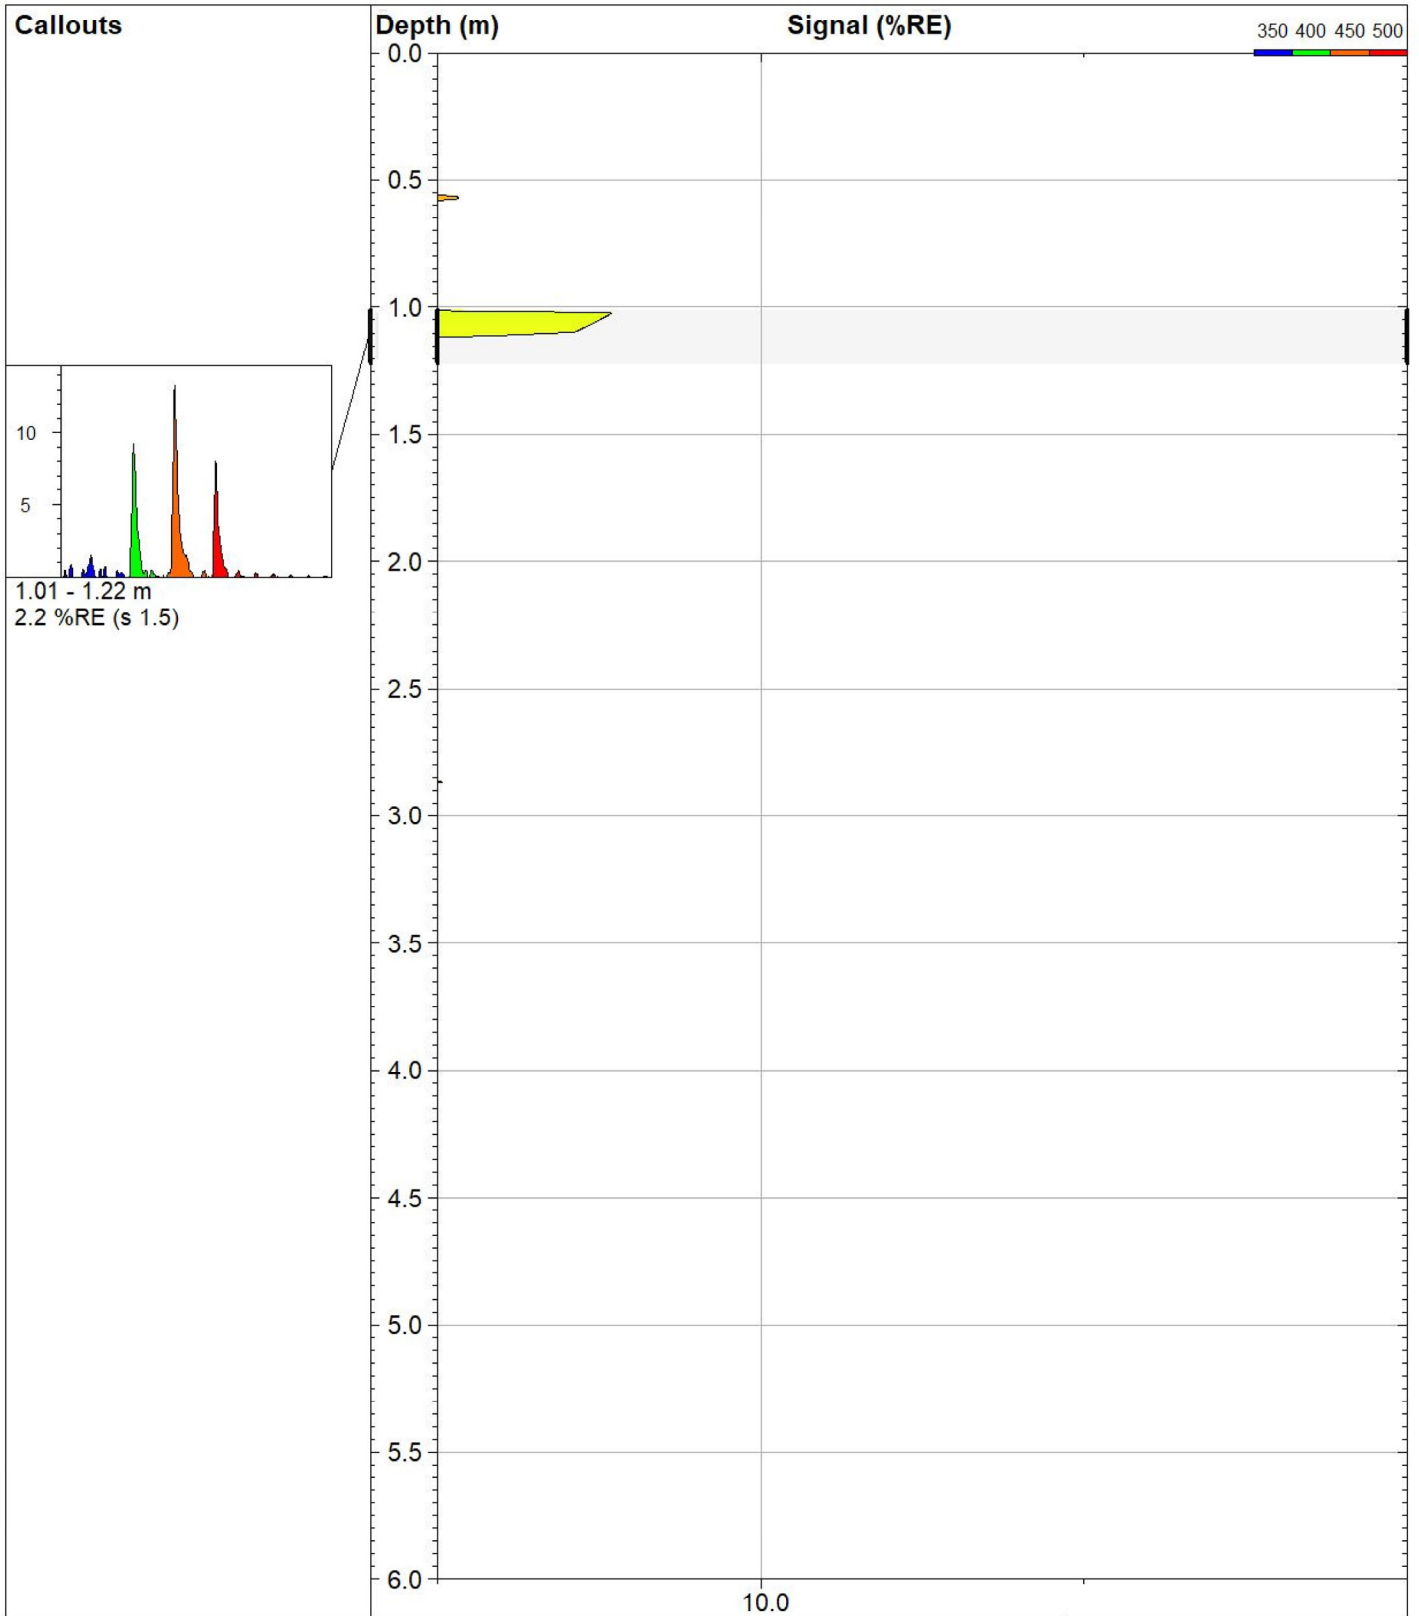
**LIF20146**

*Final depth:*  
**3.15 m**

*Max signal:*  
**4.5 %RE @ 1.02 m**

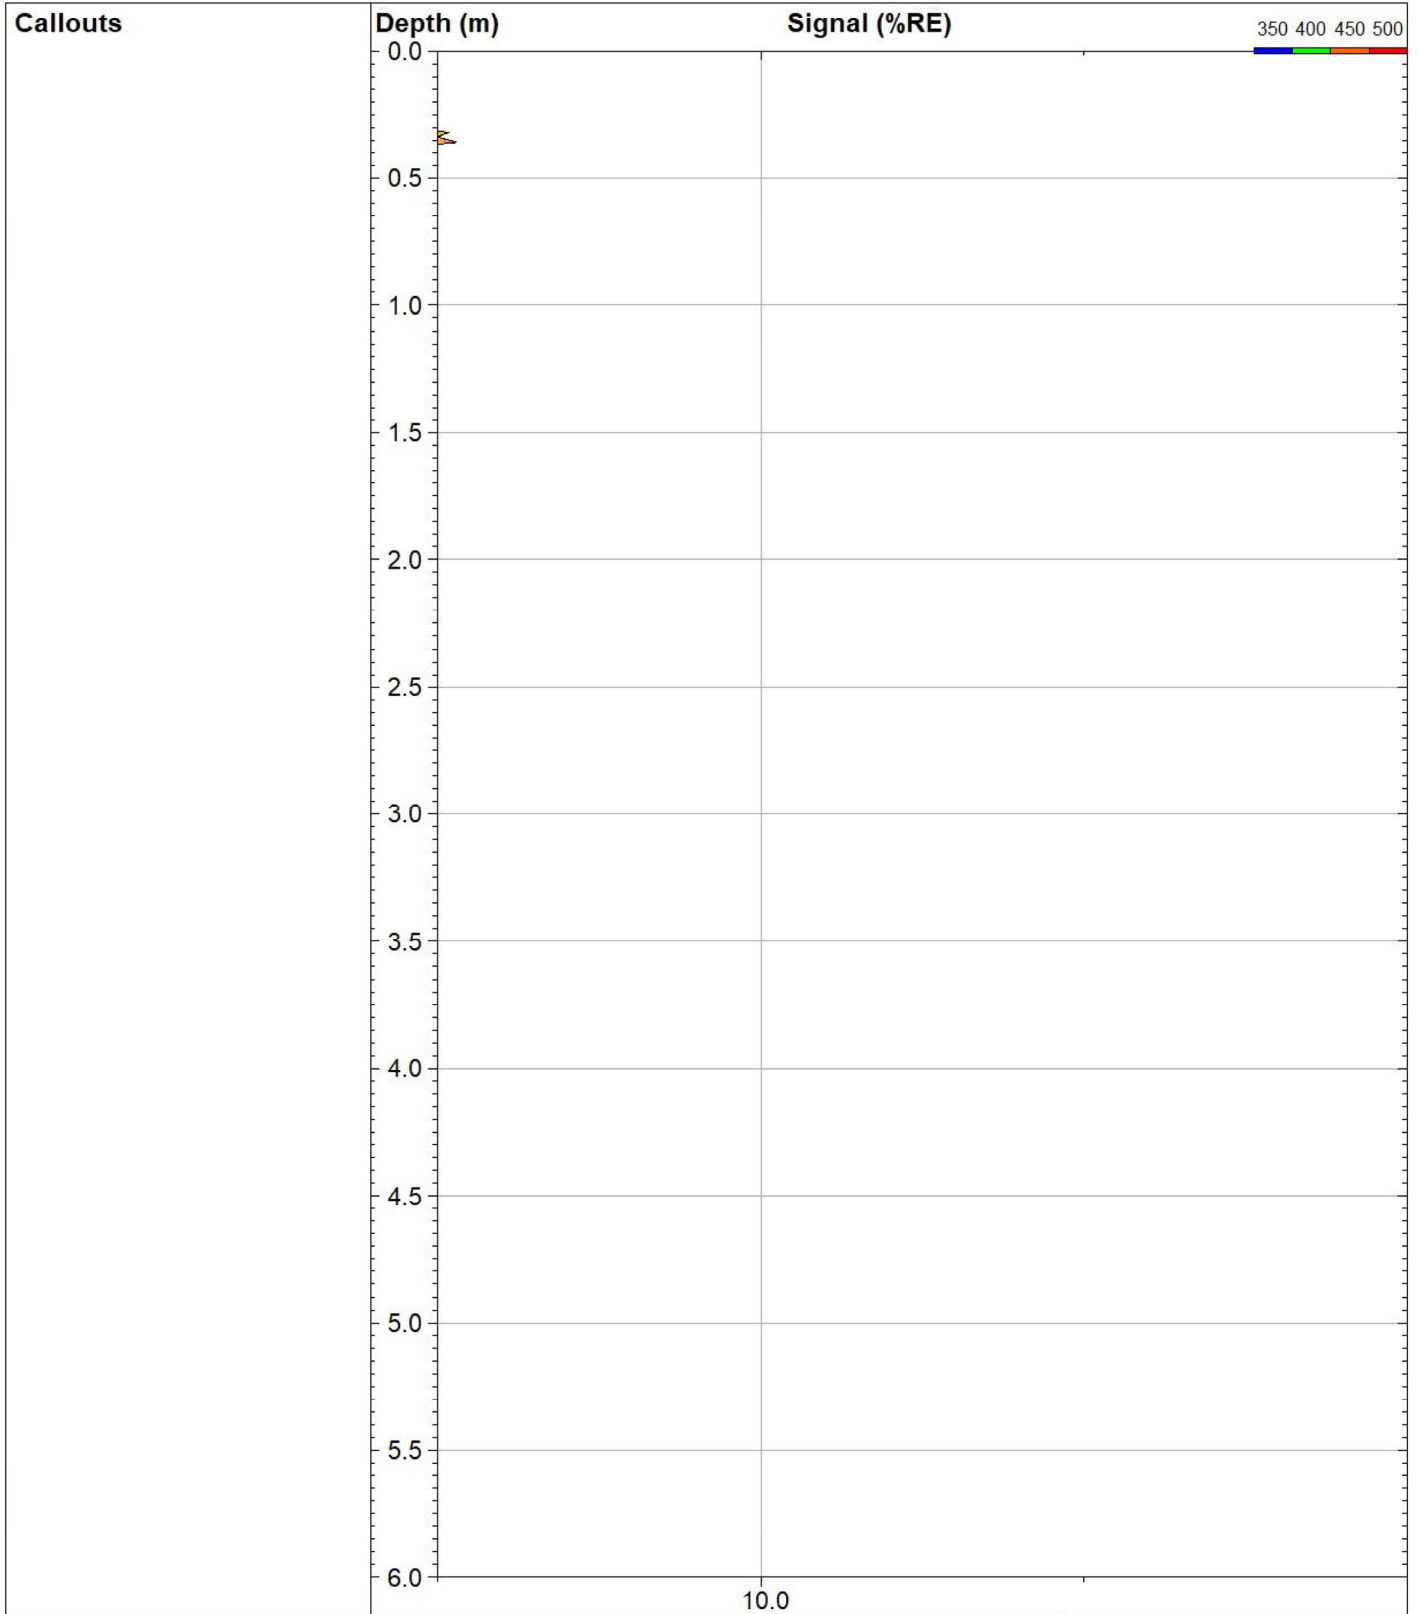
**LIF20147**

*Final depth:*  
**3.15 m**

*Max signal:*  
**2.1 %RE @ 0.36 m**

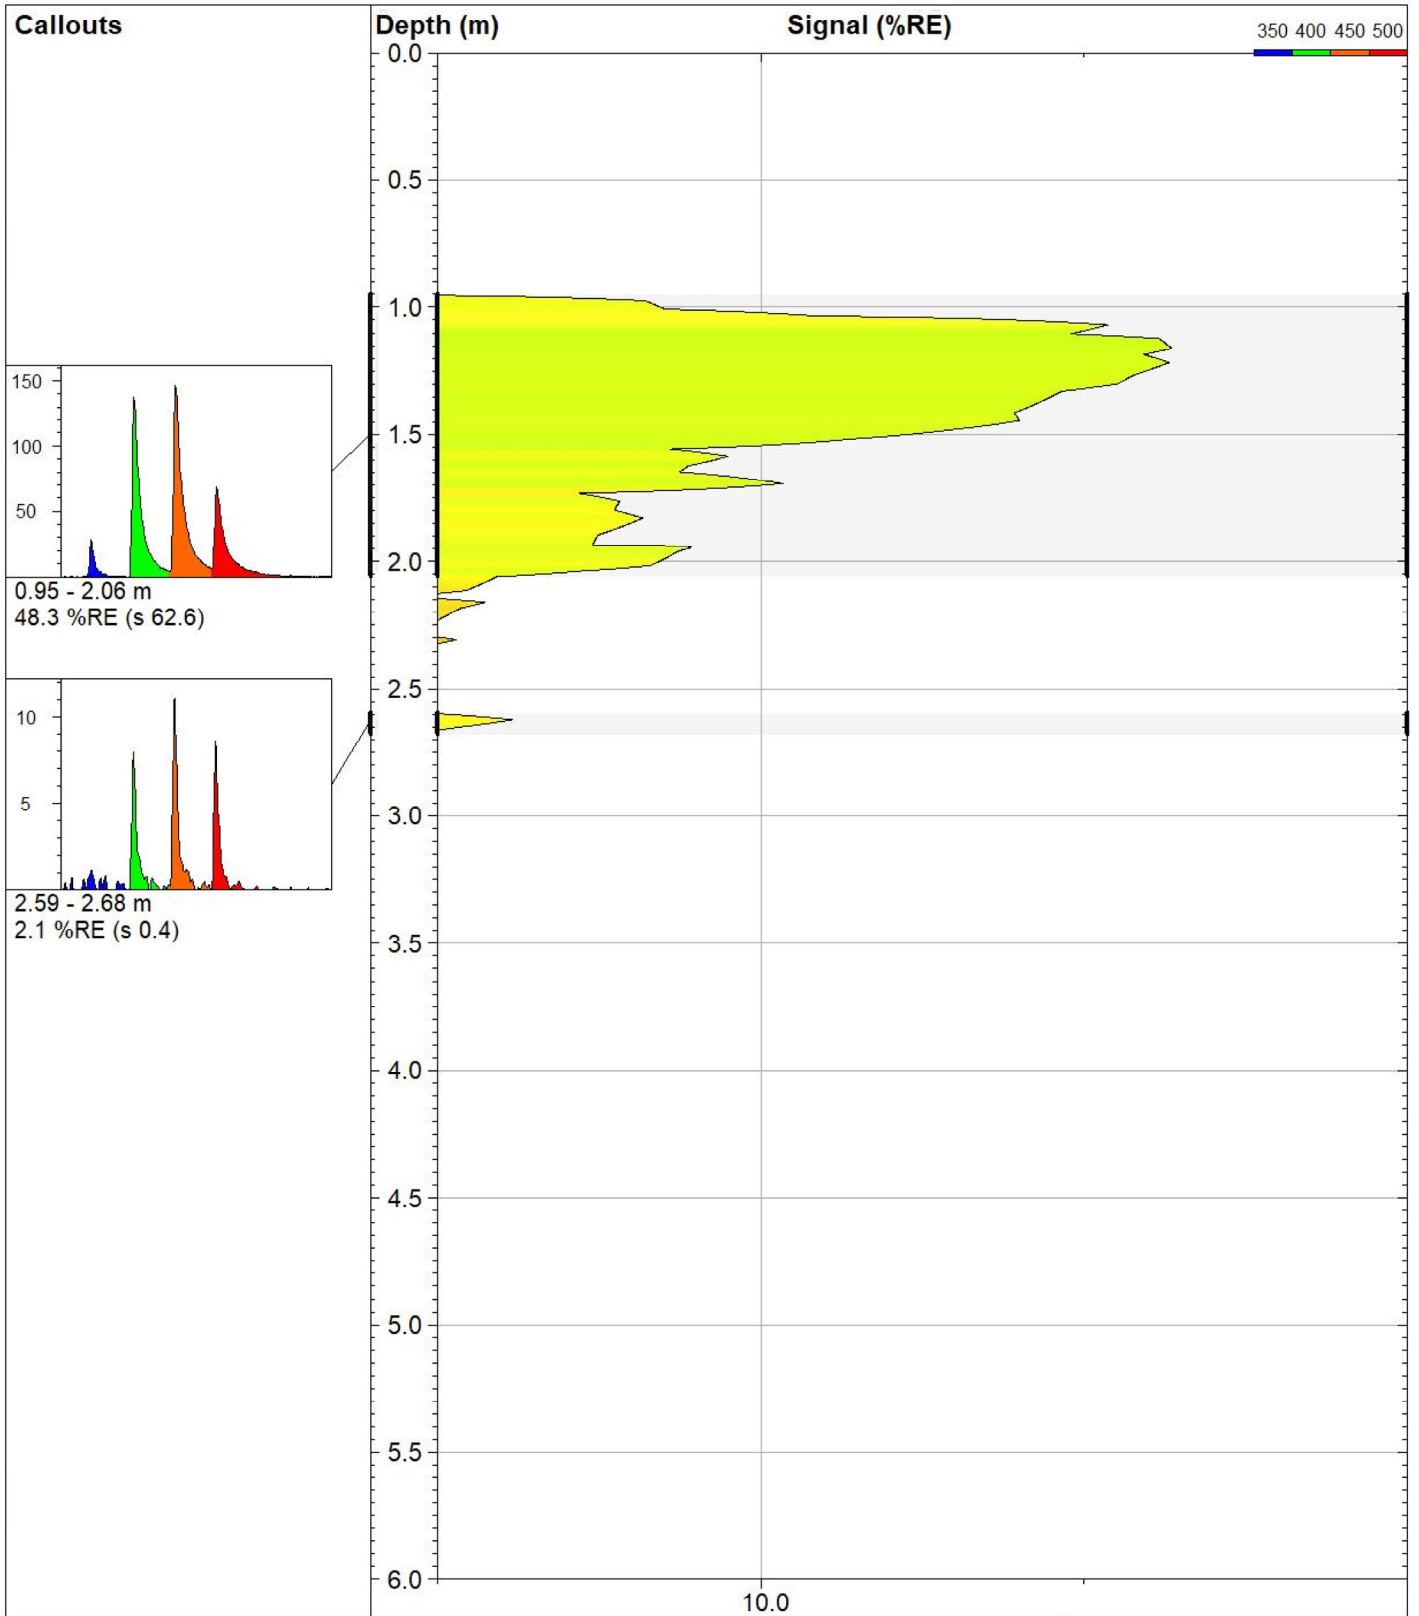
**LIF20149**

**Final depth:**  
3.06 m

**Max signal:**  
187.8 %RE @ 1.16 m

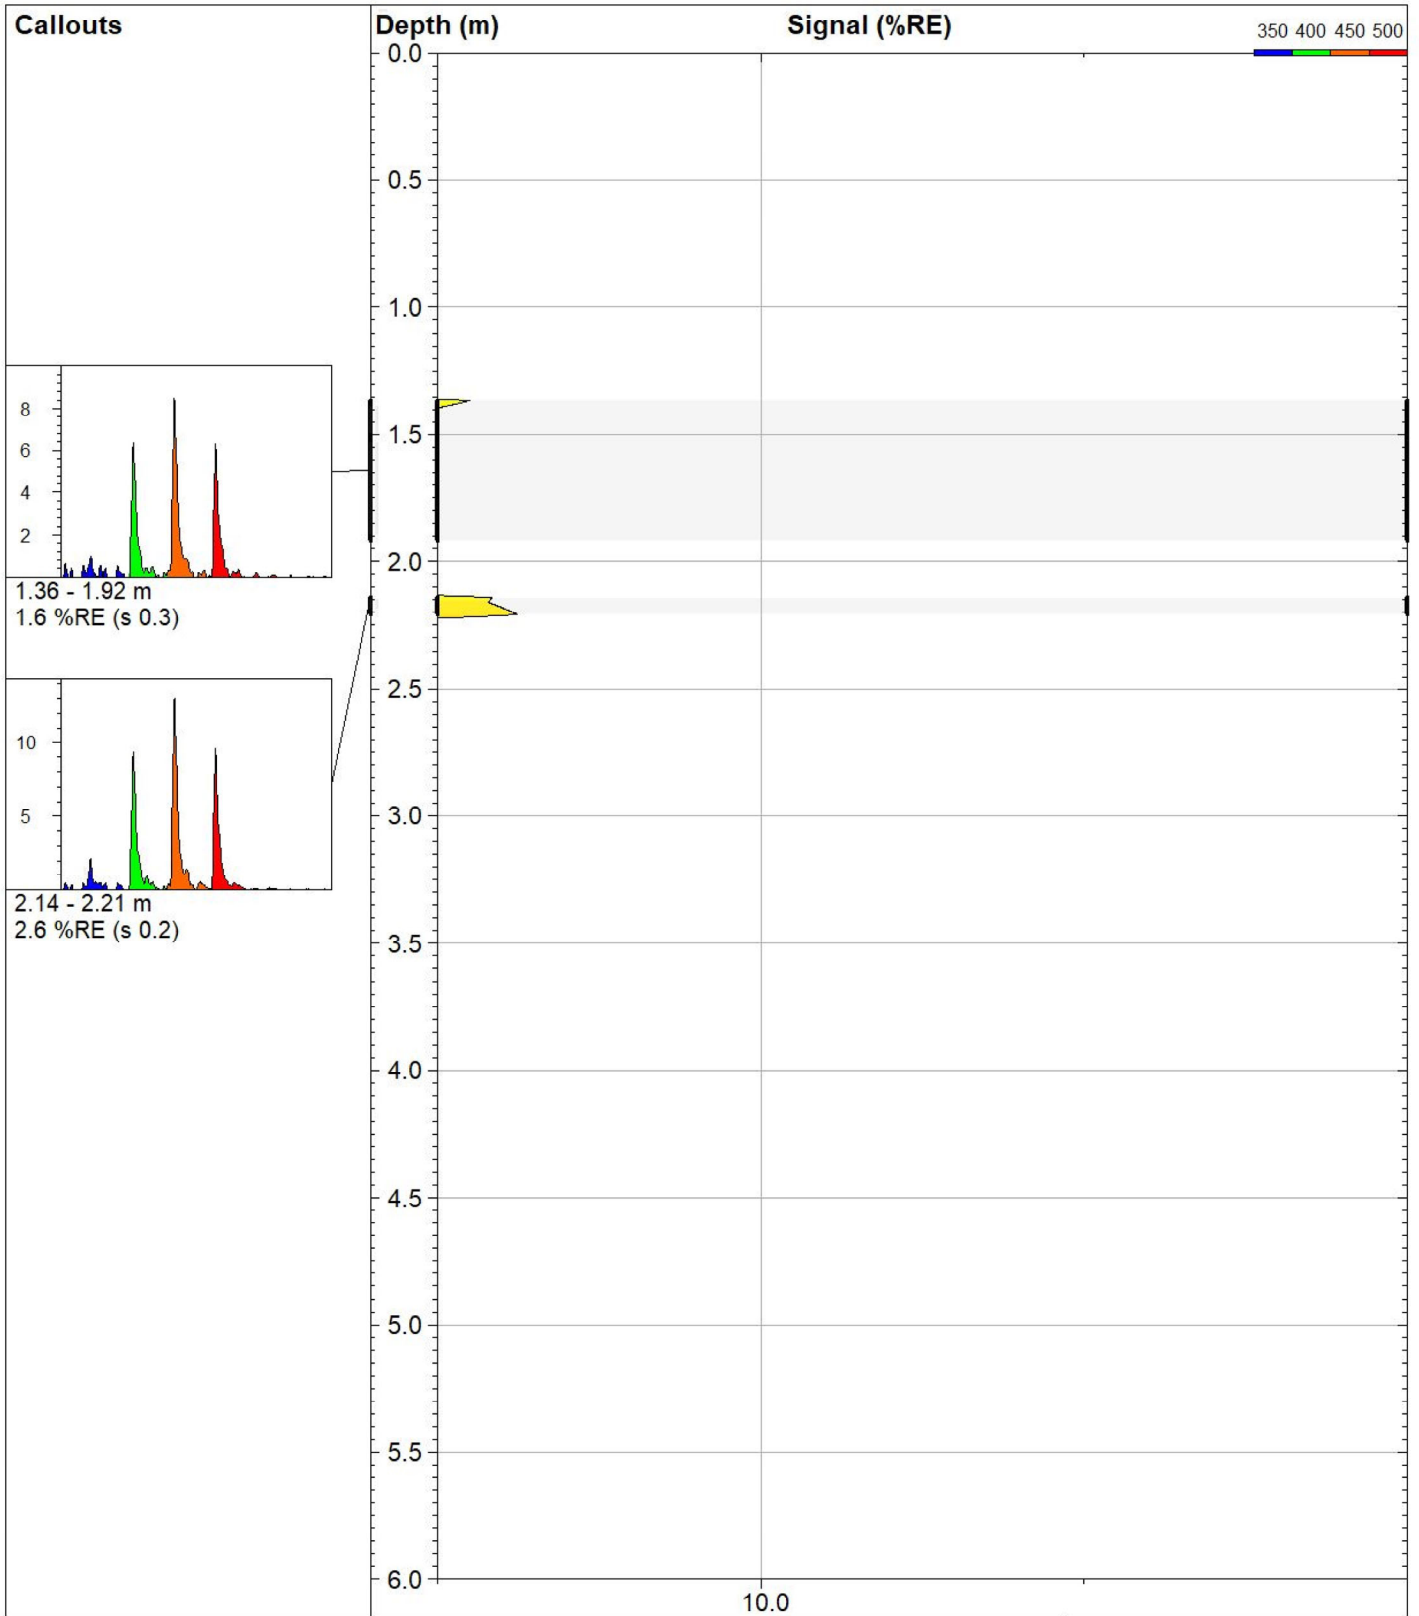
**LIF20150**

*Final depth:*  
**3.06 m**

*Max signal:*  
**2.8 %RE @ 2.21 m**

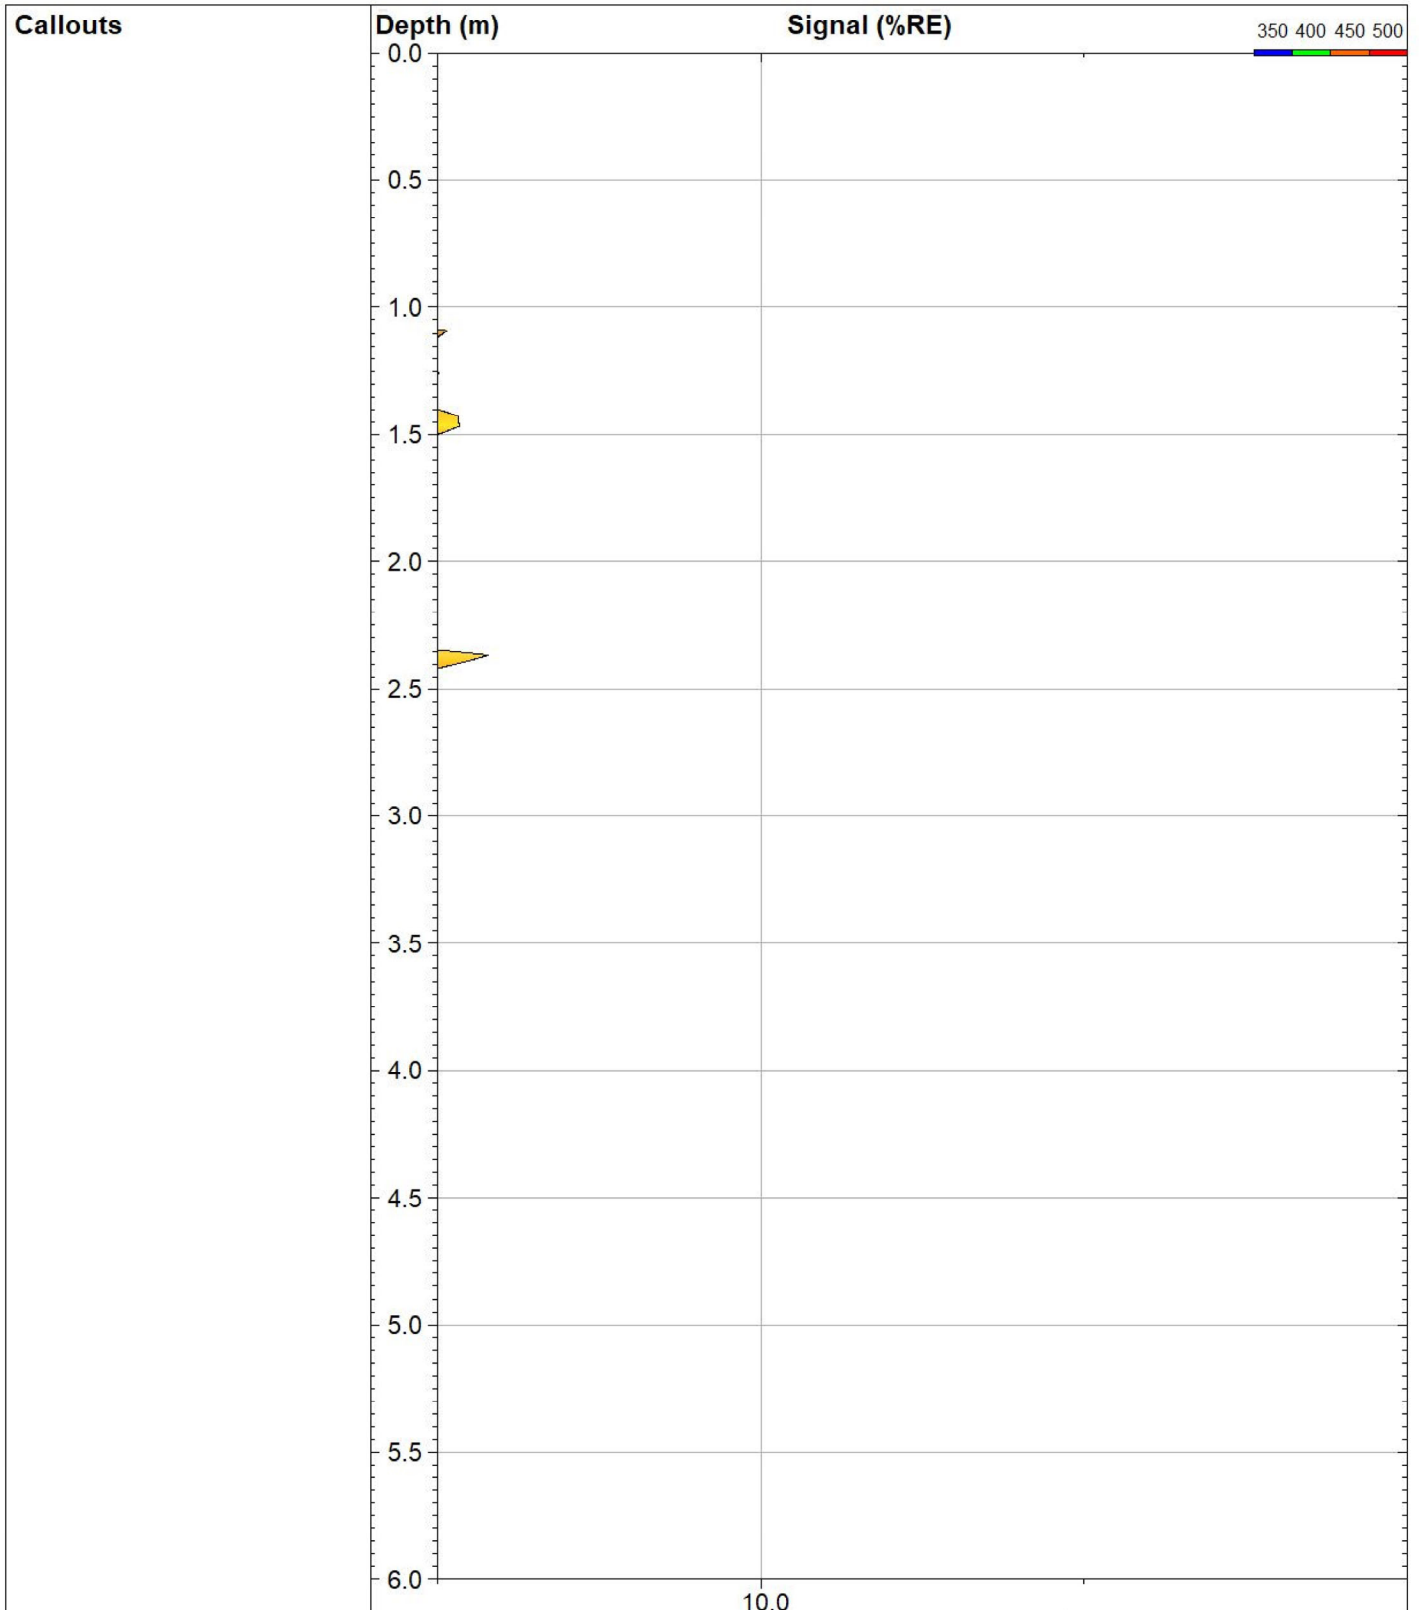
**LIF20152**

Final depth:  
**3.06 m**

Max signal:  
**2.4 %RE @ 2.37 m**

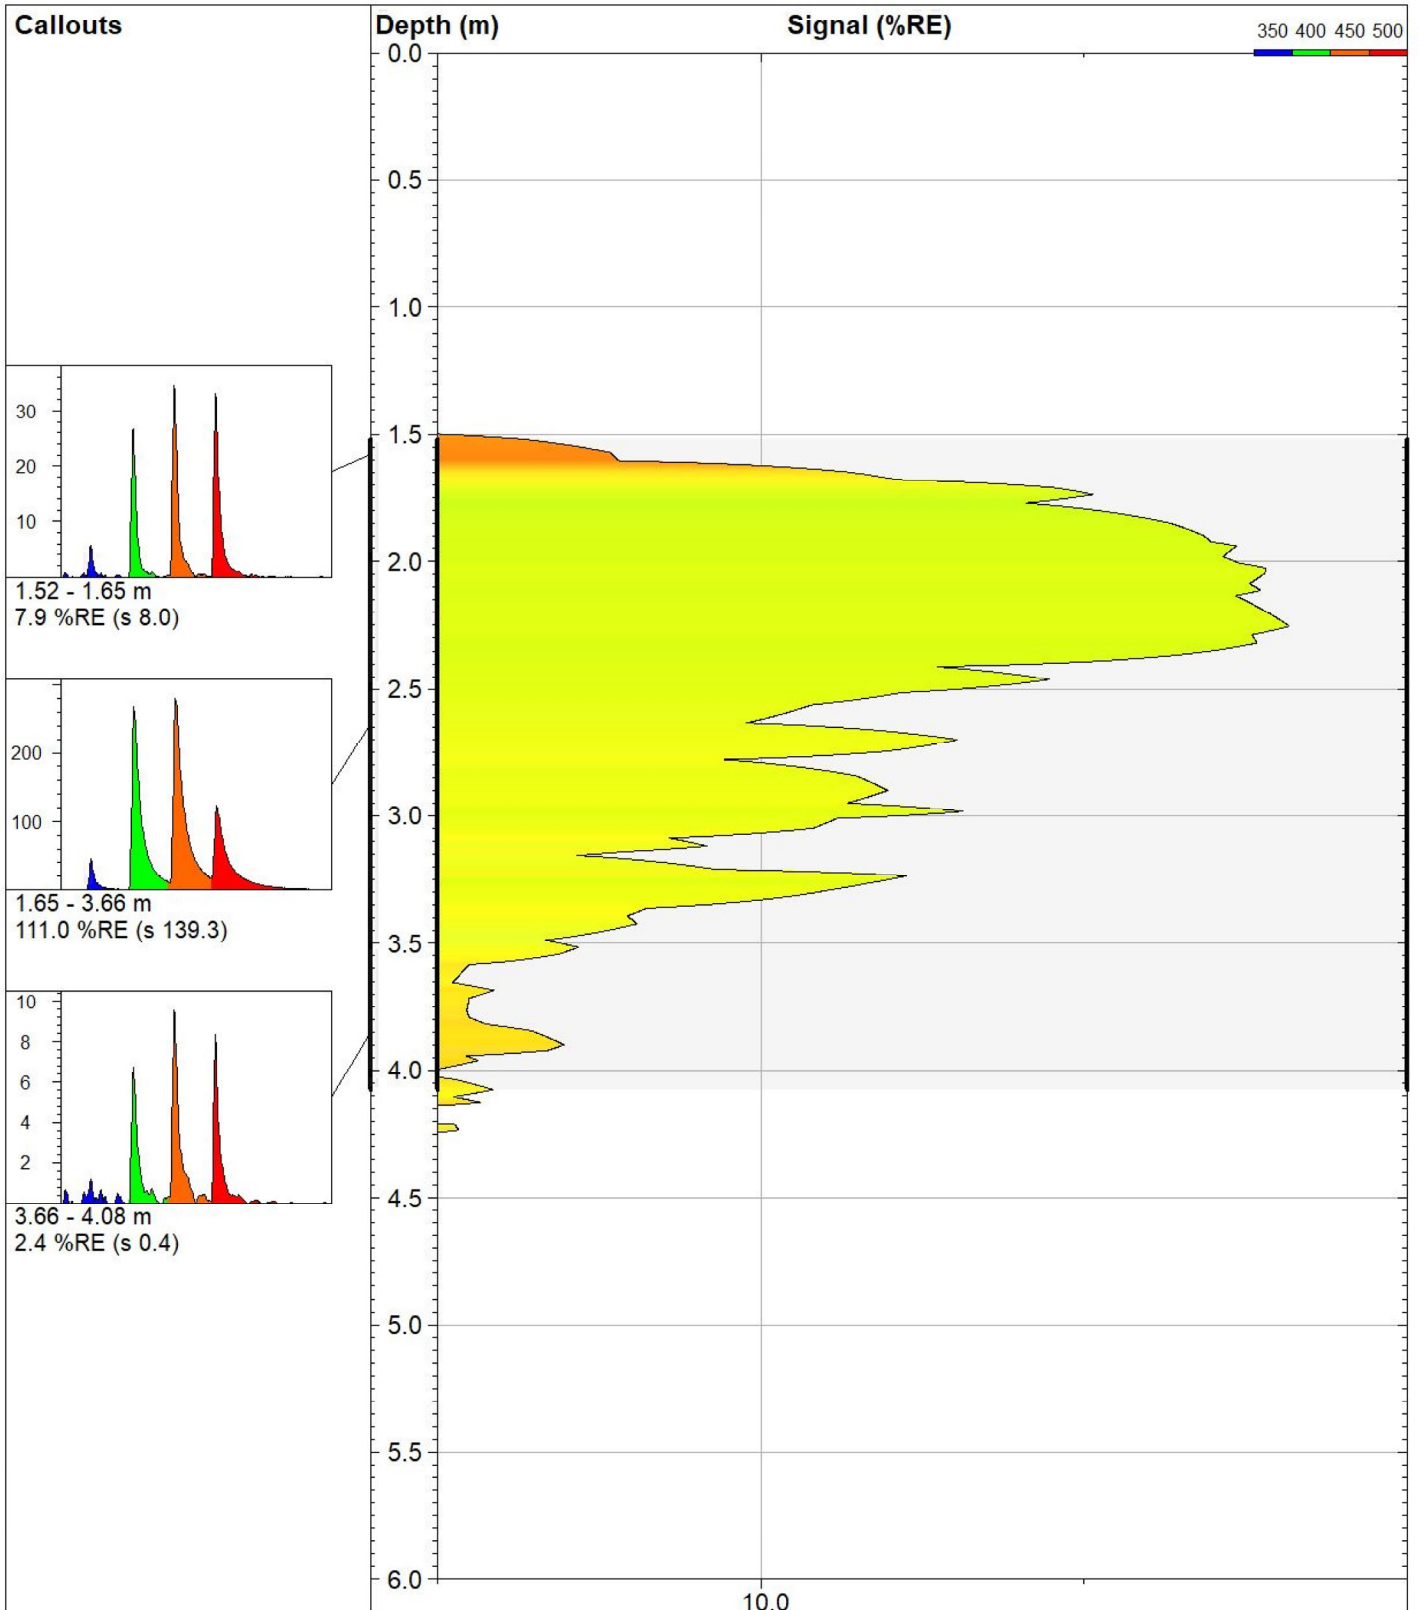
**LIF20154**

Final depth:  
**4.28 m**

Max signal:  
**432.9 %RE @ 2.25 m**

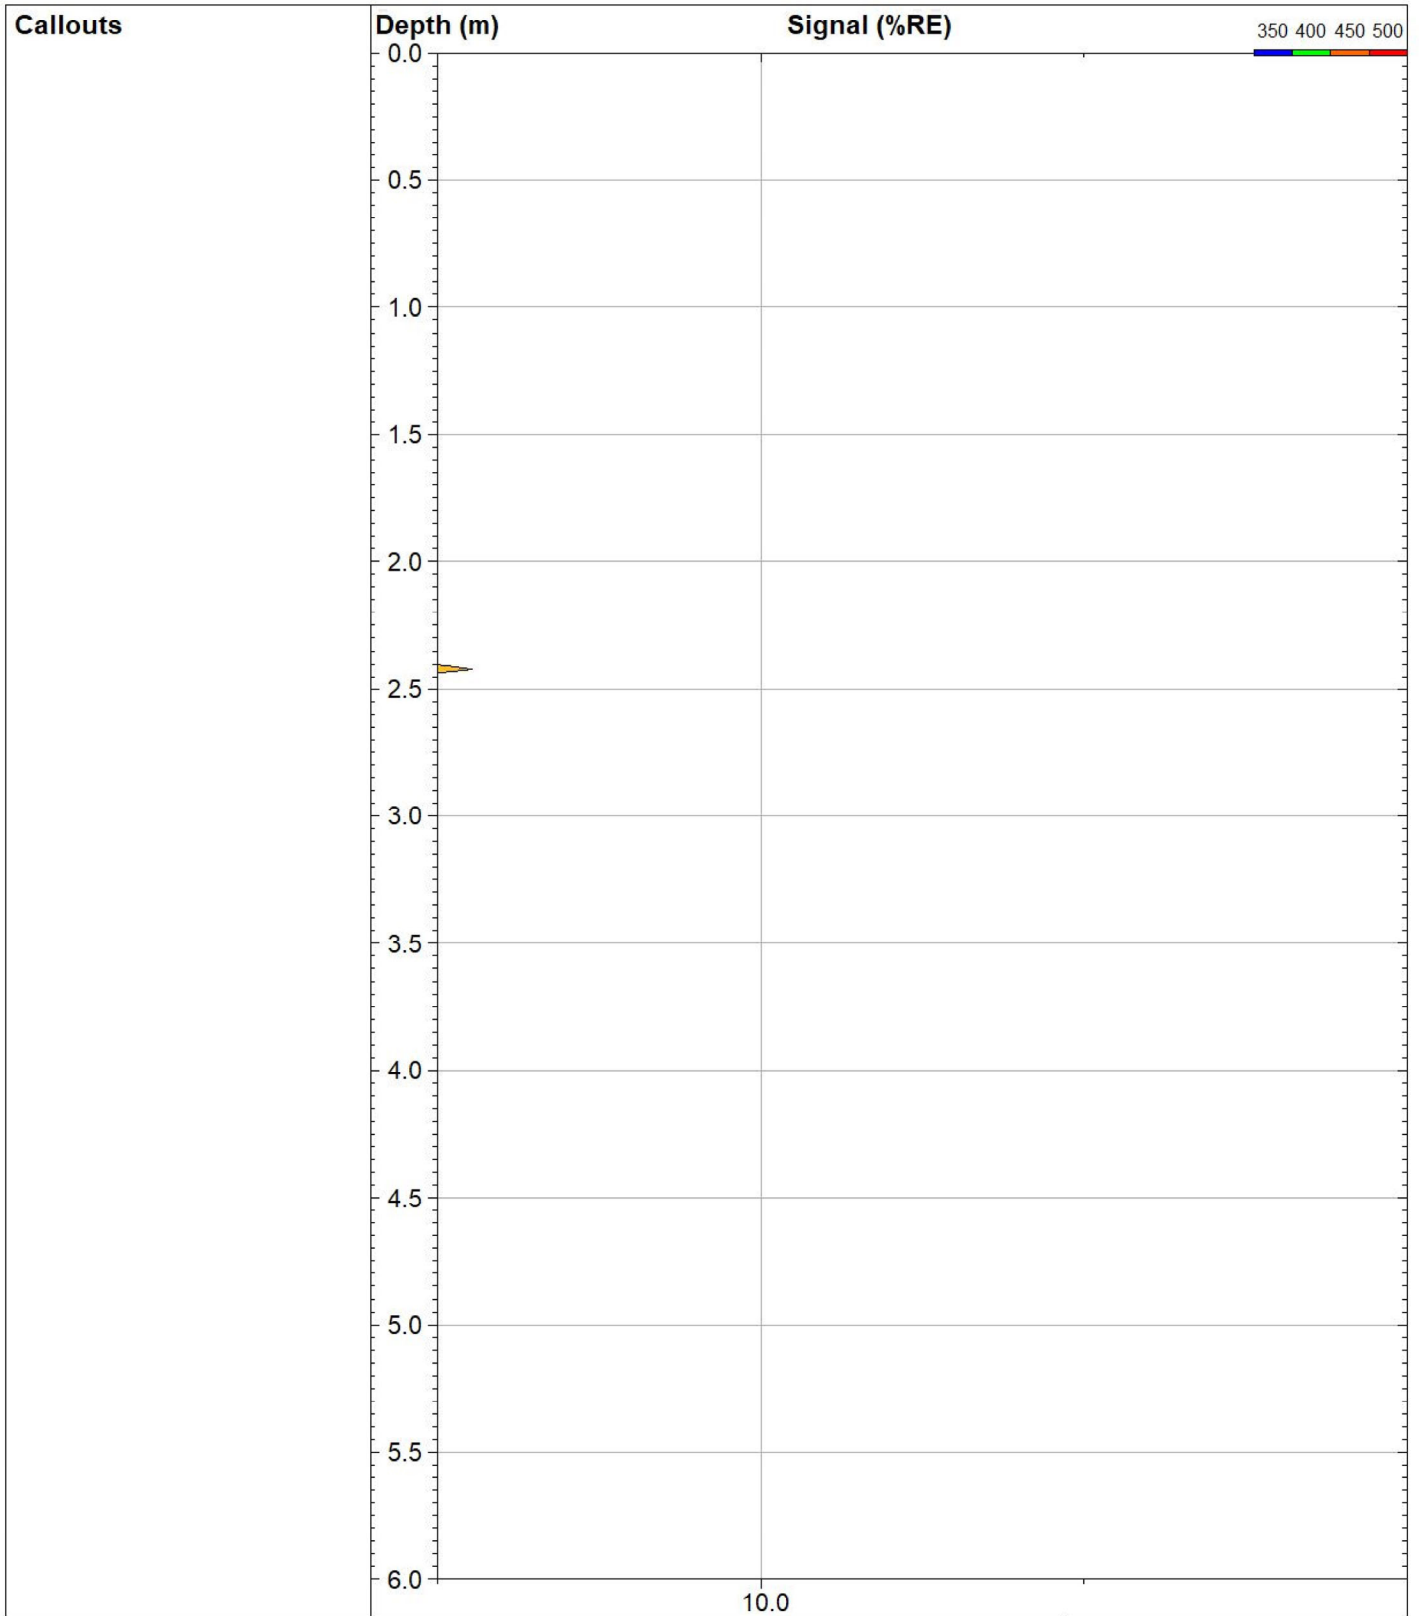
**LIF20155**

*Final depth:*  
**3.08 m**

*Max signal:*  
**2.3 %RE @ 2.42 m**
