**VERTEX**  
Environmental Inc.

**LIF20129**

Site:  
**Canatara Park**

Client / Job:  
**RWDI / VE848**

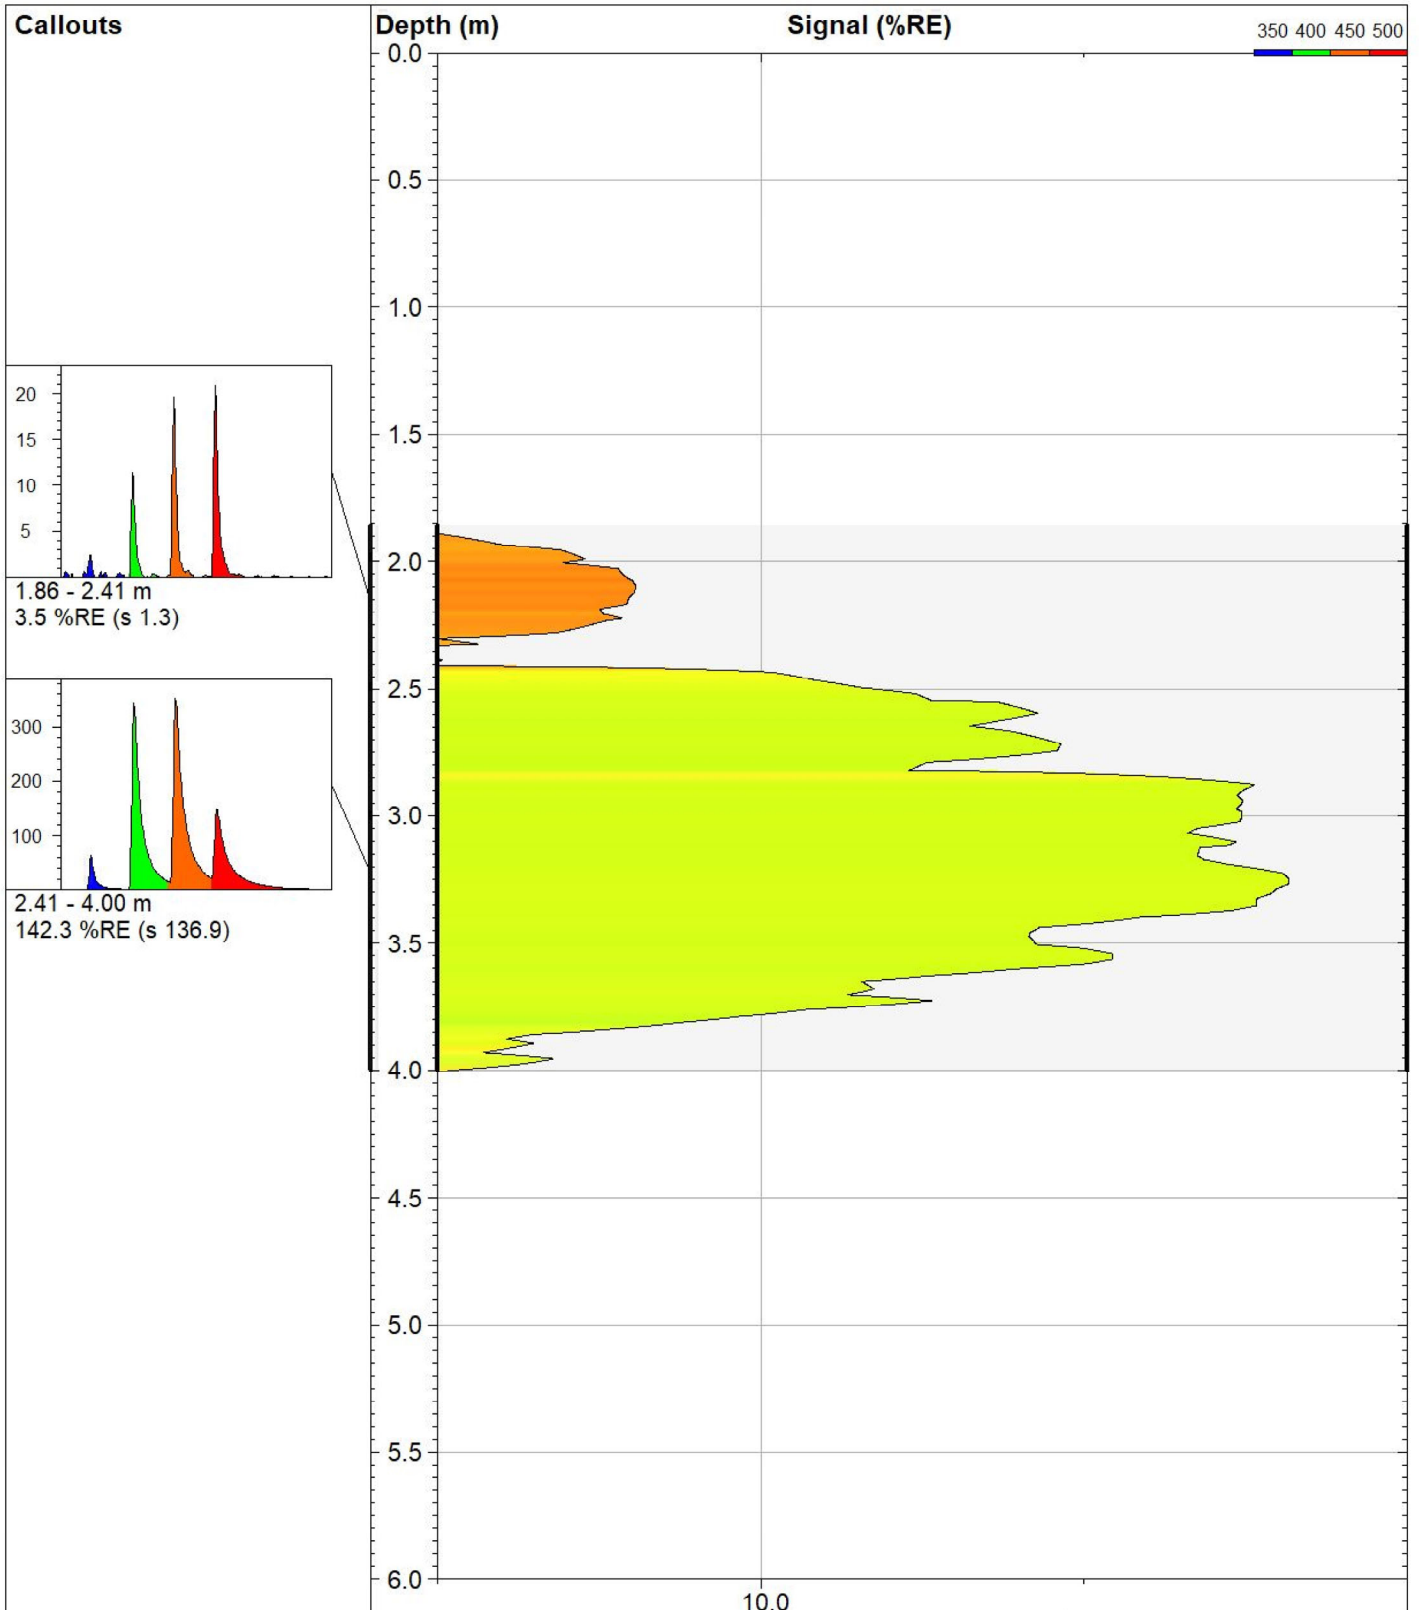
**LIF20156**

Final depth:  
**4.27 m**

Max signal:  
**431.4 %RE @ 3.27 m**

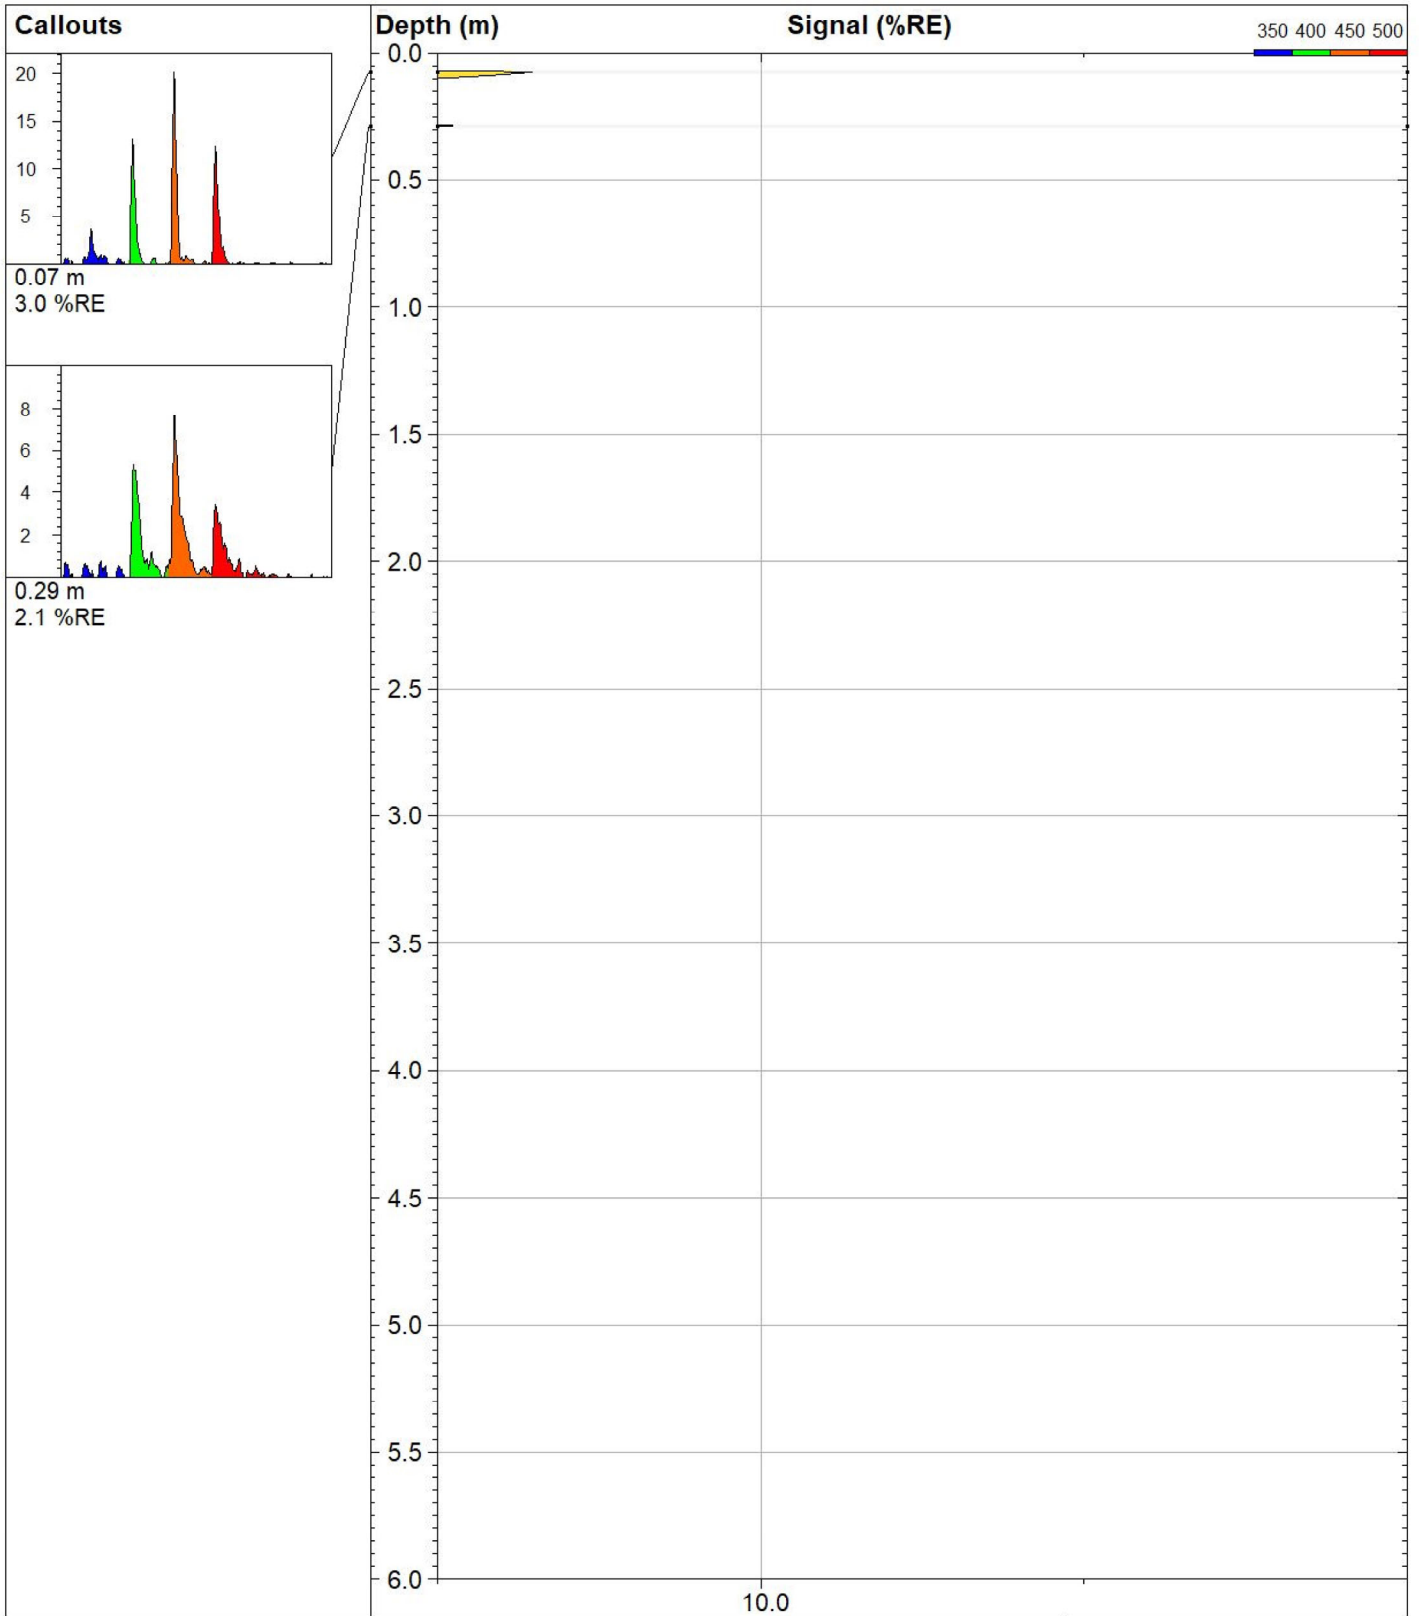
**LIF20157**

*Final depth:*  
**3.69 m**

*Max signal:*  
**3.0 %RE @ 0.07 m**
